GOM² PRESSURE CORING TOOL WITH BALL VALVE (PCTB) LAND TEST INITIAL REPORT

Submitted by: Peter B. Flemings Stephen Phillips Tom Pettigrew Tessa Green

GOM² Pressure Coring Tool with Ball Valve (PCTB) Land Test Initial Report

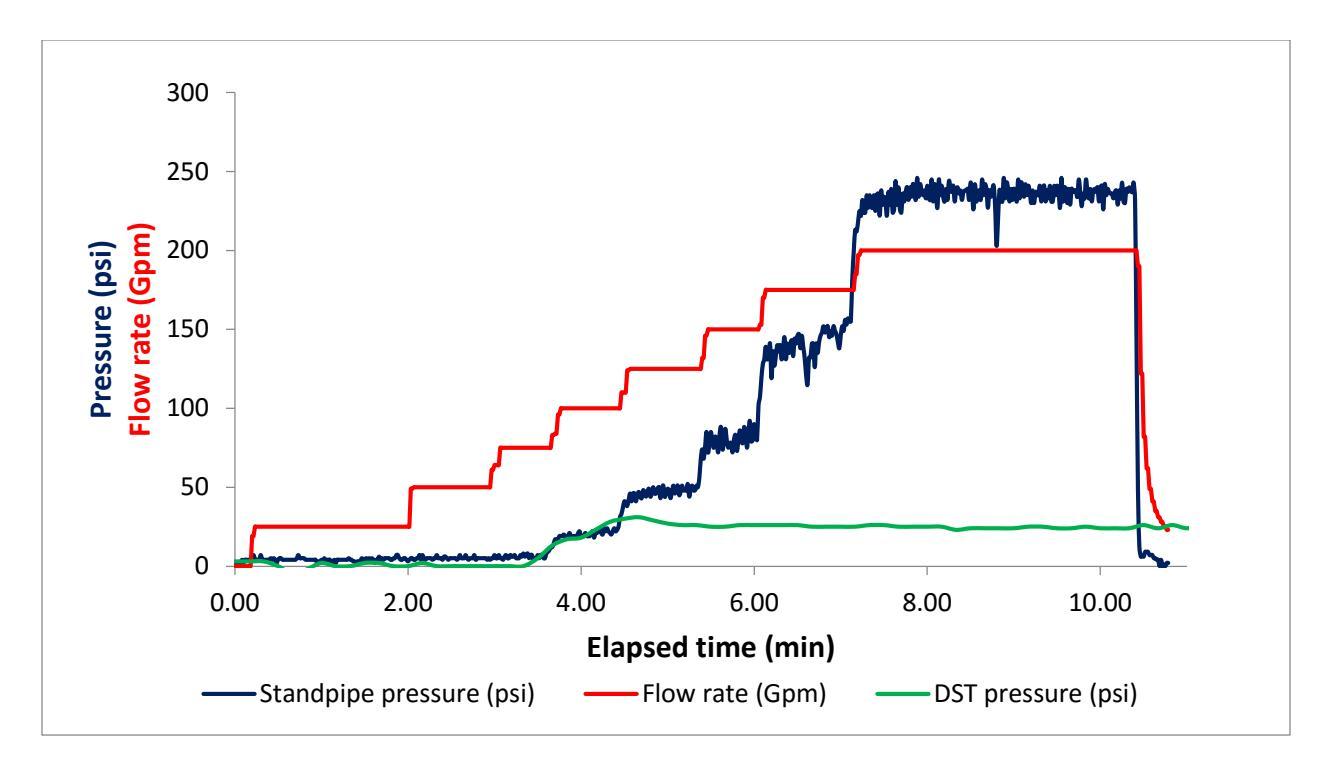
The Flow Test 1 results are illustrated in Figure 1. Flow Test 1 tested the 10%" face-bit configured PCTB tool as one continuous flow test, starting with a pump rate of 25 GPM, and continuously ramping up the flow rate at 25 GPM increments. The first Flow Test ramped up the flow rate by 25 GPM increments to 200 GPM, increasing standpipe pressures to 246 psi. Examination of the core liner after the test showed no indications of collapse. Pressure data from inside the core liner measured by "fish pill" data storage tags (DST) show an increase to 30 psi during the first two flow rate steps, and then a leveling off at 25 psi for the remainder of the test.

Figure 1: Flow Test 1 results. Pressure was measured at the rig floor (standpipe pressure, blue line) and inside the core liner ('DST' is acronym for 'data storage tag', which is a 'fish pill'). At a pump rate of 200 Gpm, the flow standpipe pressure is ~250 psi.

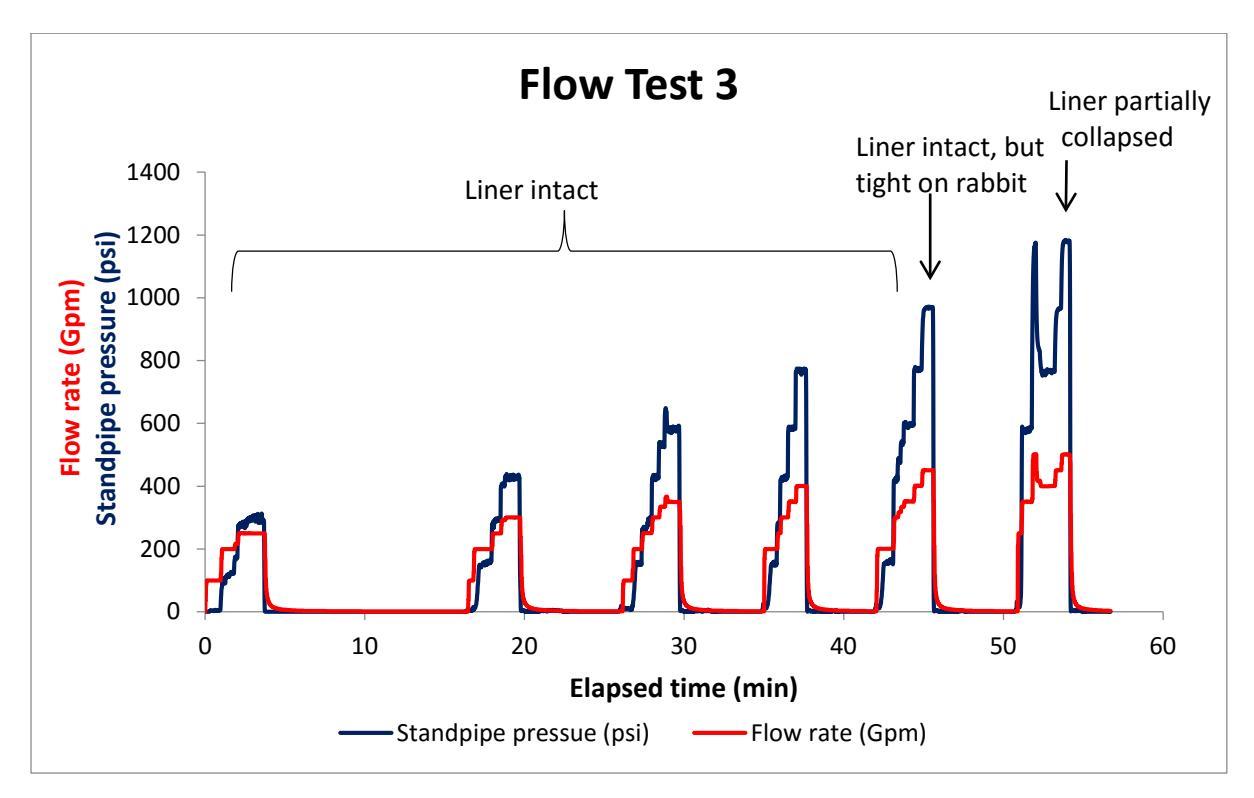
Flow Test 3 was performed to liner collapse with the PCTB cutting-shoe configuration PCTB and the 9%" cutting-shoe bit. In this test, the flow rate was incrementally increased. However, between each flow rate, the PCTB was extracted by wireline and the core liner was examined for evidence of collapse. In this case, at a flow rate of 450 Gpm, the standpipe pressure was 972 psi and when the core liner was examined it was slightly deformed. At the next flow rate of 500 Gpm, the standpipe pressure was 1184 psi and the liner was found to have been collapsed when examined. No DST data were available from within the core liner. Results of Flow Test 3 are shown in Figures 2 and 3.

Figure 2: Flow Test 3 (liner collapse test). Flow rate in red and standpipe pressure in blue.

Between each flow rate increase, the PCTB was extracted by wireline and the core liner was examined for evidence of collapse. At 450 Gpm, the standpipe pressure was 972 psi and when the core liner was examined it was slightly deformed. At the next flow rate of 500 Gpm, the standpipe pressure was 1184 psi and the liner was found to have been collapsed when examined. No DST data were available from within the core liner.

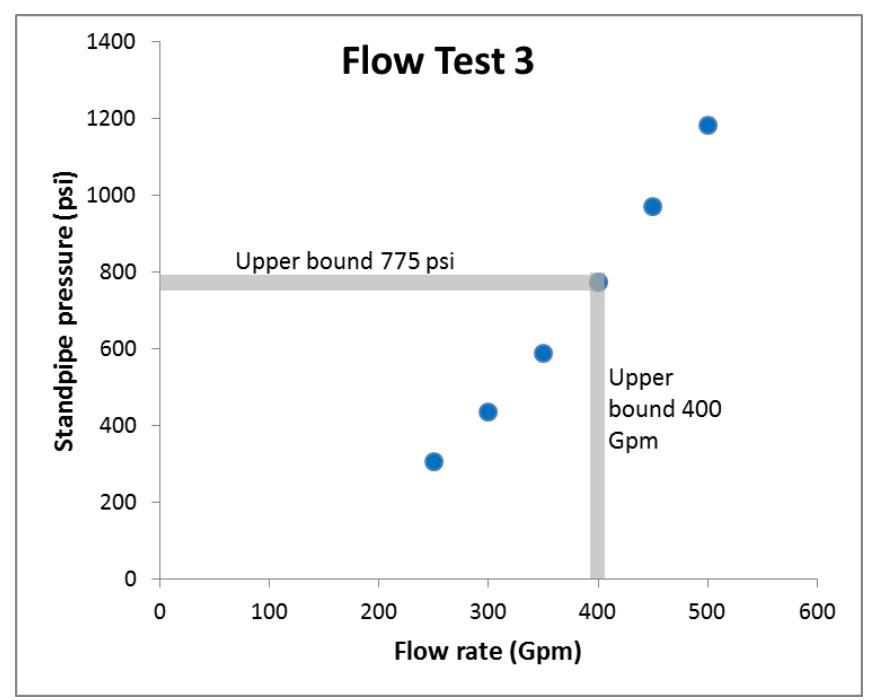
Figure 3: The results of Flow Test 3 suggest 400 Gpm is an upper bound for the PCTB cutting-shoe configuration.

Flow Test 3 (liner collapse test) suggests that a significantly larger standpipe pressure can be applied without collapsing the liner. In this example, during the Field Dynamic Flow Test, no liner deformation was observed up to a flow rate of 400 GPM or a standpipe pressure of 770 PSI. This is perhaps an upper bound for the standpipe pressure that the tool can withstand without collapsing the core liner. At a flow rate of 500 GPM with a corresponding standpipe pressure of 1184 PSI, the liner was found to have collapsed. Upon recovery we noted that only part of the core liner had collapsed (Fig. 4), the area from the ball-valve up about 3 feet. In this section of the tool, the liner is not supported by the inner-tube when in the coring position, which allows for the pressure differential to establish between the liner and the inner-tube. This test indicates that a flow rate of 400 GPM with a corresponding stand pipe pressure of 770 psi is perhaps a true upper bound for operating the PCTB without collapsing the liner (Fig. 3).

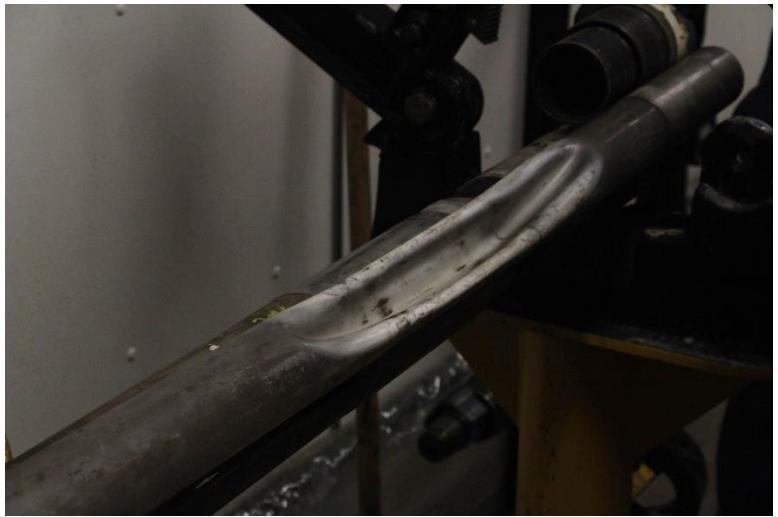
Figure 4: Collapsed liner after Flow Test 3.

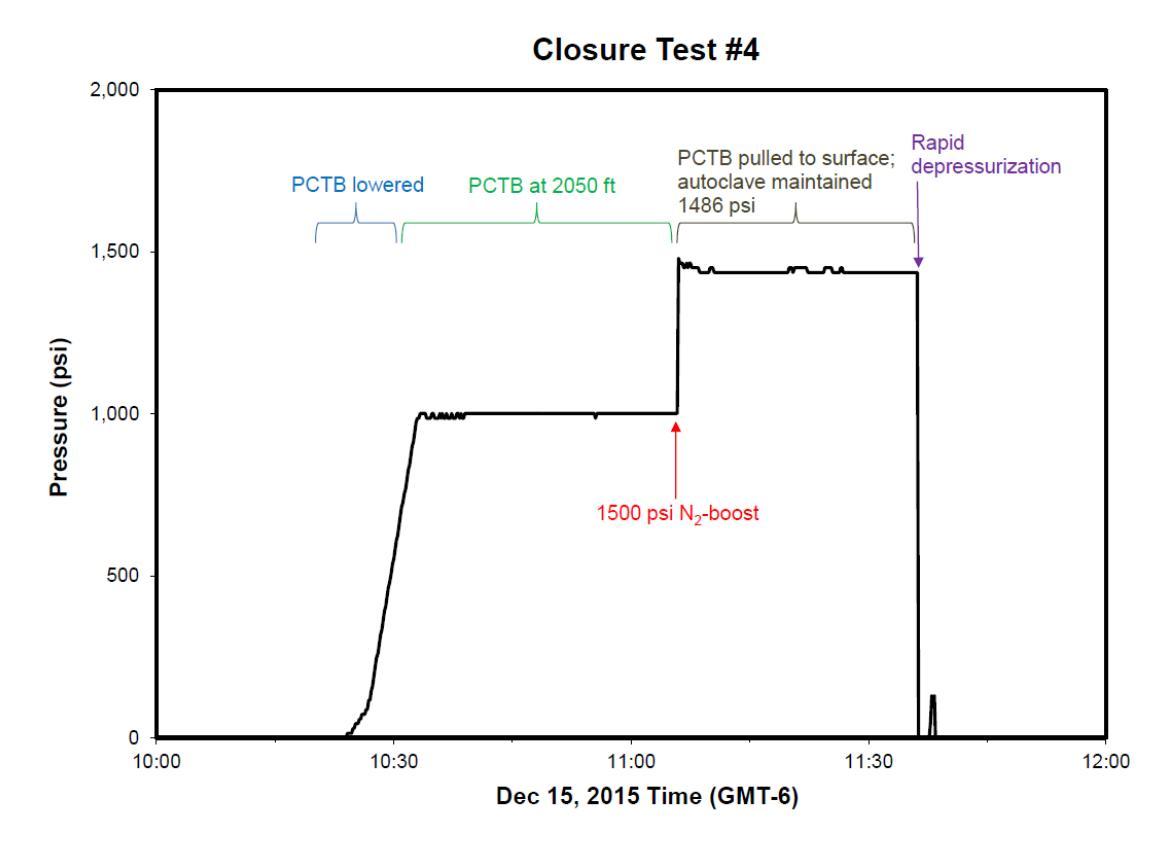
<u>Closure Test 4:</u> The PCTB was deployed on wireline and actuated. The PCTB was then recovered and the autoclave maintained a pressure of 1486 psi (Fig. 5). DST data indicate the autoclave boost fired correctly.

Fig 5: DST pressure from Closure Test 4.

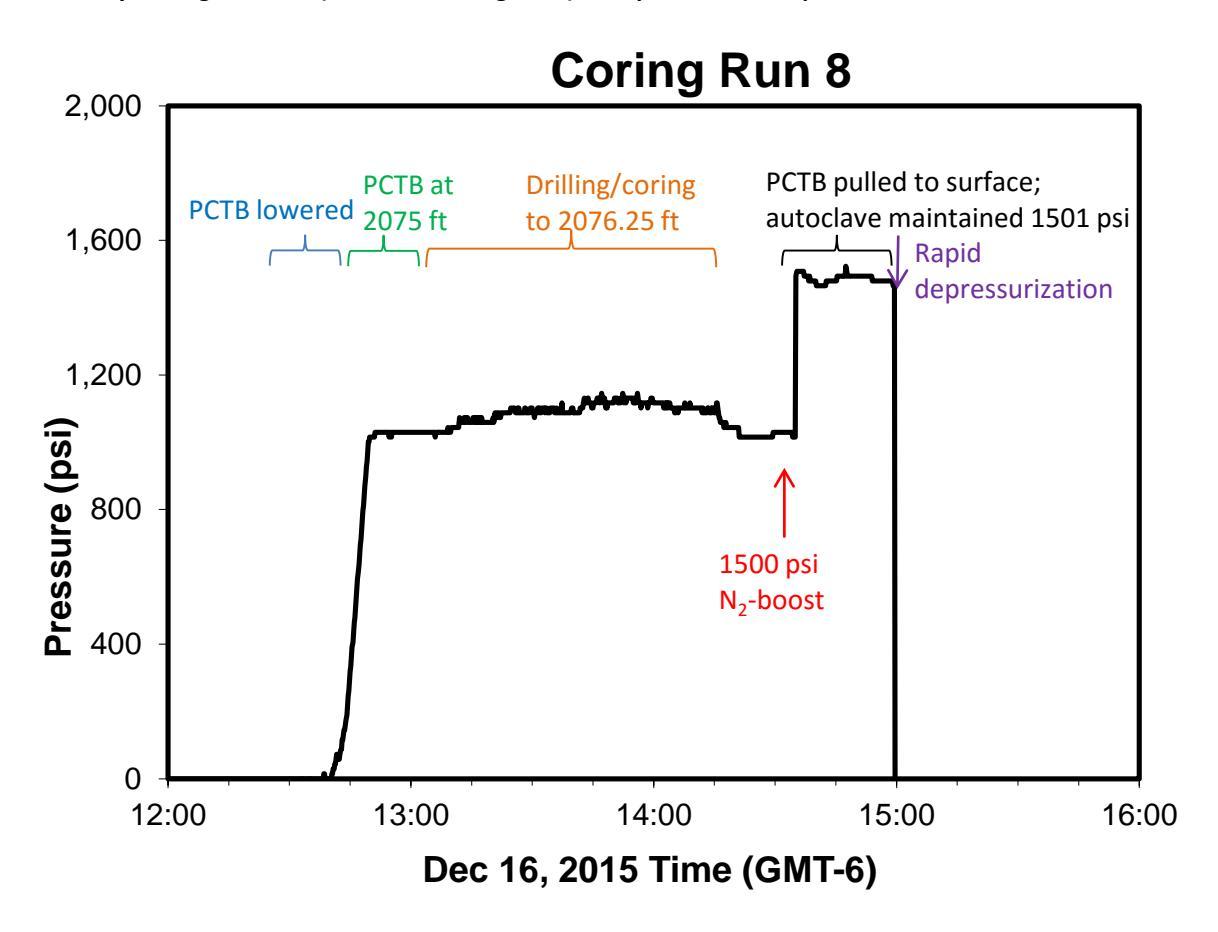
<u>Coring Test 7:</u> Coring Test 7 began at a depth of 2075 ft. using the PCTB face-bit configuration and 10-5/8" face-bit. Coring ended at a depth of 2076.25 ft after 1 hr of coring. The ball valve closed properly following a successful twist-off of the formation, and the autoclave maintained a pressure of 1710 psi. 20" of mudstone were recovered under near the nitrogen boost set pressure. <u>Coring Test 8:</u> The eighth and final coring test of the land test began at a depth of 2076.25 ft. using the same face-bit configuration as tests 6 and 7. Coring ended at a depth of 2078.38 ft. after 1 hr of coring and the PCTB recovered. The ball valve closed properly following a successful twist-off of the formation, and the autoclave maintained a pressure of 1501 psi. 29" of shale with limestone were recovered at the nitrogen boost set pressure (Fig. 6).

Fig 6: Successful operation of Coring Test 8.

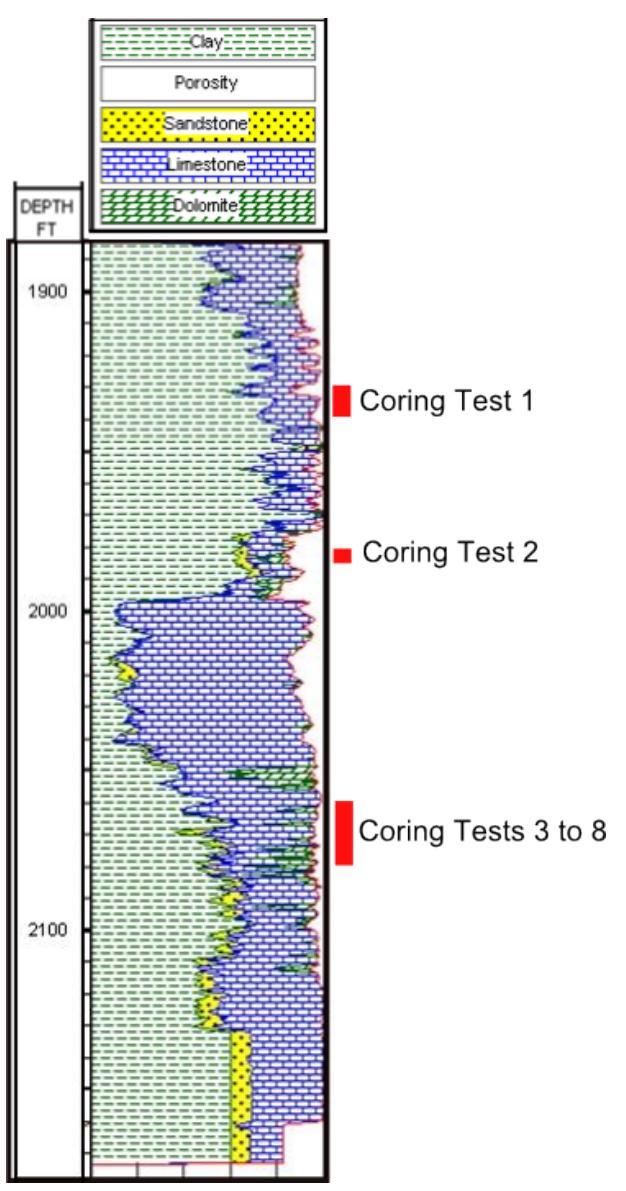
The first two Coring Tests were made in the relatively soft mudrock of the Eagle Ford Formation. Coring Test 3 was performed at the base of the limestone Buda Formation, and Coring Tests 4 through 8 were made in the marlstone and interbedded mudstone and limestone of the Grayson formation (Fig. 7).

Figure 7: Depths of coring tests plotted with lithology. Lithologic logs from the Cameron Test and Training Facility were provided by Schlumberger.

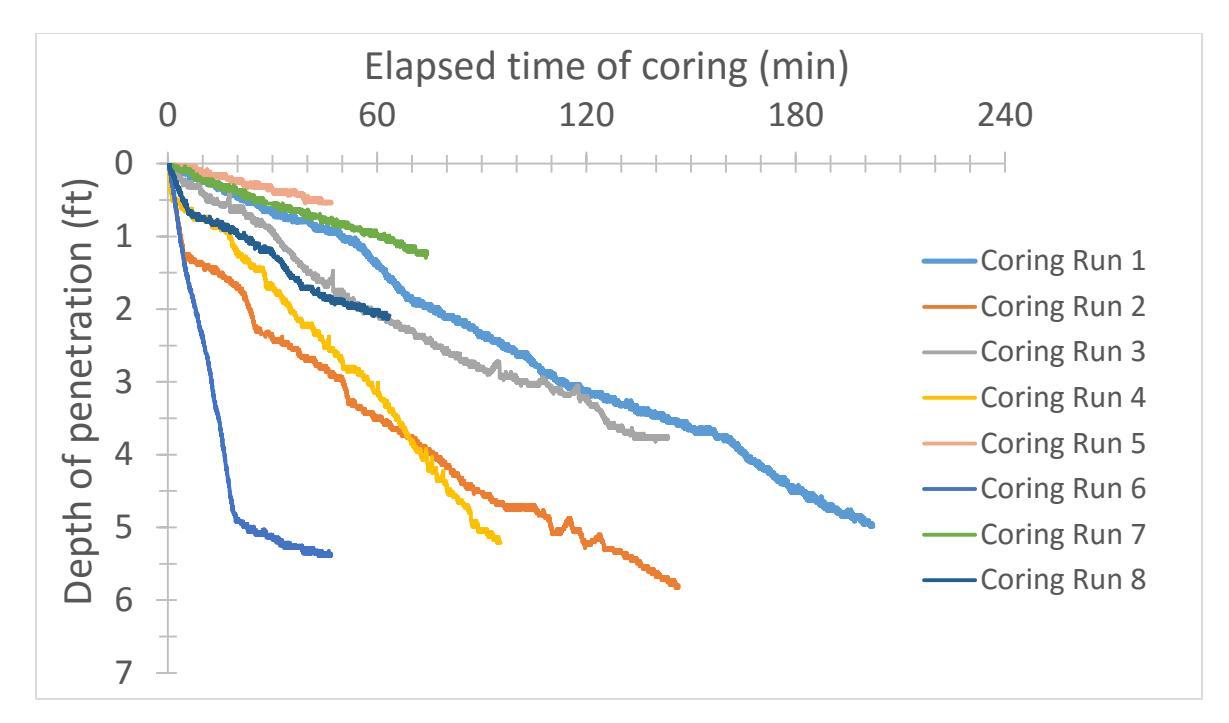
Overall, coring rates were very low during each the Coring Tests (Fig. 8). Penetration rates did not differ by PCTB configuration. Coring Tests 1 through 5 were made with the cutting-shoe configuration, in the clay-rich Eagle Ford Formation and the more carbonate-rich Buda and Grayson Formations. (Fig. 7). A core was recovered at boosted pressure during Coring Test 1; however, the N₂ boost occurred near the rig floor after the core had nearly dropped to atmospheric pressure. Several attempts were made to drill down to more favorable formations without an increase in successful coring using the cutting-shoe configuration. Bit-balling and jet-plugging were problematic in the cutting-shoe configuration, but the problem appeared to be lessened in the carbonate formations. In Core 3, after coring the most carbonate-rich interval of the test, the PCTB recovered an intact core, but without proper ball valve closure. As the amount of clay increased again in Cores 4 and 5, recovery dropped drastically. Slow penetration rates persisted in the hard carbonate-rich rock, and jamming of the ball valve continued to be an issue. After the liner collapse tests, the flow rates during Coring Tests 4 and 5 were increased up to 300 Gpm from 225 Gpm in previous tests. Even with increased flow rates in Coring Test 5, these issues persisted.

Figure 8: Depth versus penetration for all coring tests.

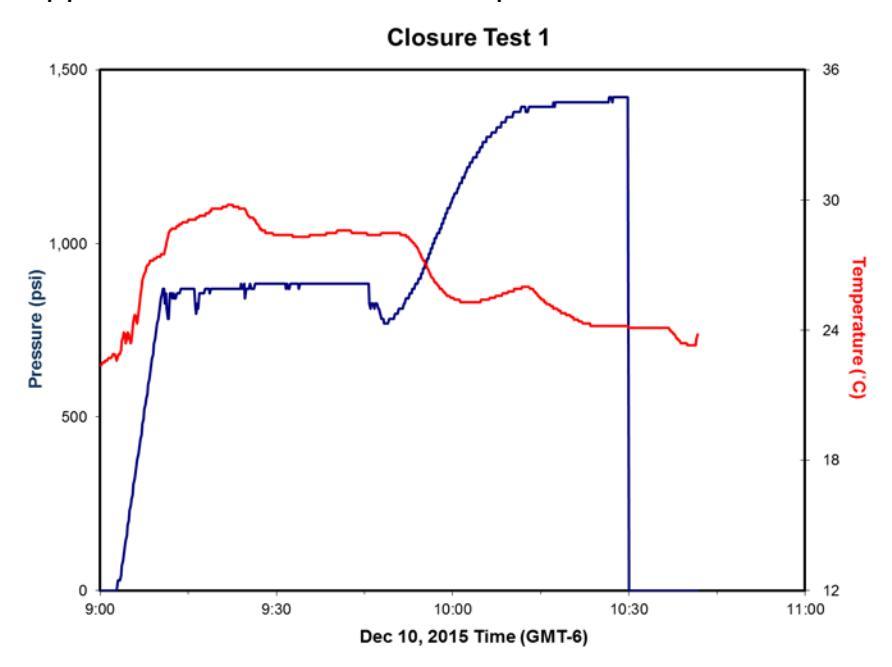
<u>Closure Test 1:</u> The autoclave boost was set at ~1500 psi. Upon recovery, the autoclave was found to contain 1408 psi pressure. Subsequent review of the fish pill data indicated that the autoclave boost occurred slowly over a brief period of time. This was attributed to a nearly fully closed bullet valve which restricted the hydraulic boost flow driven by the nitrogen gas charge in the accumulator. However, at no time did the autoclave pressure drop below ~800 psi.

Figure A1: DST data from Closure Test 1.

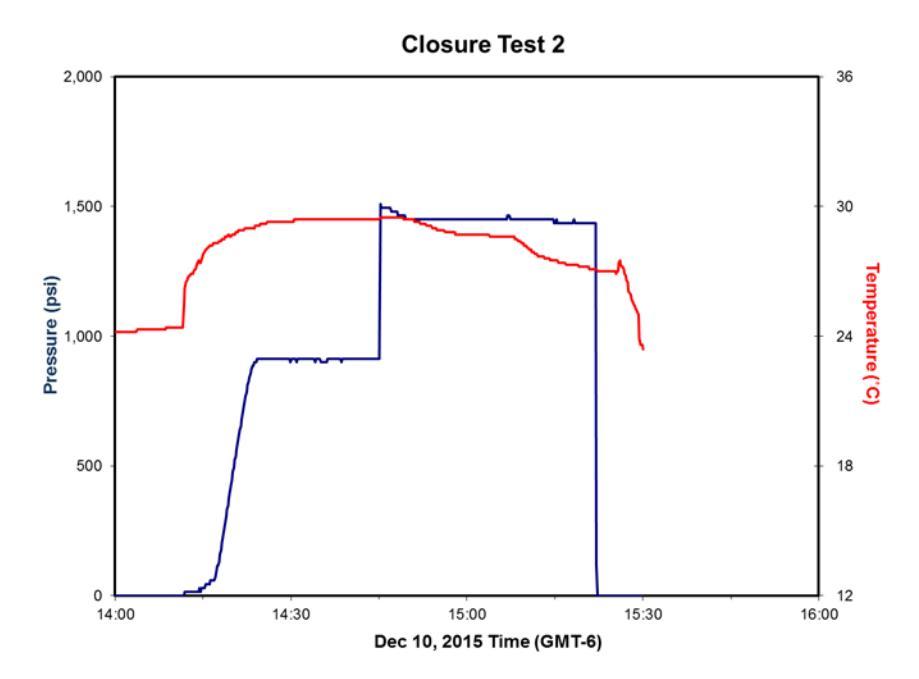
<u>Closure Test 2</u>: The autoclave boost was set at ~1500 psi. Upon recovery, the autoclave was found to be at 1580 psi.

Figure A2: DST data from Closure Test 2.

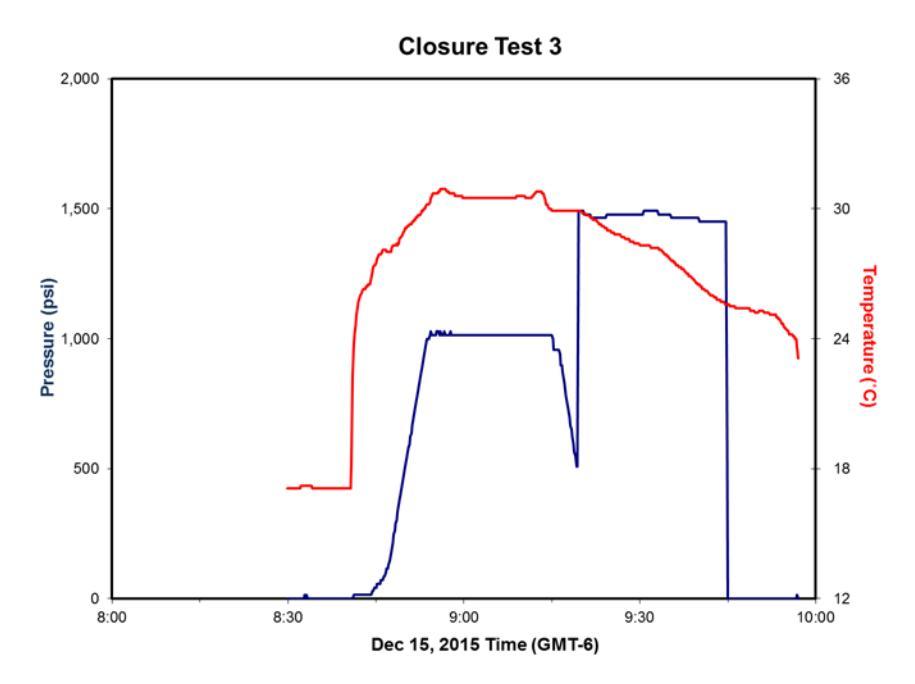
<u>Closure Test 3:</u> The PCTB was deployed on wireline and actuated. The PCTB was then recovered and the autoclave maintained a pressure of 1484 psi. DST (fish pill) data indicate that the autoclave boost fired correctly but the boost was late.

Figure A3: DST data from Closure Test 3.

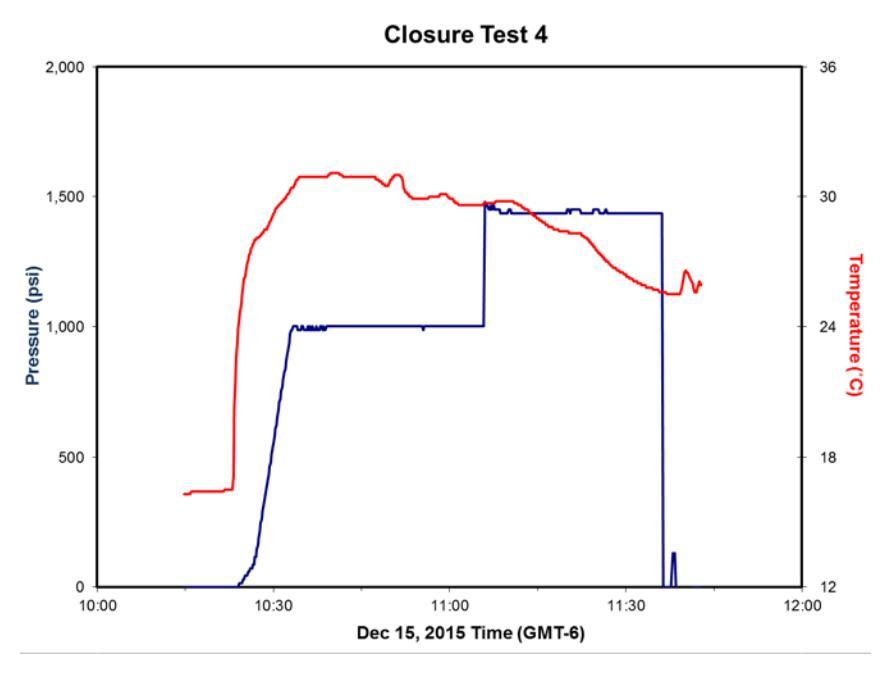
Figure A4: DST data from Closure Test 4.

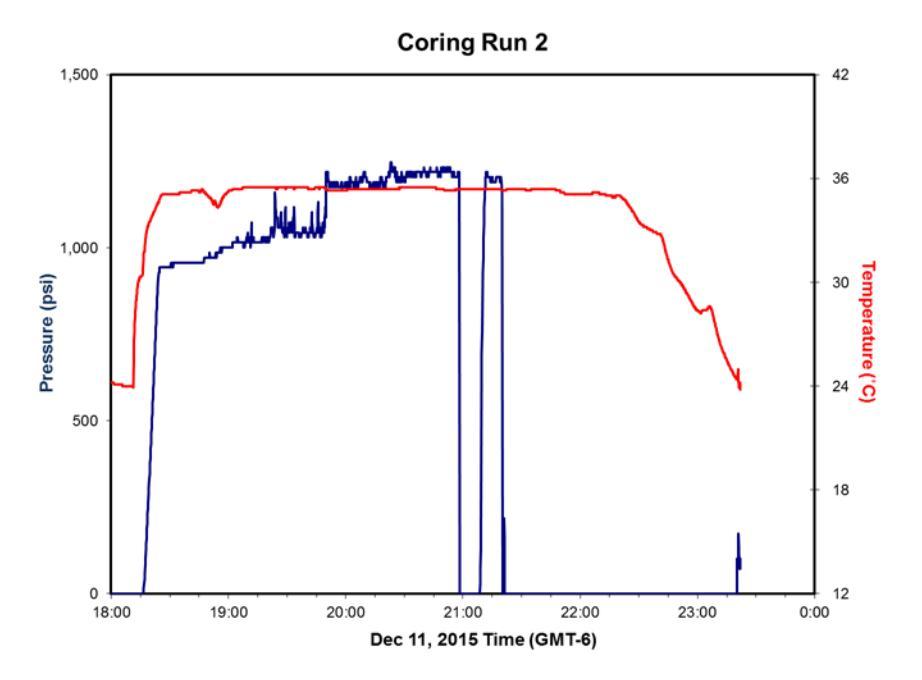
<u>Core Test 2:</u> The hole was drilled using a center bit from 1943 ft. to 1992 ft. before attempting Coring Test 2. Core Test 2 (9-7/8" cutting-shoe configuration) cored ~3 ft. to 1995 ft. over 2 hr and when the PCTB was recovered, although the ball valve had closed, it was not sealed and the autoclave pressure was found to be 0 PSI. The seal on the ball valve was coated with mud containing angular fragments preventing a seal. 29" of core and ~ 9" of core catcher material were recovered. The DST (fish pill) data was inconclusive in that the DST worked only intermittently and there was no useful data during recovery of the core.

Figure B2: DST data from Coring Run 2. Note the dropouts in data starting at 21:00.

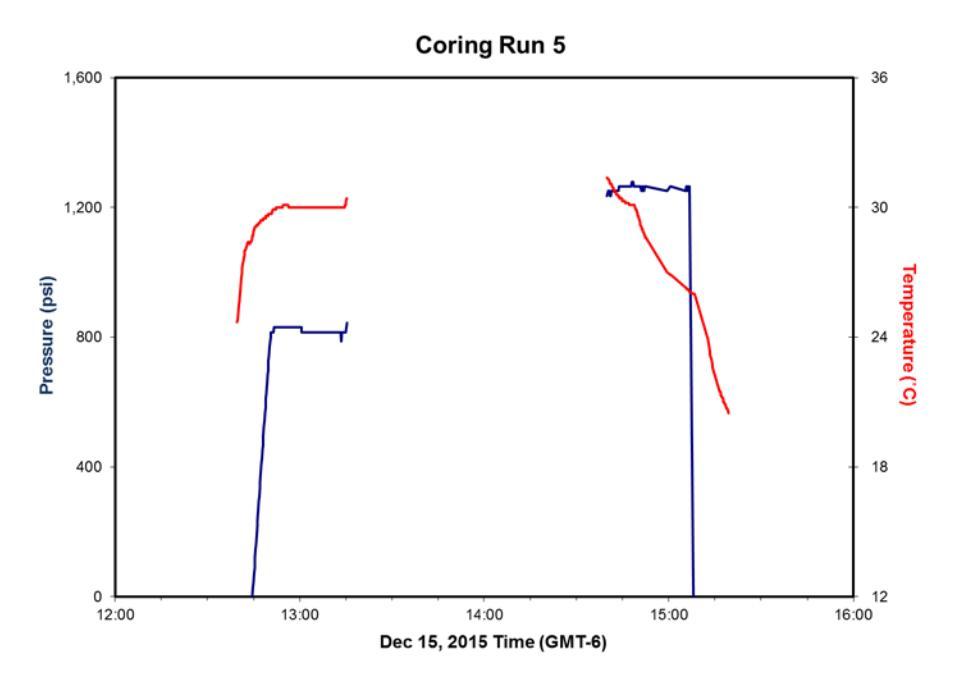
Figure B4: DST data from Coring Run 5. There is a drop out of data in the middle of the run.

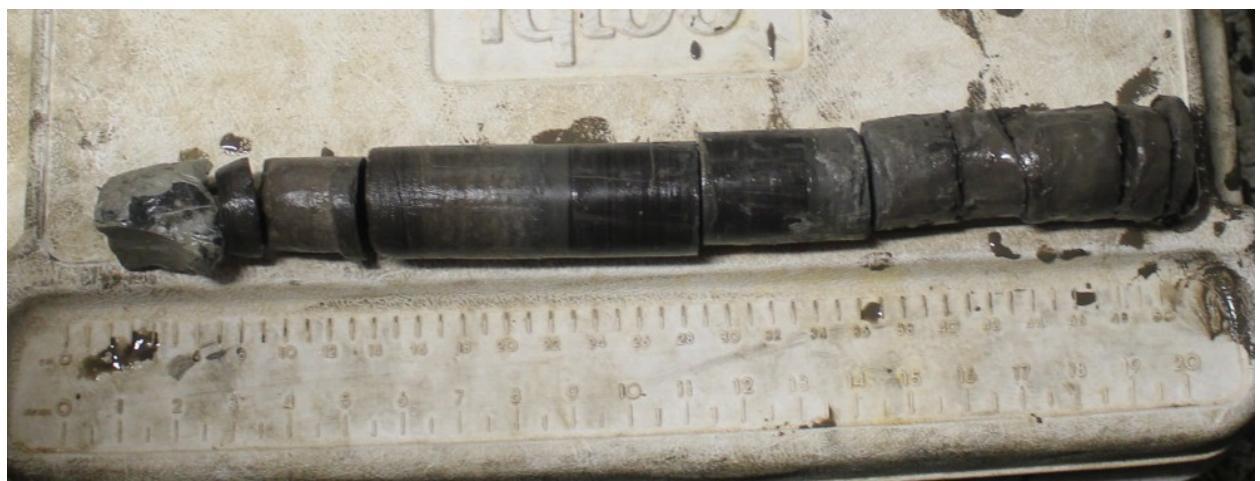
Figure C1: Core 1

<u>Coring Test 1:</u> Operational time 16:30hr to 21:00 hr. BHA set at 1871 ft. at start of test. At 17:50, the BHA reached the bottom of the hole to begin drilling at 1938 ft. for the first coring test. The PCTB was then lowered by wireline into the hole. Coring began at 17:30. Drilling then proceeded slowly, with a penetration of 5 ft. over 3 hr. The PCTB was recovered at 22:00 with a pressure of 1490 psi. The PCTB was recovered at 22:00 with a pressure of 1490 psi. The DST (fish pill) data show that the boost fired late while the tool was being raised up the hole, at around 100' MD. A 1.5 ft. core of silty shale to siltstone was recovered. The flow ports on the cutting-shoe were clogged and the outer edge of the core showed evidence of grinding.

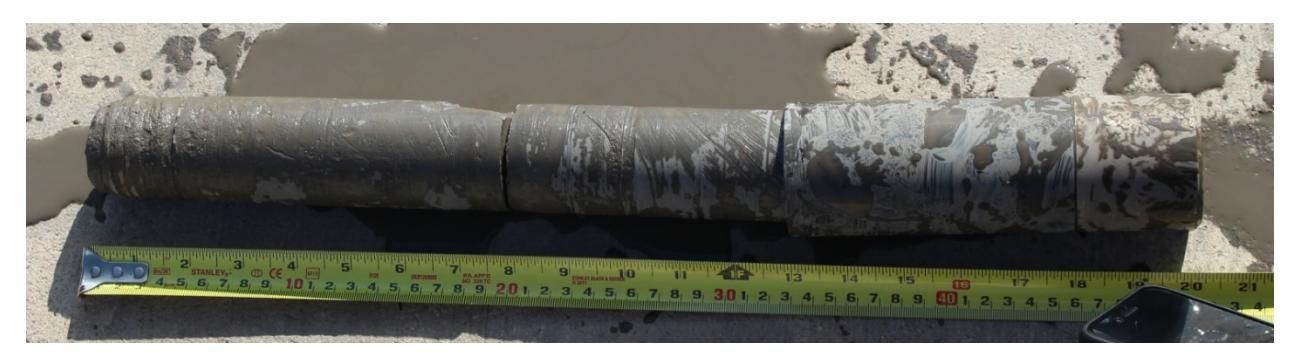
Figure C3: Core 6

<u>Coring Test 6:</u> Coring Test 6 began at a depth of 2069.57 ft. using the PCTB face-bit configuration and 10-5/8" face-bit and ended at a depth of 2075 ft after 45 min of coring. Upon recovery of the PCTB the ball valve was found not to have closed due to a piece of core sticking out of the core catcher. A total of 36" of rock was recovered.

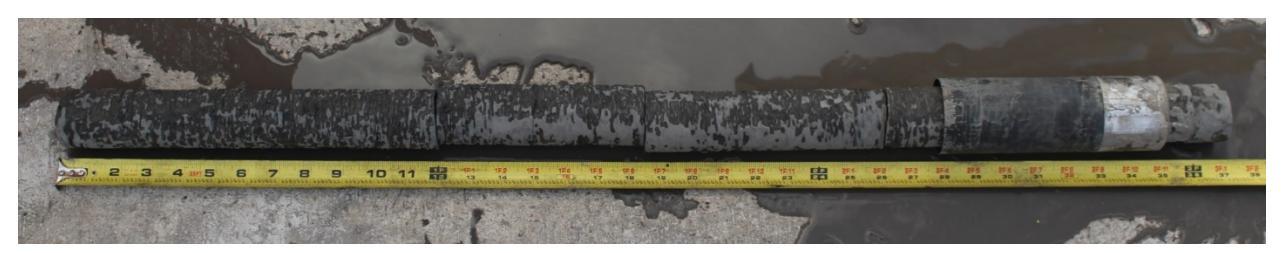
Figure C4: Core 7

<u>Coring Test 7:</u> Coring Test 7 began at 09:00 from a depth of 2075 ft using the face-bit configuration, with an 8-10 klb bit weight and 250 Gpm flow rate. Coring ended at 10:10 at a depth of 2076.25 ft. The PCTB was recovered at 10:45. The PCTB ball valve closed properly following a successful twist-off of the formation, and the autoclave maintained a pressure of 1710 psi. 20" of mudstone were recovered in core 7P with a spiral fracture visible at the bottom of the core. The mudstone appeared to be carbonate-cemented, but was not nearly as hard as the rock in the bottom of core 6P.

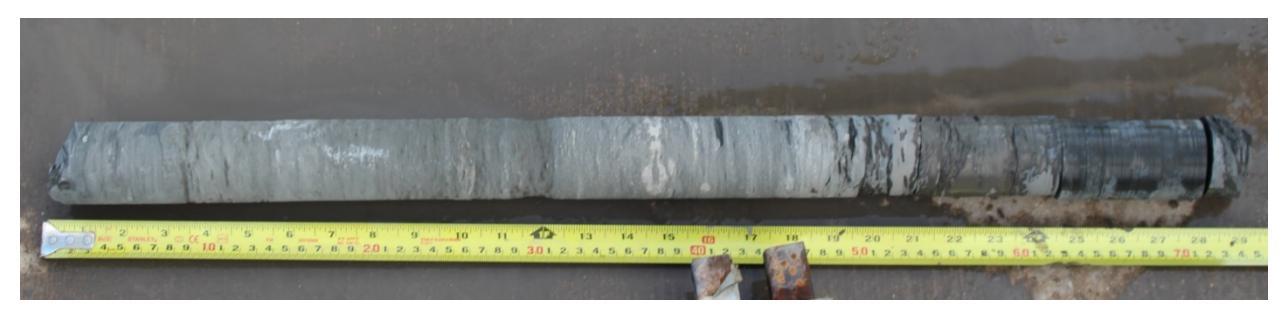
Figure C5: Core 8

Coring Test 8: The eighth and final coring run of the land test began at 13:17 from a depth of 2076.25 ft, using the same configuration as Runs 6 and 7. Coring ended at 14:21 at a depth of 2078.38 ft. The PCTB was recovered at 14:45. The PCTB ball valve closed properly following a successful twist-off of the formation, and the autoclave maintained a pressure of 1501 psi. 29" of shale with limestone were recovered in core 8P with the twisted-off surface visible at the bottom of the core. The top of core 8P appeared to match the fractured surface at the bottom of core 7P.
