# GOM2 PRESSURE CORING TOOL WITH BALL VALVE (PCTB) LAND TEST II REPORT

08/06/20

The University of Texas at Austin 101 East 27<sup>th</sup> Street, Suite 4.300 Austin, TX 78712-1500 e-mail: pflemings@jsg.utexas.edu

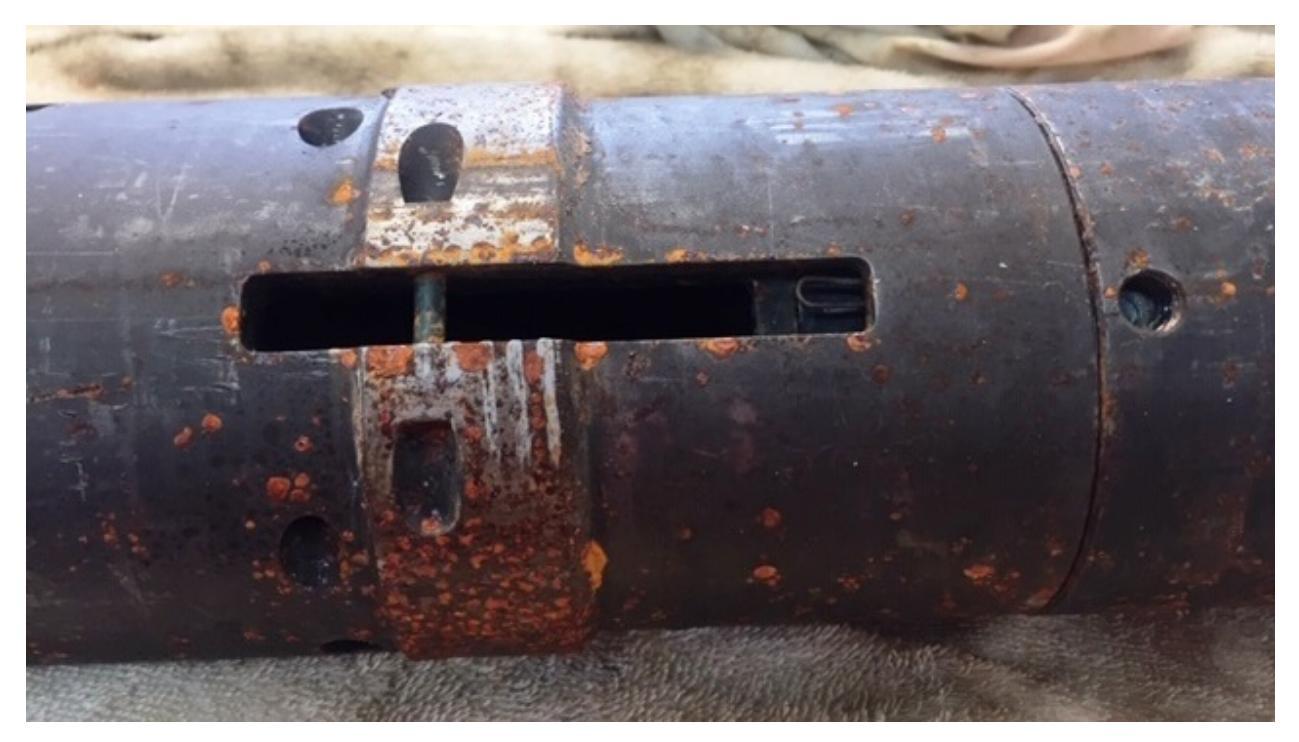
Figure 4-2. Missing locking dog.

Prior to disassembly of the PDT one of the locking dogs was observed to be missing (Figure 4-2). It appeared that the locking dog had sheared the pivot pin.

The loss of the locking dog is believed to be a result of the free falling-PDT slamming into the BHA landing shoulder. It is theorized that upon landing in the BHA, the missing locking dog did not have enough time to clear the landing sleeve as the landing sleeve instantaneously moved upward relative to the latch body. This action caused the locking dog pivot pin to shear, allowing the locking dog to fall out of the latch.

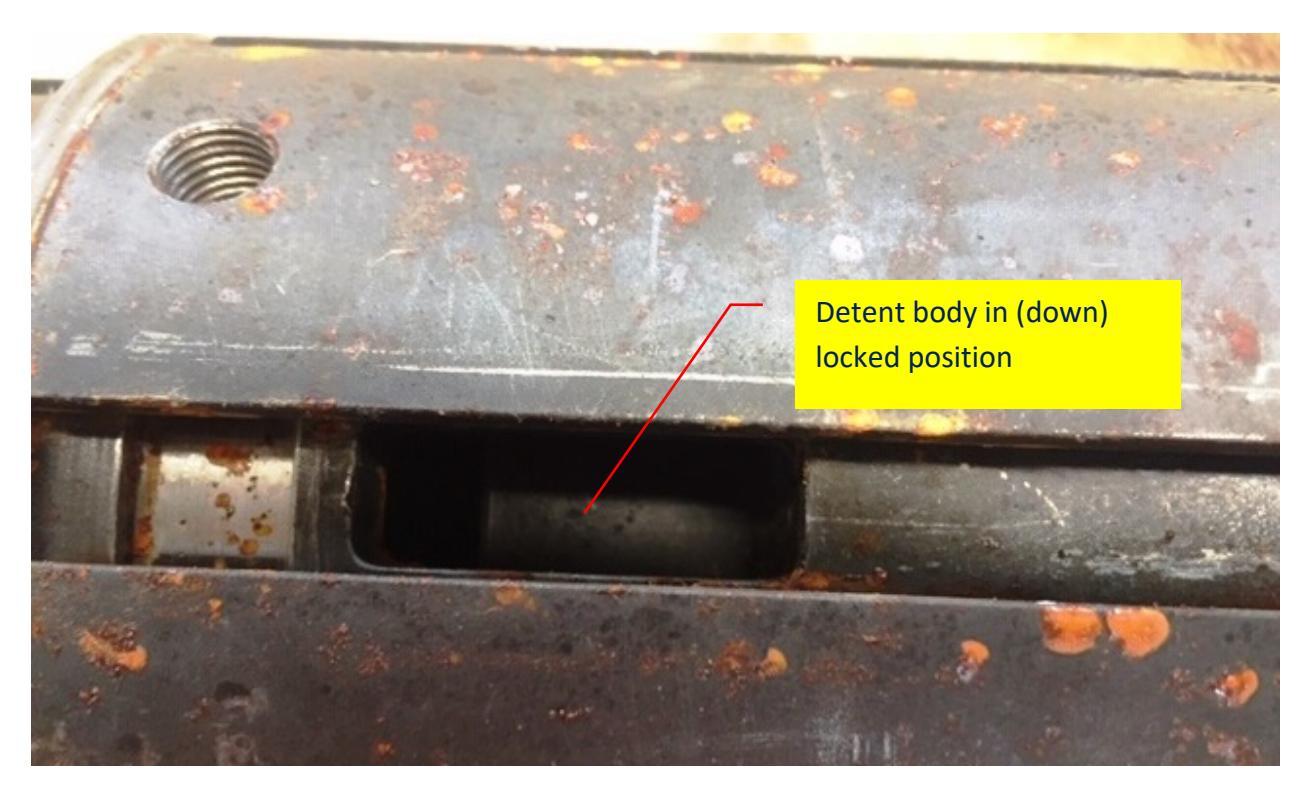
It was also observed that the latch detent body was still in the locked (down) position (Figure 4-3).

*Figure 4-3. Detent body in locked (down) position.*

This is an indication that the detents had failed allowing the RPT to release from the PDT. Upon disassembly of the PDT latch the following was observed:

land test. Although the detents were designed to hold more than eight times the static load of the PDT, impact loading during handling and deployment were apparently enough to initiate the shear failure.

- Upgrade the detents to stronger material. The upgrade of the locking dogs to stronger material between the bench testing and the land test improved their performance. No bending of the locking dogs was observed after the land test. This same approach should be taken with the detents.
- 2. Square off the latch dogs load heels to provide a better load bearing surface.
- 3. Square off the detent latch dog groove load side to provide a better load bearing surface.

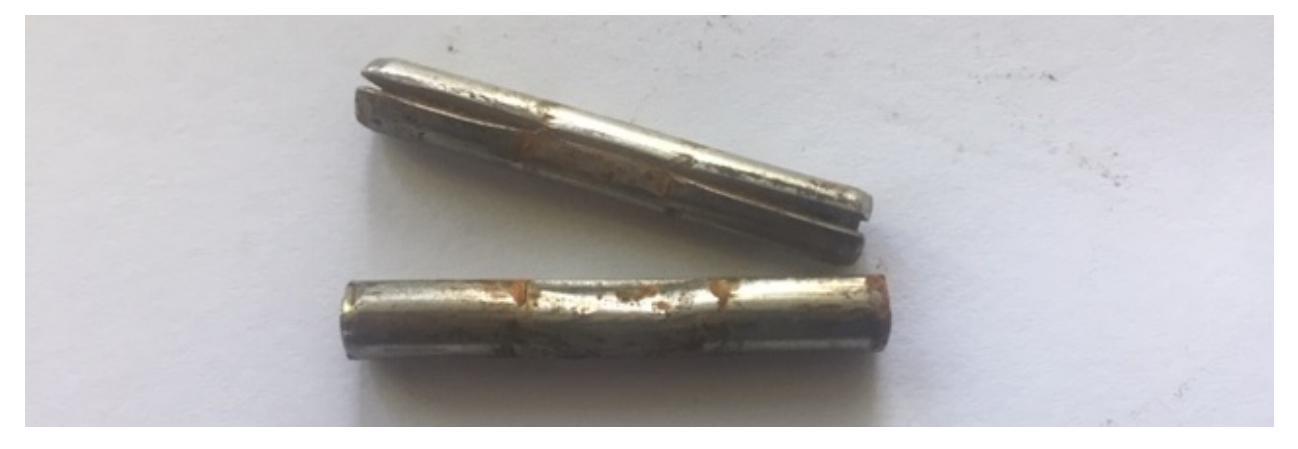
- 1. All of the dog pivot pins had been either deformed or sheared (Figure 4-4).
- 2. Most of the dog retaining pins had been deformed (Figure 4-4).
- 3. The upper latch dog heels were brinelled on the lower inner corners (Figure 4-5, Figure 4-6).
- 4. All four detents were missing.
- 5. The detent retaining spring was missing.
- 6. The detent body, and all other latch parts, appeared undamaged.

Figure 4-4. Deformed pivot and retaining pins.

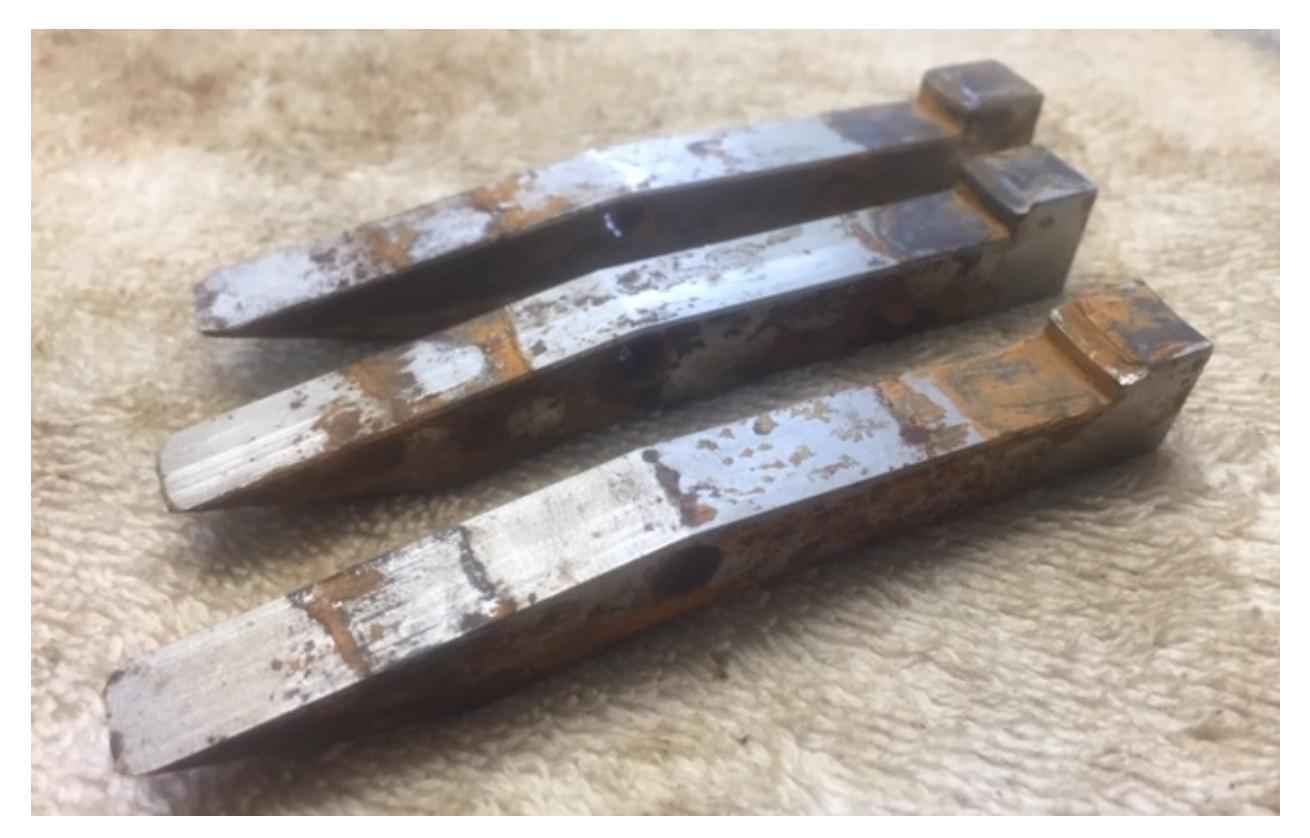
Figure 4-5. Upper latch dogs with brinelled heels

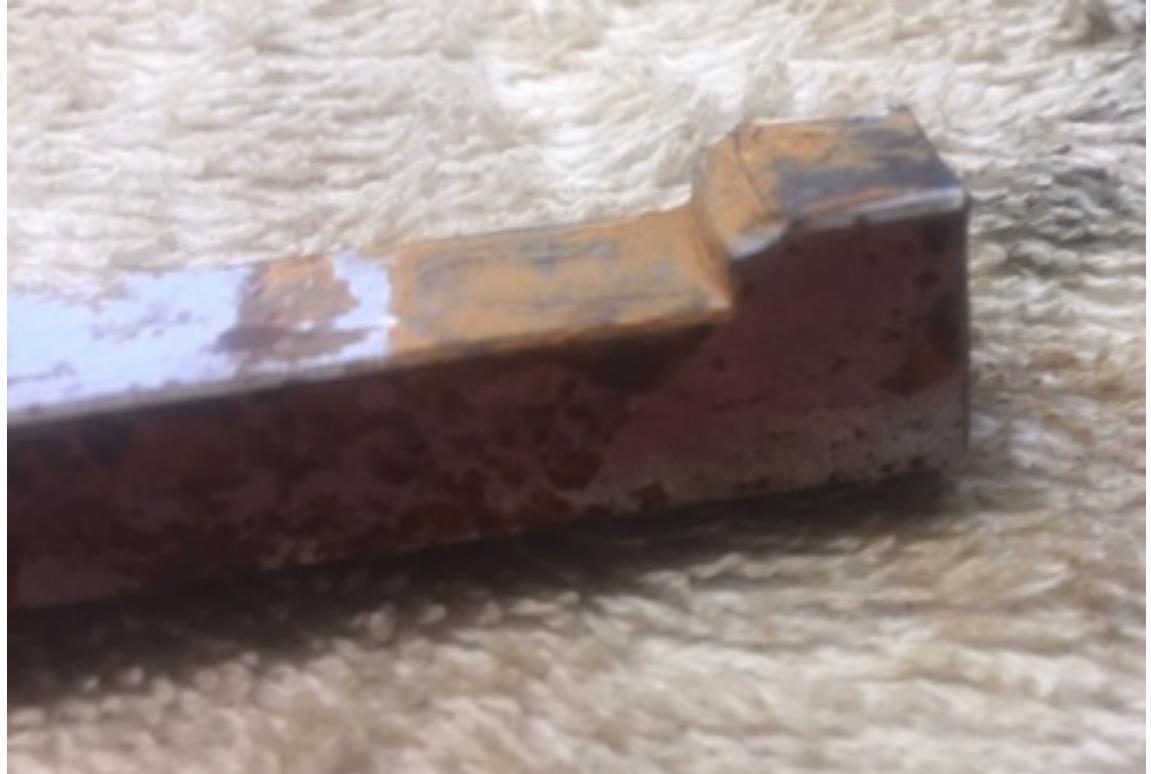
Figure 4-6. Close up of upper latch dog brinelled heel.

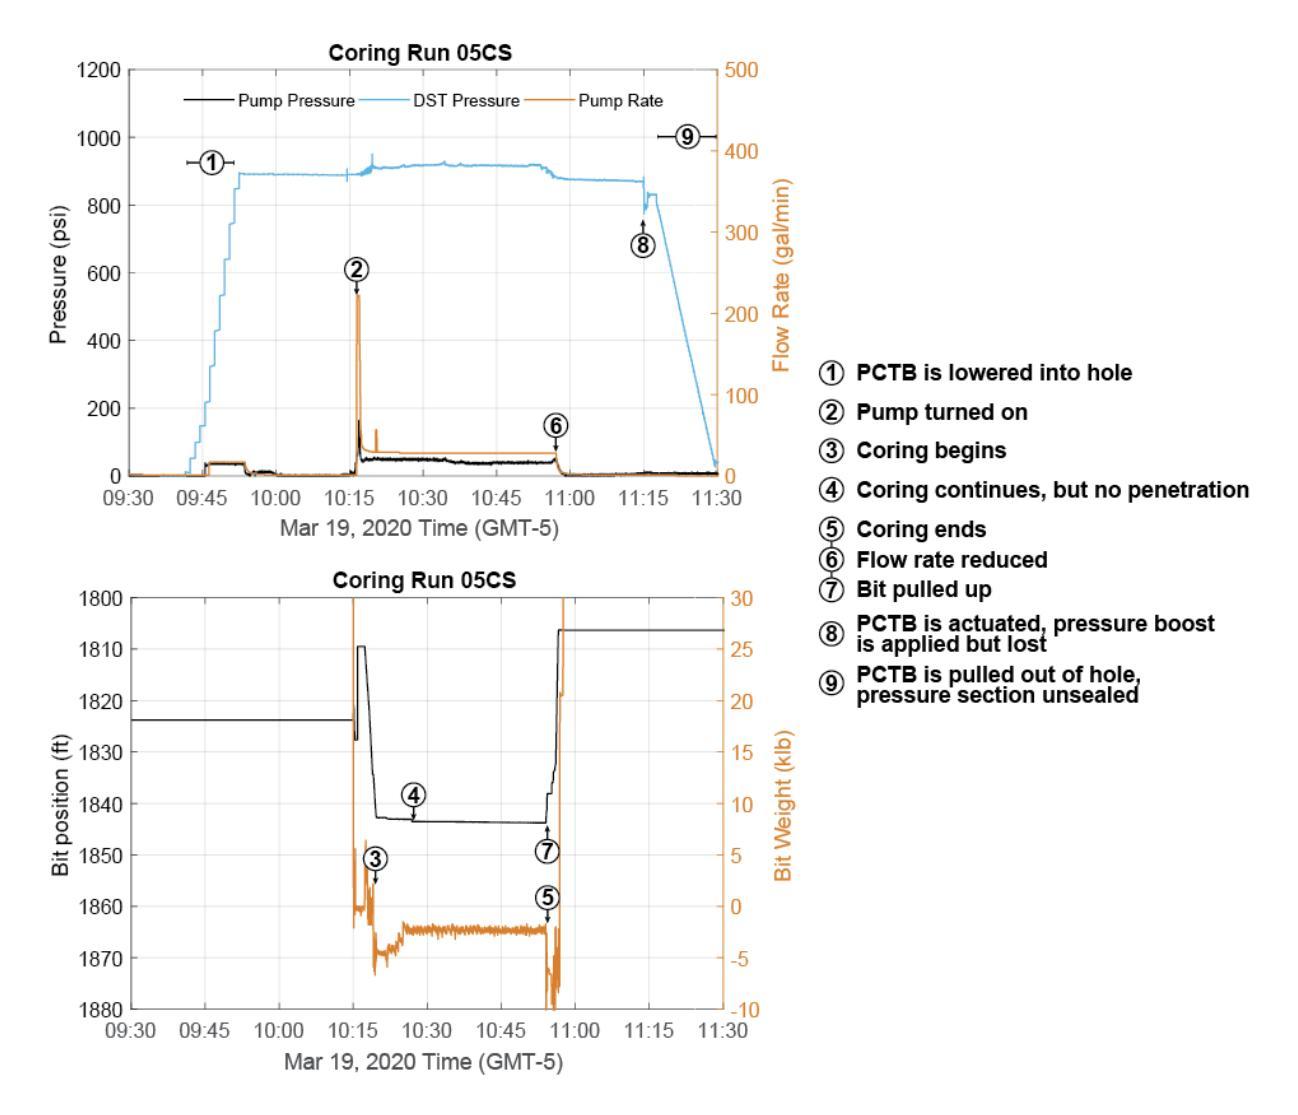
The PCTB did not properly seal in any subsequent tests. Figure 5-5 and Table 5-2 show our interpretation of the major events during coring run CTTF-05CS which occurred on 3/19/2020. (1) At 09:42 the PCTB was lowered into the hole, shown by the increase in hydrostatic pressure being recorded by the DST. (2) At 10:17 the pumps were turned on. (3) At 10:20 there was weight on bit and coring begins. Bit depth began to increase, and slight pressure perturbations can be seen in the DST pressure. (4) At 10:28 penetration halted. We interpreted this to be the bit balling up. (5,6,7) At 10:50 after no further penetration, the flow rate was reduced, and the bit was raised. This ended the coring. (8) At 11:15 the pulling tool actuated the PCTB which attempted to close the ball valve and trigger the pressure boost. The sealing and pressure boost were unsuccessful. A slight pressure jump in the pressure from the DST data at (8) may record the boost attempt. (9) The PCTB was pulled out of the hole from 11:15-11:30. DST pressure indicates that the pressure decreased as the tool was pulled out of the hole, thus following the wellbore pressure as the tool was raised. At the surface there was no pressure maintained in the PCTB.

Figure 5-5. DST and rig instrumentation plots for core CTTF-05CS. The PCTB tool did not seal correctly, and the core was recovered with no pressure. The pressure boost can be seen in the DST data but quickly dissipated since the core was not sealed. Our interpretation of significant events during coring is shown. See also Table 5-2. DST data timestamps were shifted +5.5 minutes to match to rig instrumentation timestamps.

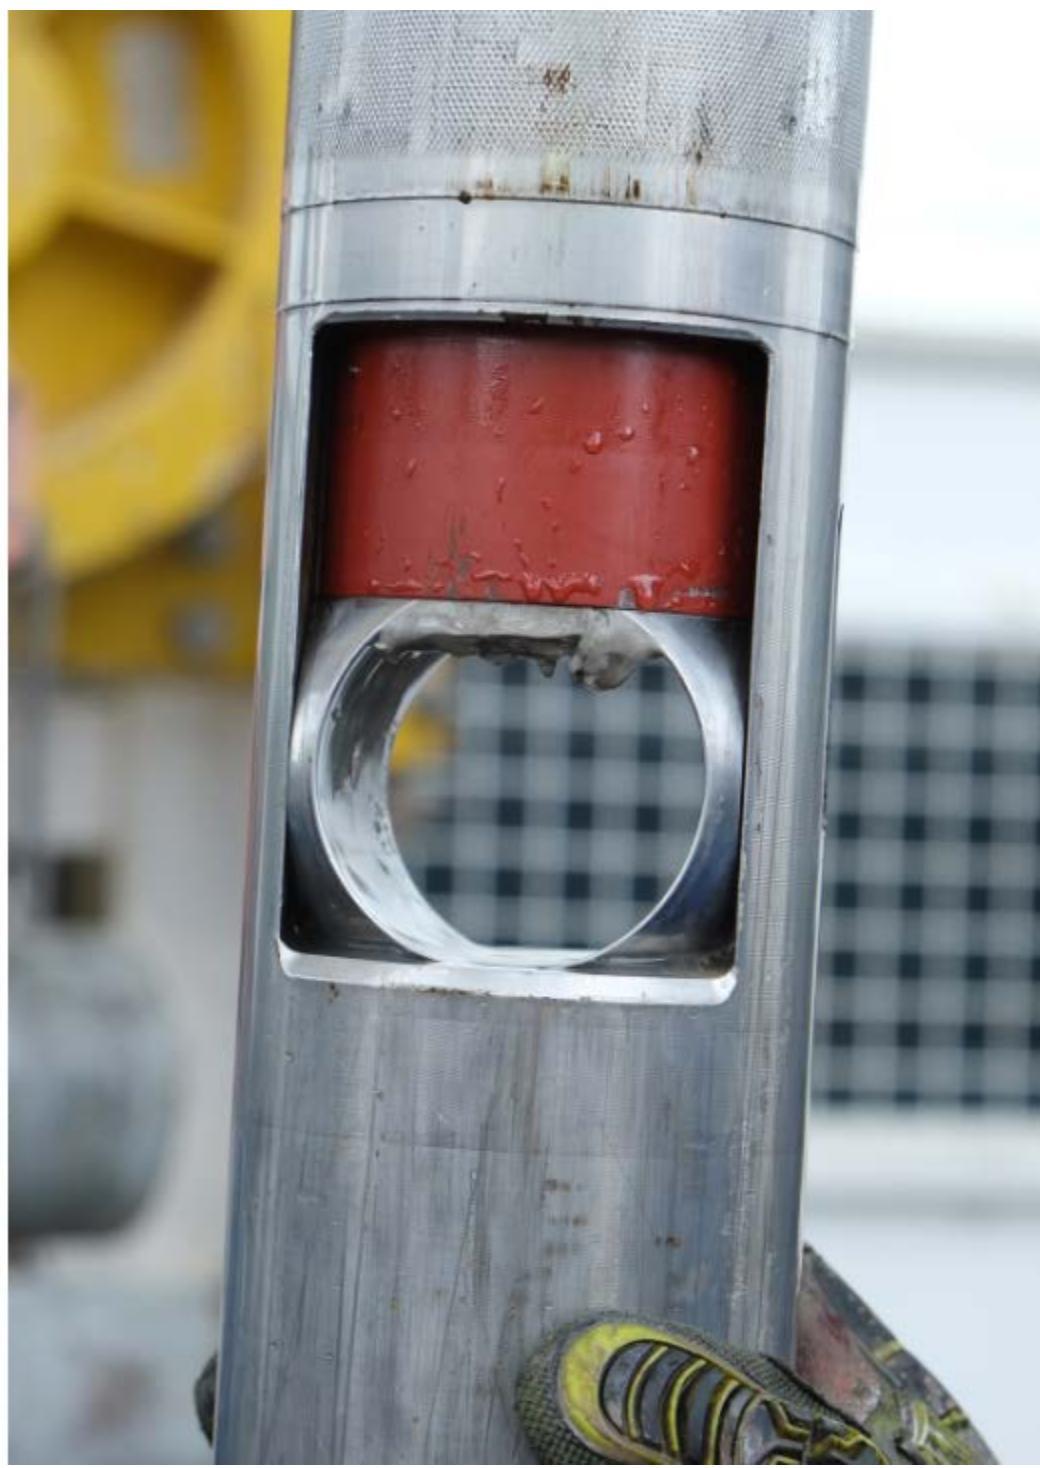
Figure 5-7. Illustration of an apparently closed ball valve upon recovery from the hole. Although it is apparently sealed, no pressure was held. It is interpreted that either it was a leaky seal or that the ball valve closed after the pressure was boosted. Note the mud and silt between the ball and the seal carrier (red).

To resolve this issue, it will be necessary to be able to systematically recreate the failure mode where sediments jam the seal carrier. Geotek will explore this immediately at Salt Lake by adding sediment to mud to simulate the conditions at Cameron. At the same time, Geotek and Pettigrew Engineering will explore possible design changes to improve sealing in the presence of mud with cuttings.

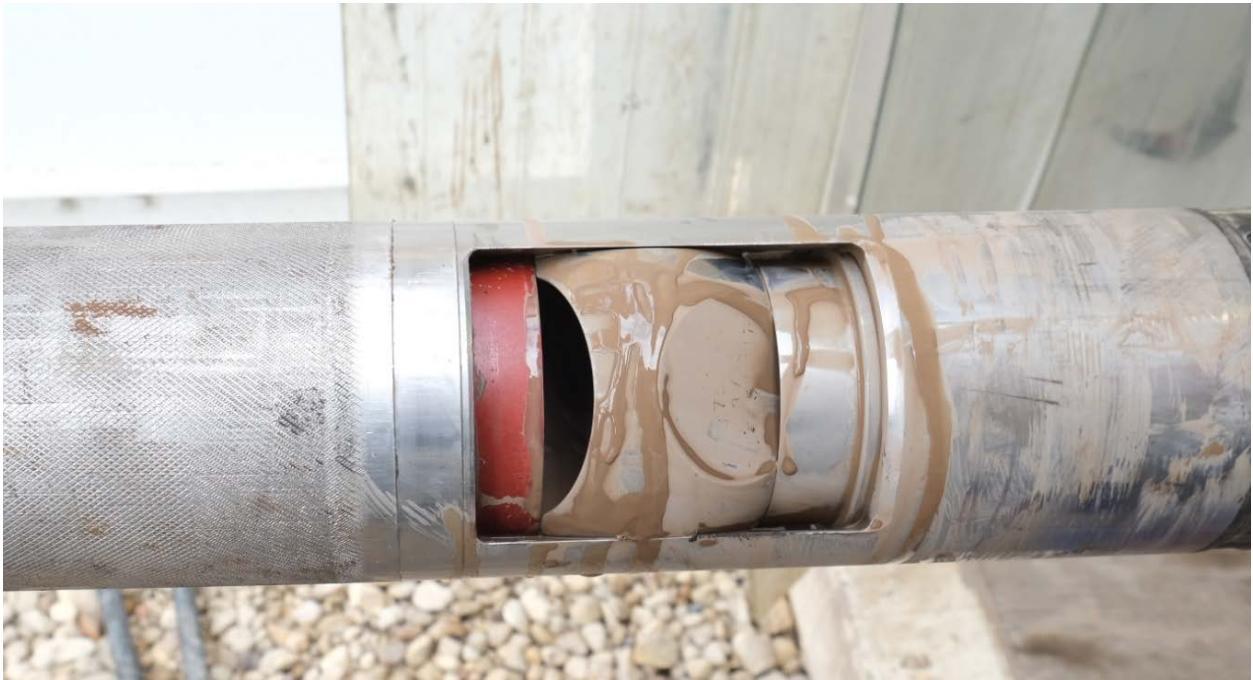
Figure 1: Image of a partially closed ball valve.

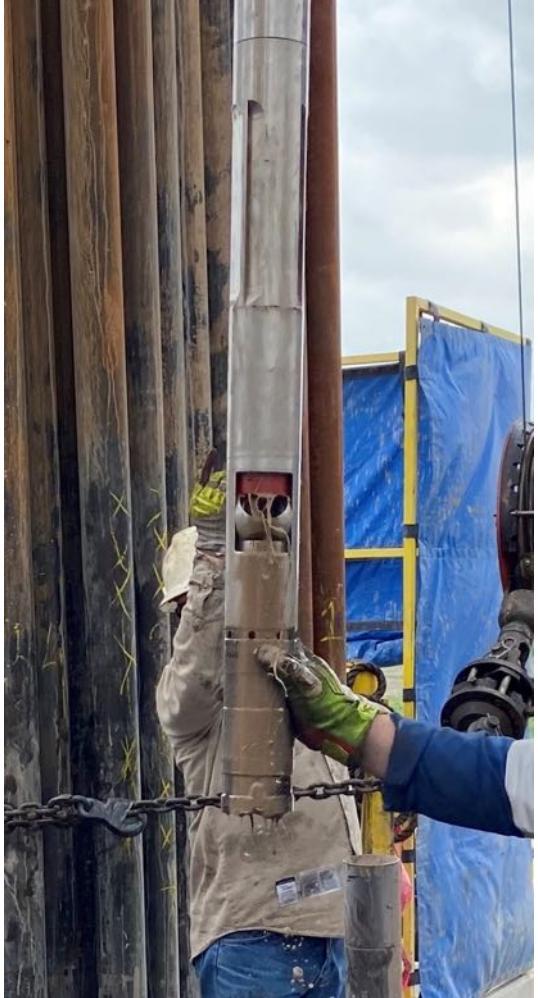
When pulled to the surface, the tool was not pressurized and the ball valve was in a halfclosed position. Detailed post-run analysis showed no failure mode apart from a stiff ball valve.

Failure mode: Incomplete ball closure

Figure 6. Seal carrier (red part), ball valve and ball follower (below the ball valve) after coring run 3CS.

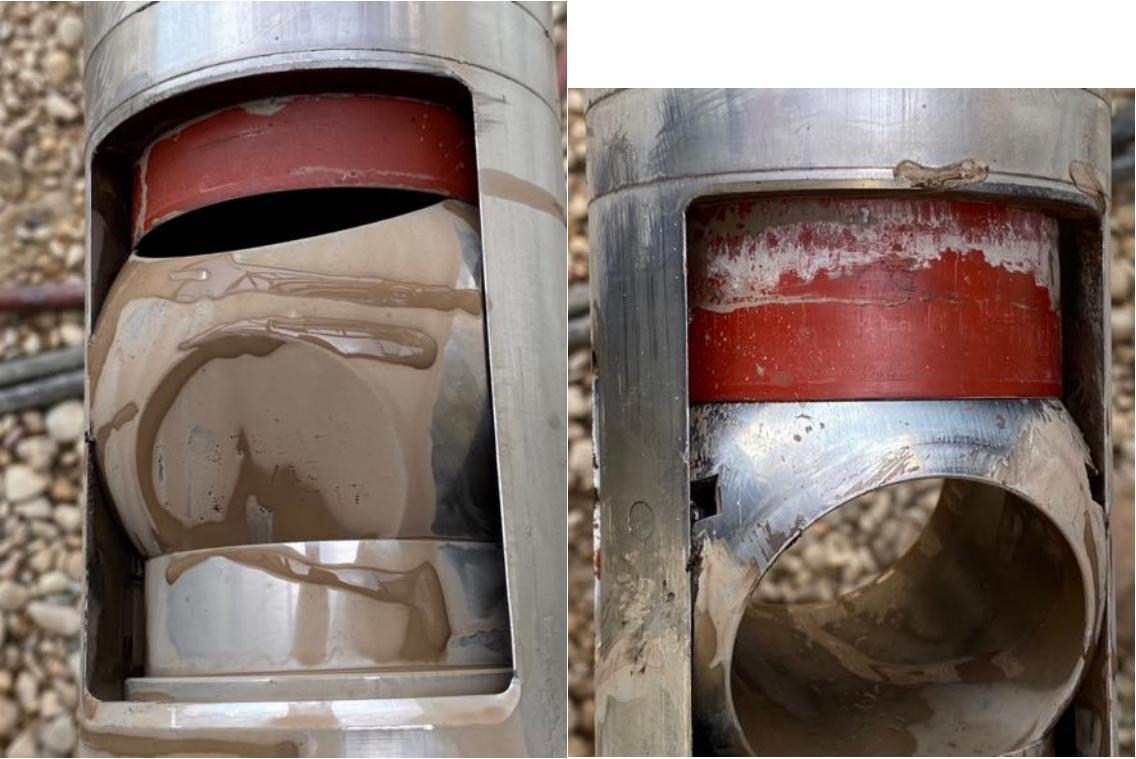
At the surface the ball was again observed to be only partially closed. In post-run analysis the seal carrier was found to be stiff and difficult to move, with significant amounts of fine grit present in the annulus between seal carrier and ball valve housing.

Failure mode: Incomplete ball closure

Figure 8. Seal carrier (red part), ball valve and ball follower after coring run 4CS. On recovery to the coring van (L) and after hammering to move the ball and sleeve (R). Note the material above the 'tide' mark on the seal carrier and the streaks close to the edge of the ball housing.

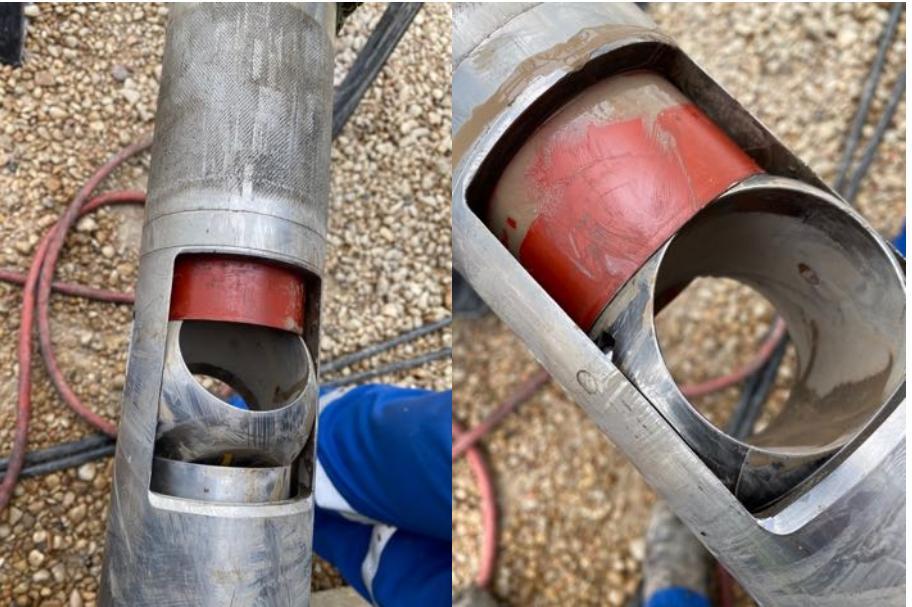
At the surface, the ball was again observed to be partially open. In post-run analysis the ball valve mechanism was again found to be stiff with grit present.

Failure mode: Incomplete ball closure

Figure 13. Ball valve, seal carrier (red part) and ball follower after Core Run 6CS. Note that the ball was moveable by hand suggesting that the seal carrier or spring was jammed above it. Note the coarse-grained looking material after the seal carrier has been moved down.

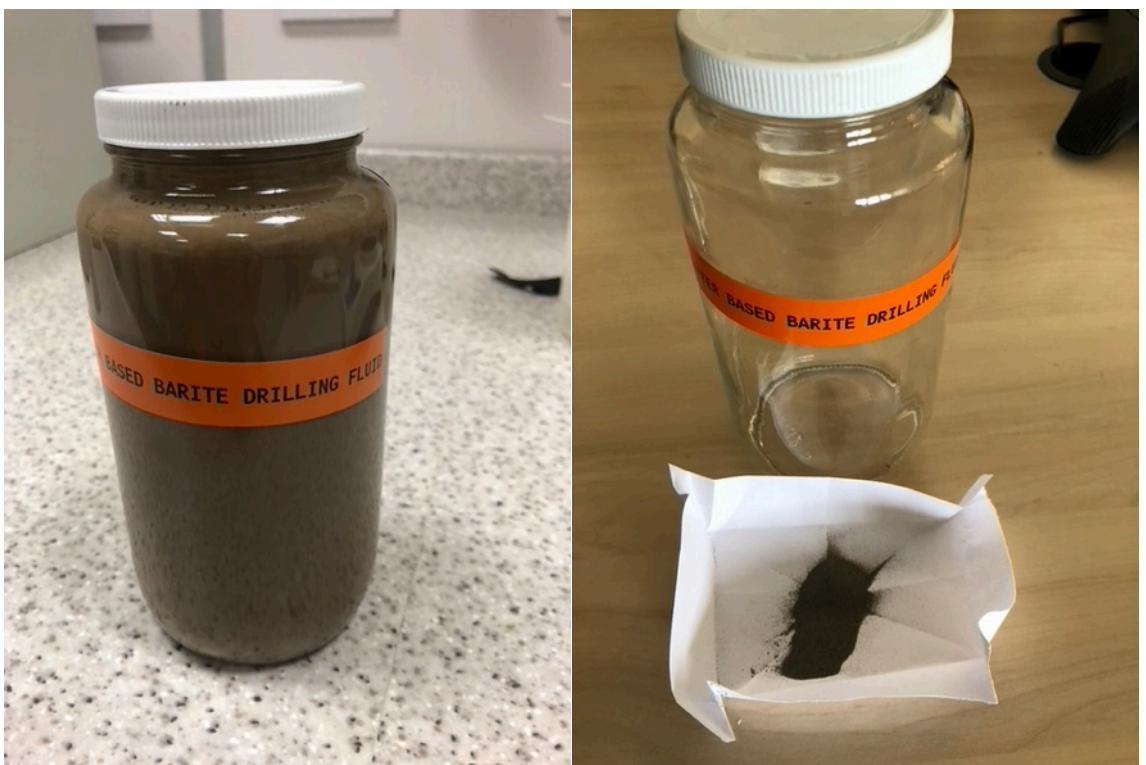
Figure 16. Mud sample from CTTF (L) and the coarse-grained material sieved from the mud (R).

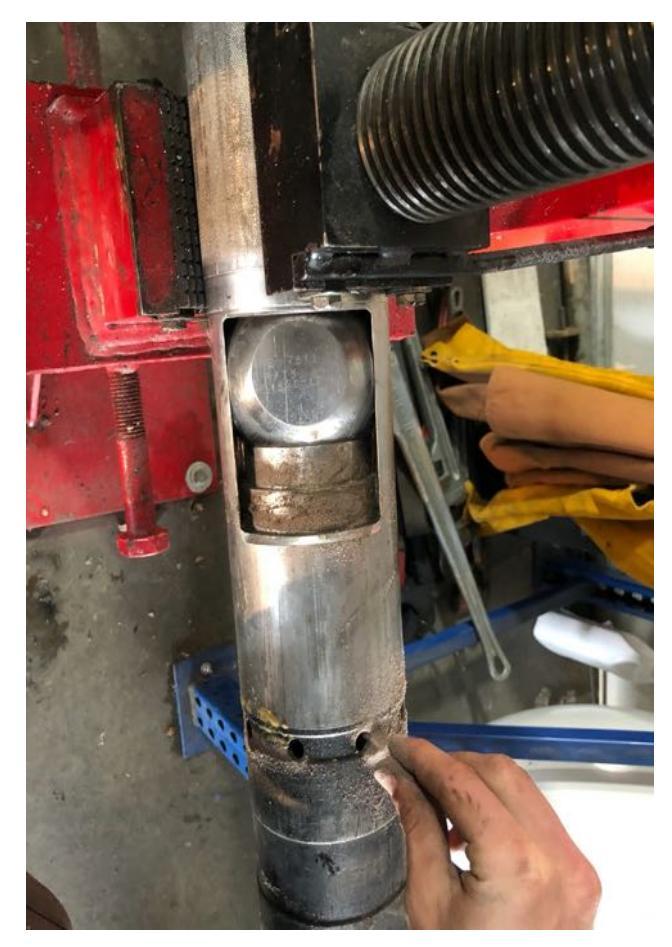
Figure 20. Ball valve assembly with applied Aluminum Oxide

The ball valve was actuated in the test fixture filled with water and failed. The ball valve closes halfway before jamming.
