# Oil & Natural Gas Technology

## Quarterly Research Performance Progress Report (Period Ending 12/31/2015)

### Deepwater Methane Hydrate Characterization and Scientific Assessment

# GOM<sup>2</sup> PRESSURE CORING TOOL WITH BALL VALVE (PCTB) LAND TEST INITIAL REPORT

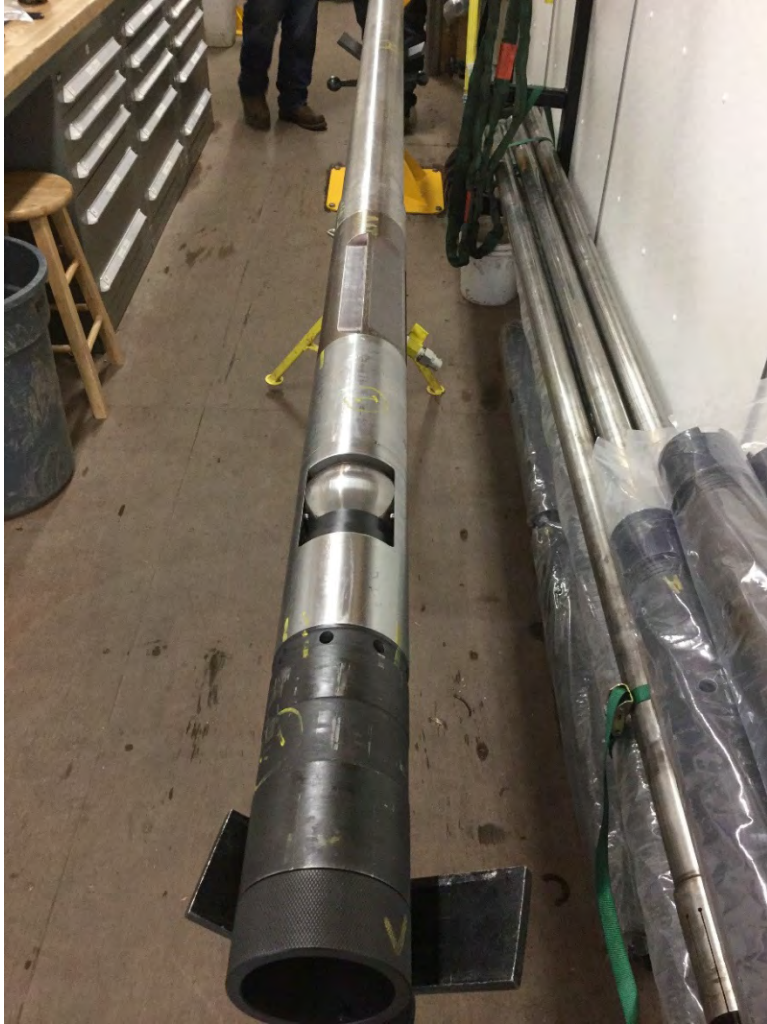
**Figure 1: PCTB (Pressure Coring Tool with Ball)**
