DOE Award No.: DE-FE0023919

Quarterly Research Performance Progress Report

(Period Ending 06/30/21)

Deepwater Methane Hydrate Characterization & Scientific Assessment

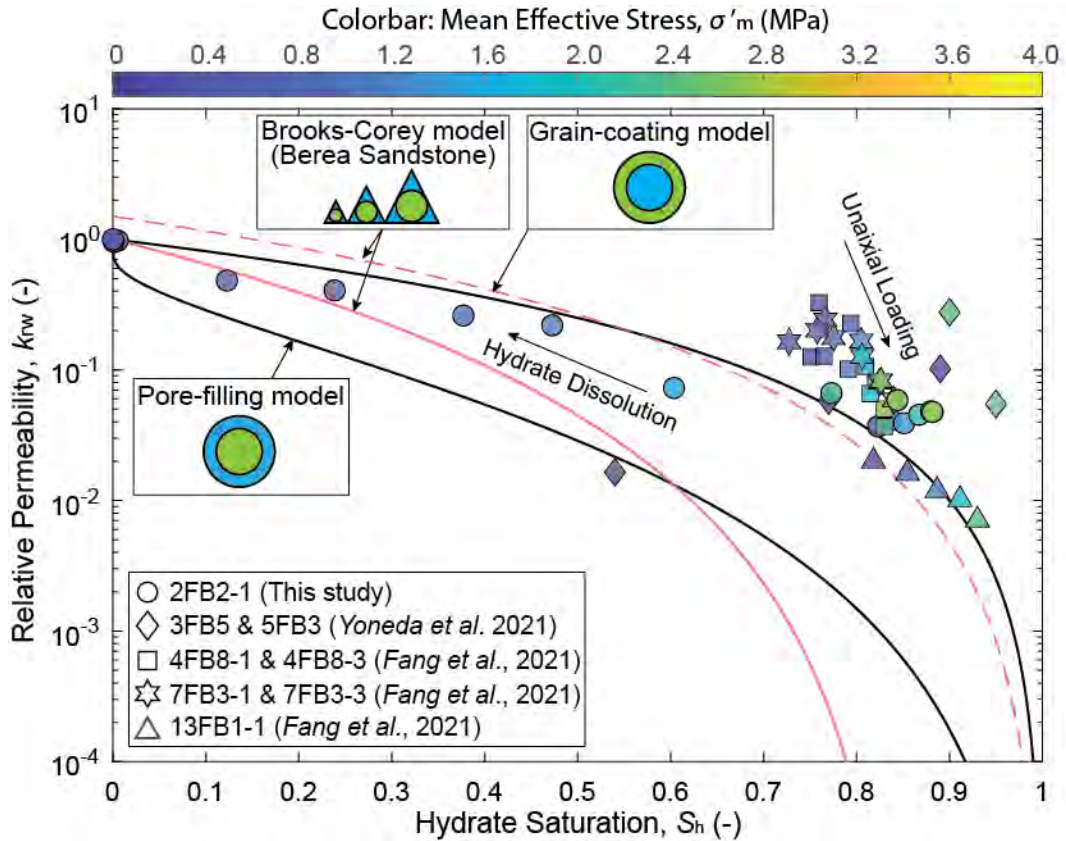
Figure 1-1: Dependence of log-scale relative permeability ( $k_{rw}$ ) on hydrate saturation ( $S_h$ ) and mean effective stress ( $\sigma'_m$ ). The relative permeability is a dimensionless parameter calculated as a ratio of effective permeability to intrinsic permeability. The effective permeabilities are measured in pressure core samples in presence of hydrate. The intrinsic permeability is measured in absence of hydrate. When the pressure cores are uniaxially loaded up to their in-situ effective stress at 3.8 MPa, the intrinsic permeability are changing with stress. Thus, the intrinsic permeability corresponding to its paired effective permeability during the loading is estimated from the log-linear porosity-permeability relationship identified in (Fang et al., 2020). During hydrate dissolution, as the sands frame (or bulk volume) is fixed, all effective permeability values just have a single paired intrinsic permeability, which is measured at the end of the dissolution. Two solid black curves show the empirical log-linear relationship between  $k_{rw}$  and  $S_h$  based on hydrate morphology in porous media: the lower solid black curve represents a hydrate pore-filling model and  $S_h$  the upper solid black curve represents a hydrate grain-coating model (Kleinberg et al., 2003). The capillary pressure-derived Brooks-Corey model (Brooks and Corey, 1964), if hydrate is non-wetting or pore-filling, is plotted as the dashed black line using a water fitting parameter and a residual water saturation obtained from the relative permeability relationship in a Berea Sandstone (Murphy et al., 2020). If hydrate is wetting or grain-coating, the Brooks-Corey model is plotted in a dashed red line using a gas fitting parameter and a residual gas saturation in the same Berea Sandstone (Murphy et al., 2020). The mean effective stress of each specimen at each hydrate saturation is color-coded.

- UT analyzed relative permeability of UT-GOM2-1 hydrate-bearing pressure core measured in a long-term hydrate dissolution test.
  - UT found that at high hydrate saturations (e.g.,  $S_h > 80$ ), the relative permeabilities are greater than predicted by a grain-coating model (Figure 1-1).
  - UT found that when the core sample's bulk volume is fixed, the relative permeability evolution follows a trend between a pore-filling and grain-coating model. ('Hydrate Dissolution', Figure 1-1).
  - UT found that the stress ratio ( $K_0$ ) of the core in absence of hydrate is lower than the same core in presence of hydrate (Figure 1-1).

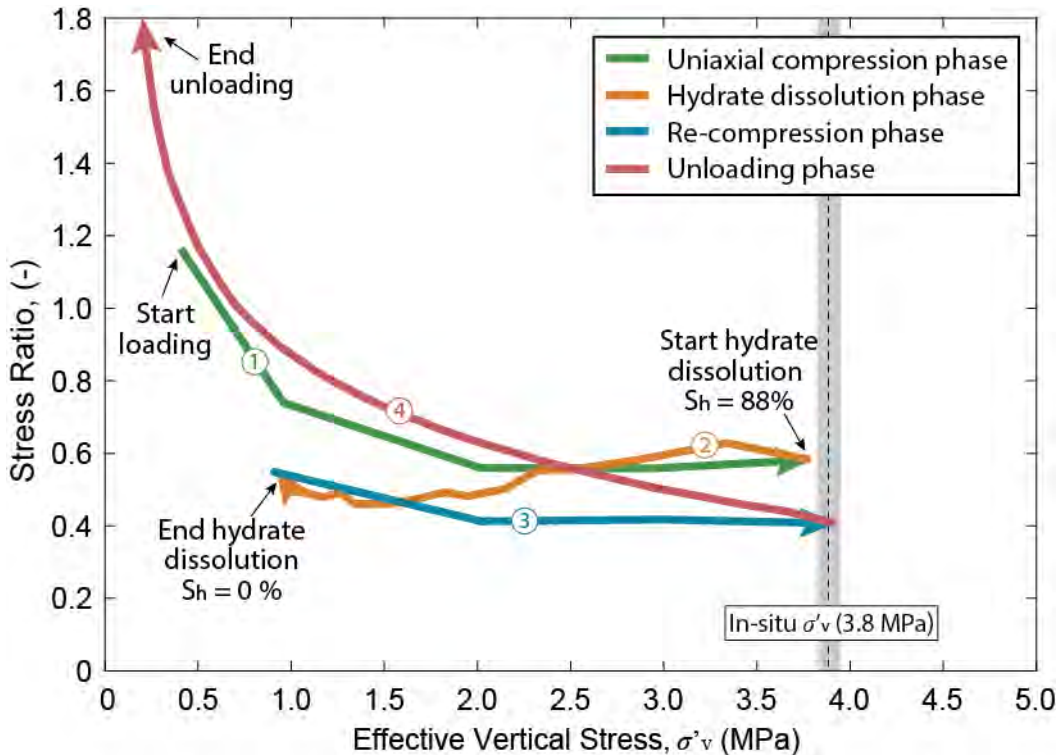
Figure 1-2. The evolution of stress ratio in hydrate-bearing pressure cores measured during the uniaxial-strain compression and hydrate dissolution. Step 1 (green curve): uniaxial-strain compression; step 2 (orange curve): hydrate dissolution under fixed bulk volume (i.e., no volumetric strain); step 3 (blue curve): reload the sample under uniaxial-strain condition; step 4 (red curve): unload the sample under uniaxial-strain condition.

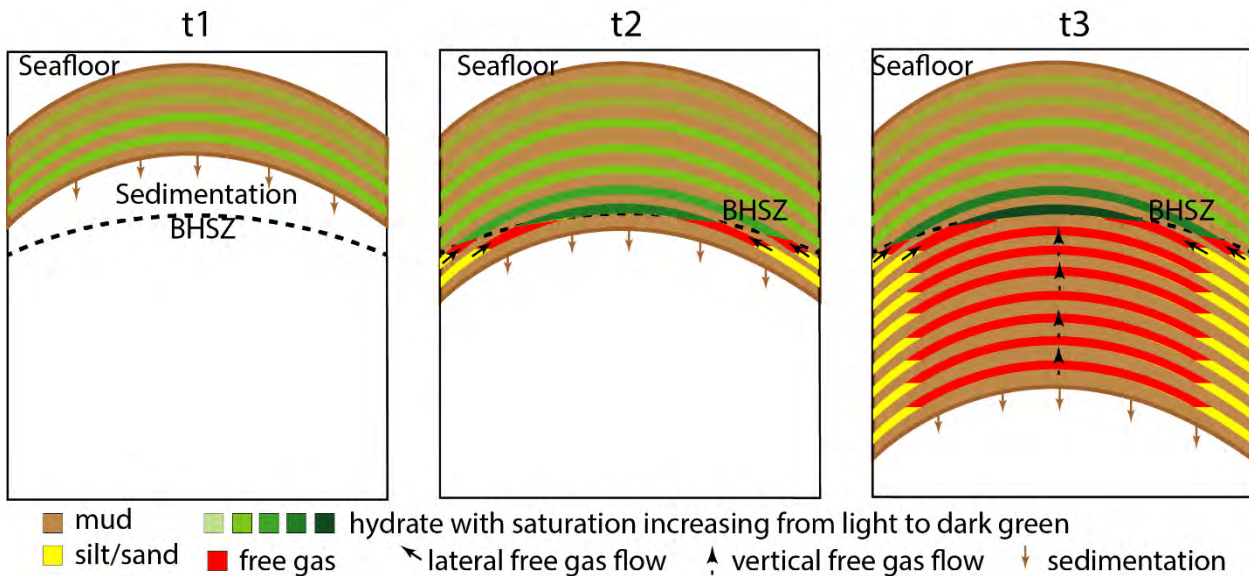
Figure 1-4: A schematic of the generation, migration, phase partitioning and accumulation of microbial methane in an evolving sedimentary system from t1 to t2 and then to t3. Methane is generated in muds, focused into sands/silts and forms concentrated methane hydrate as a sand-mud interbedded system is deposited from the seafloor and passes through the BHSZ from t1 to t2 and t3. In this model, methane is generated by biodegradation of organic carbon in muds. Hydrate does not form and methane is not trapped until a coarse-grained layer is deposited, because the nm-scale pores prevent hydrate formation in muds. Instead, methane diffuses into sands/silts where methane solidifies into hydrate. As hydrate-bearing sands/silts pass through the base of hydrate stability zone (BHSZ) during sediment burial, methane hydrate dissociates and releases free gas. The released and the newly generated free gas below the BHSZ concentrates into a vertical/dipping zone with low capillary entry pressure and high permeability and flows upward driven its buoyancy. When free gas reaches the hydrate stability zone (HSZ), capillary forces drive free gas to flow laterally, preferentially enter sands/silts, feed hydrate growth and elevate hydrate saturation

- With three-dimensional focused free gas flow, microbial methane that is generated from a much larger fetch area of the entire basin, both above and below the BHSZ, is concentrated into coarse-grained layers at structural closures to form high-concentration methane hydrate reservoirs (Figure 1-4).
- This model can well explain the formation of many observed highly-concentrated hydrate reservoirs along the continental margins, such as the concentrated hydrate reservoirs at Green Canyon 955 and Walker Ridge 313 of northern Gulf of Mexico, the first offshore gas production site of eastern Nankai Trough, Area B and Area C of NGHPE-02, and New Zealand’s southern Hikurangi subduction margin.

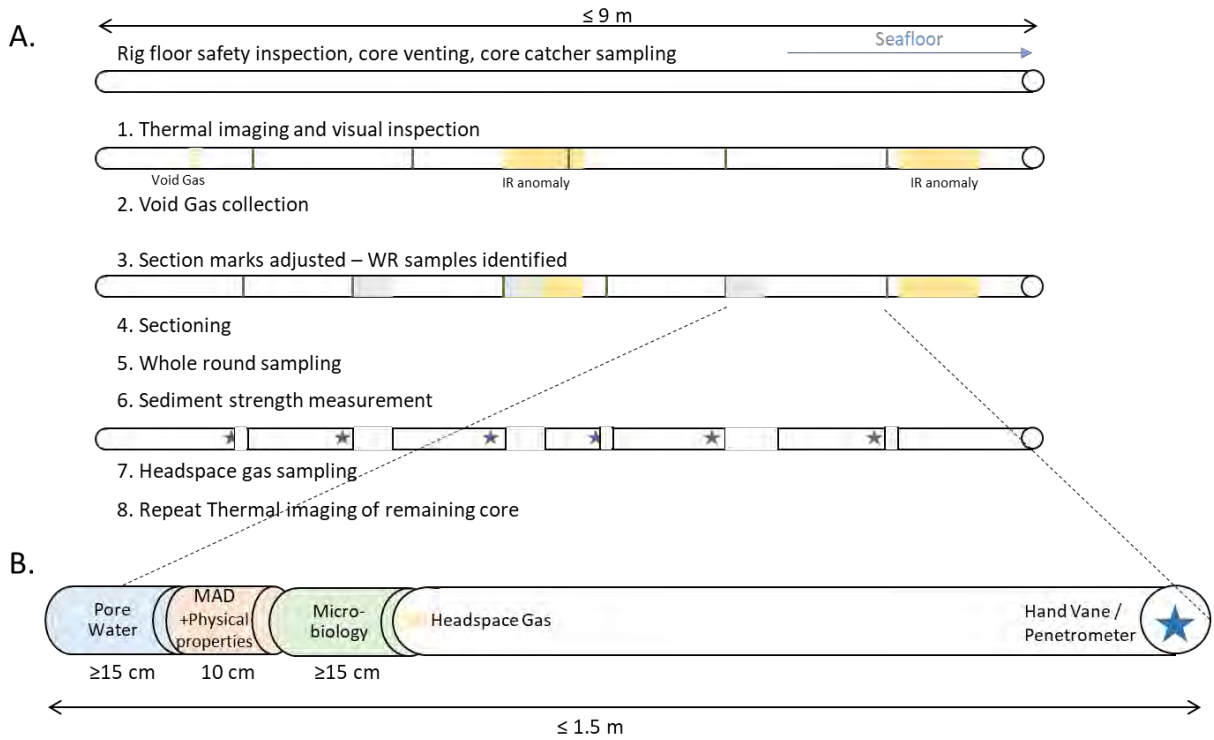
Figure 1-5. On-board Conventional Core Flow. A. ~ 9 m conventional core processing steps for a hypothetical APC/XCB core below the sulfate-methane transition zone (SMT). B. Detailed Section noting whole round sampling, headspace gas sampling, and hand-held vane and penetrometer measurement locations.

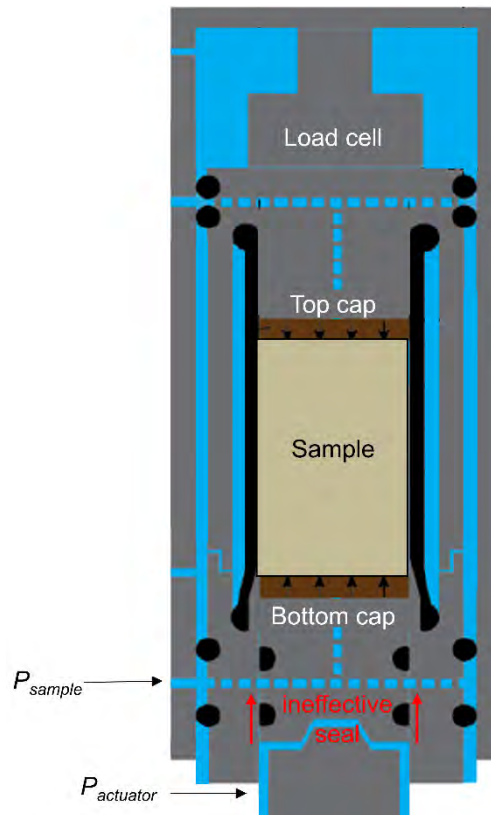
Figure 1-10. Simplified schematic of the effective stress chamber. Red arrows indicate the location of the sealing problem, where actuator and sample pressures communicate.

- We were limited to a vertical effective stress to  $\sim 4$  MPa using a motor-driven actuator. The transition to a higher capacity hydraulic loading system needed an adequate sealing between the sample and actuator pressures across the bottom cap (Figure 1-10). UT conducted engineering tests in the effective stress and acrylic chambers that identified silty sand as the primary culprit for O-rings to fail.

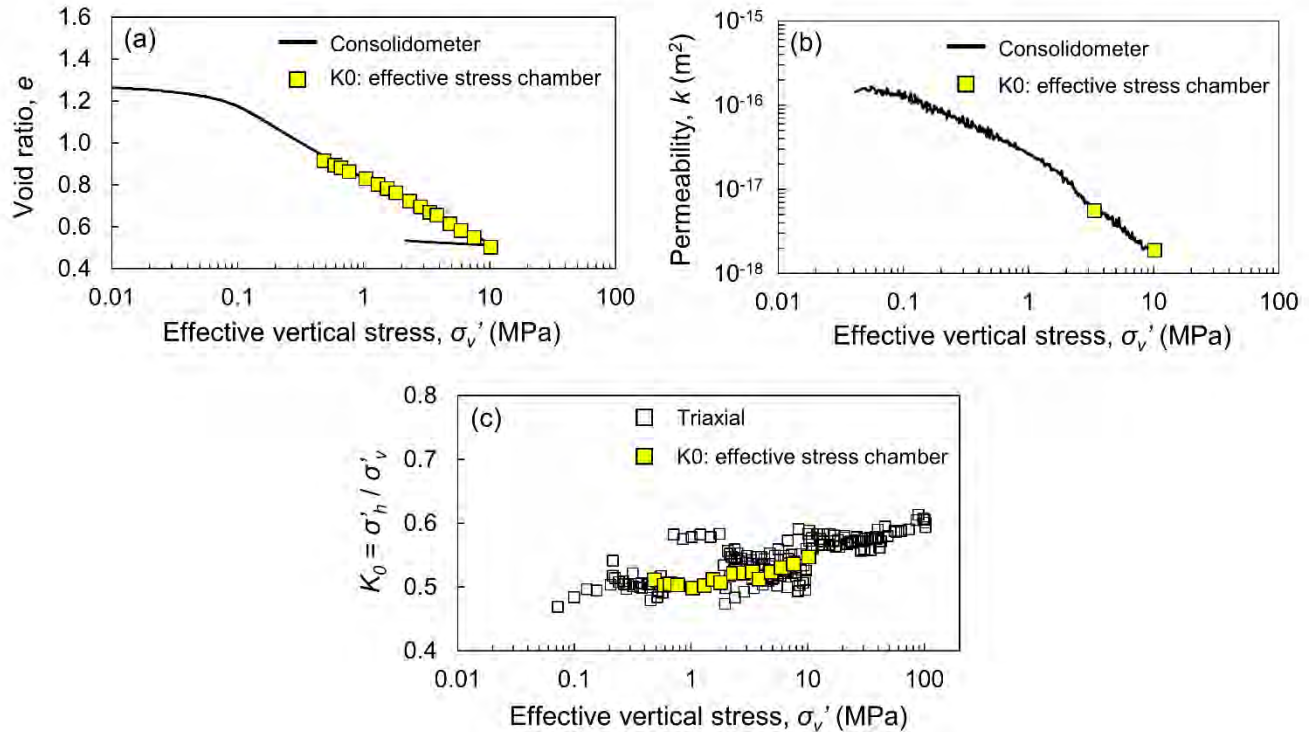
Figure 1-12. (a) Compression, (b) permeability, and (c) effective stress ratio data for a resedimented Boston Blue Clay sample obtained from the effective stress chamber and conventional geotechnical devices. Data sources in (Casey, 2014).

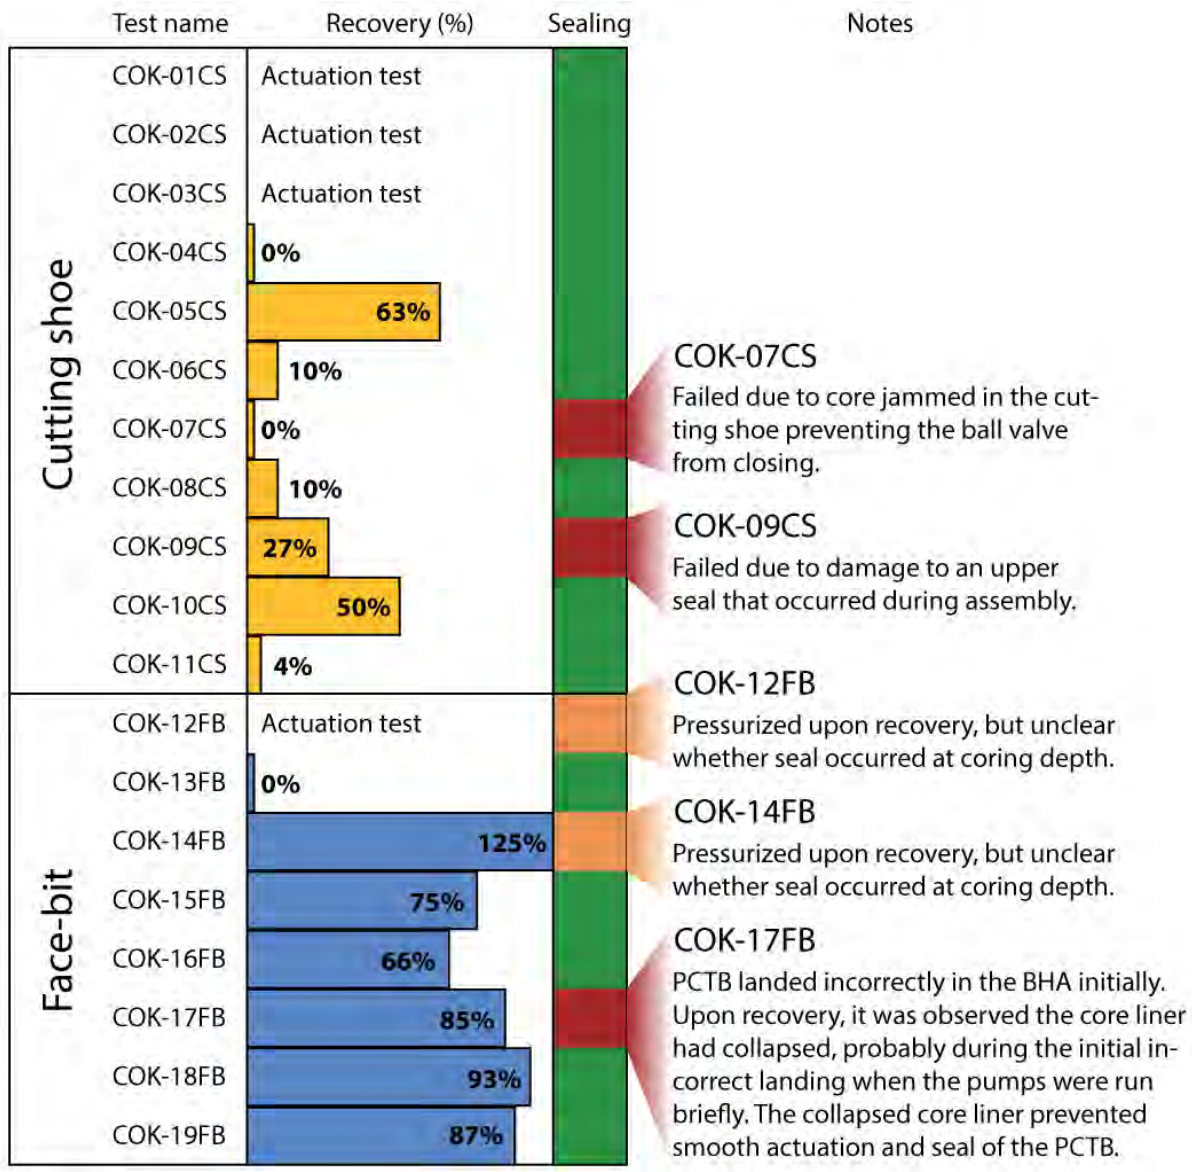
Figure 1-14: Recovery colored by configuration and seal success. The Face-bit configuration demonstrated higher recovery than the Cutting shoe configuration. Rate of successful sealing was 84%. In two tests, COK-12FB and COK-14FB, the pressure chamber was sealed and pressurized upon recover, but it is unclear whether seal occurred at coring depth.

3 coring attempts failed to seal. However, none of the 3 failed coring attempts were due to ingress of grit jamming the ball valve. Of the three failed coring tests, one was due to the hard lithology of the testing site which prevented the core from retracting into the inner barrel upon actuation. Another was due to pre-deployment damage to an upper seal. The final instance was due to the PCTB landing incorrectly in the Bottom Hole Assembly (BHA). Recommendations were made to address the reasons for the failed deployments.

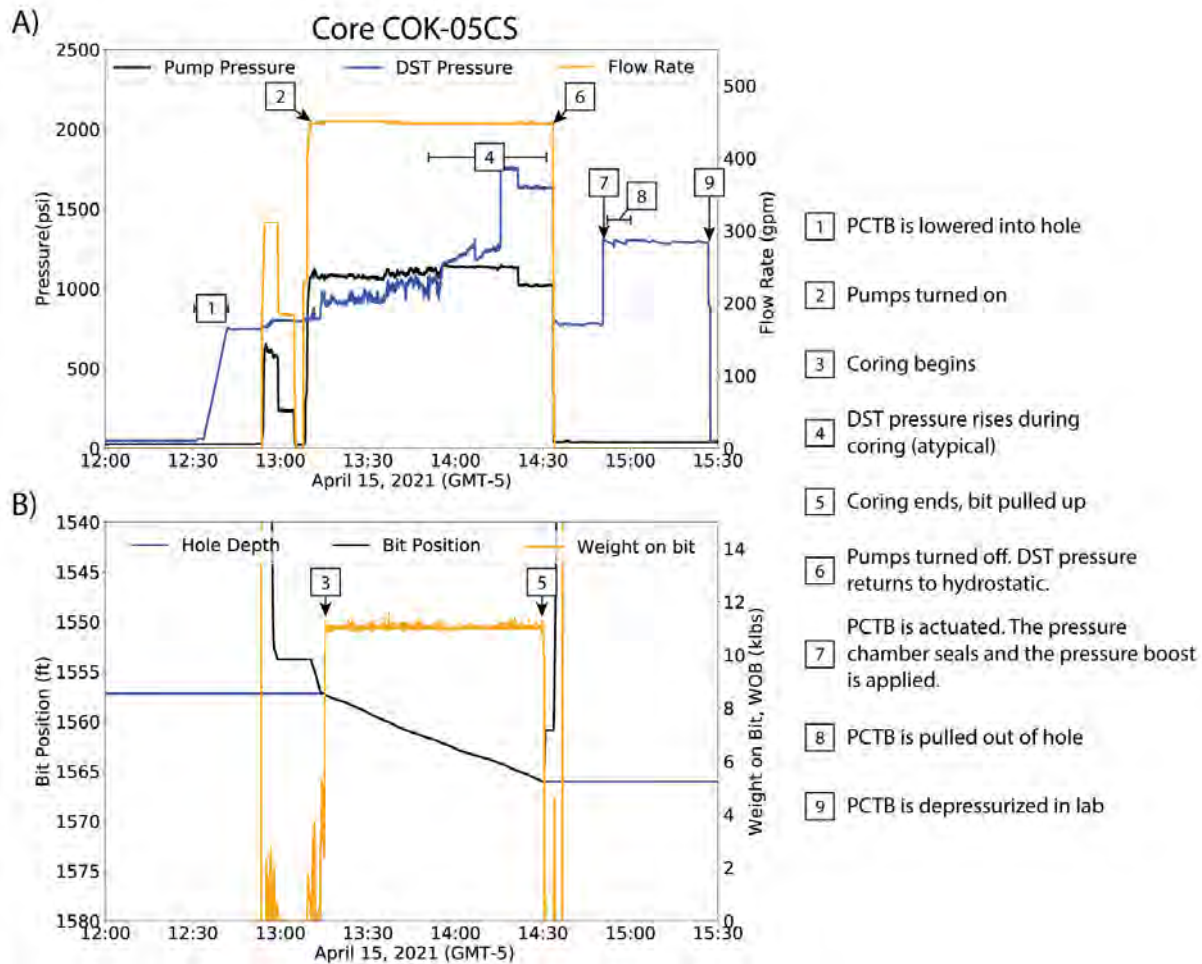
Figure 1-15: Annotated DST and rig parameter plot of representative successful deployment (COK-05CS).

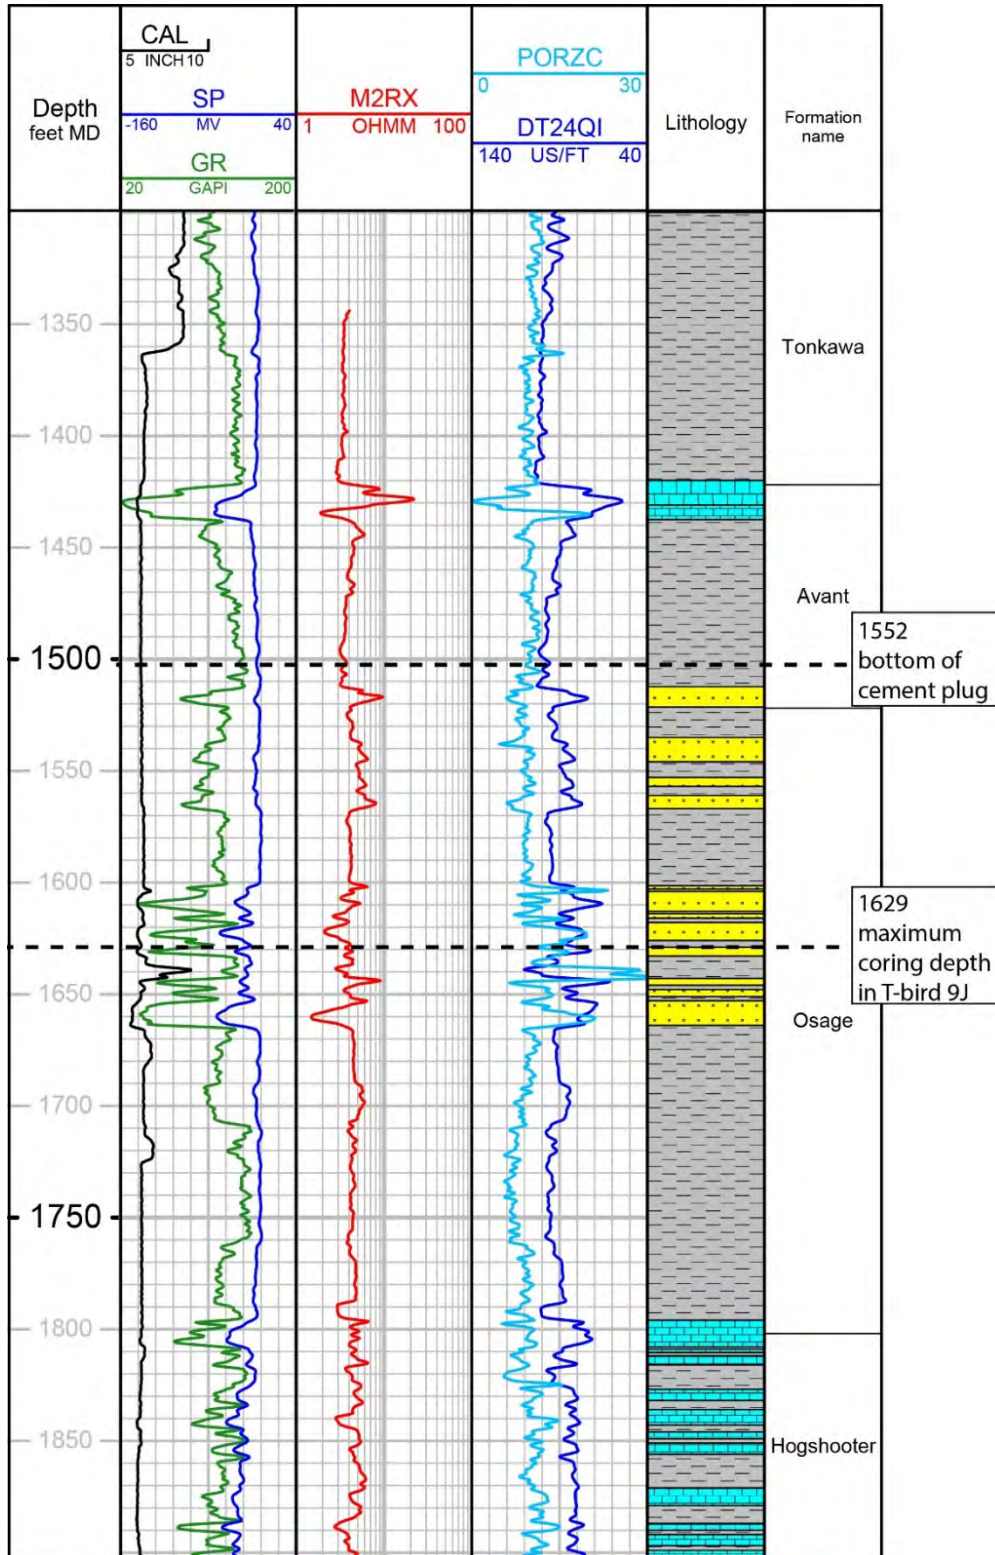
Figure 5-1. Log data and lithology interpretation in the interval of the T-BIRD 5E2 well cored in this study. Gray represents mudstone, yellow represents sandstone, and blue represents limestone. Logs used: gamma ray (GR), caliper (CAL), spontaneous potential (SP), electric resistivity (M2RX), porosity (PORZC), and sonic velocity (DT24QI). Pressure coring occurred beneath the cement plug up to a depth of 1629' MD.

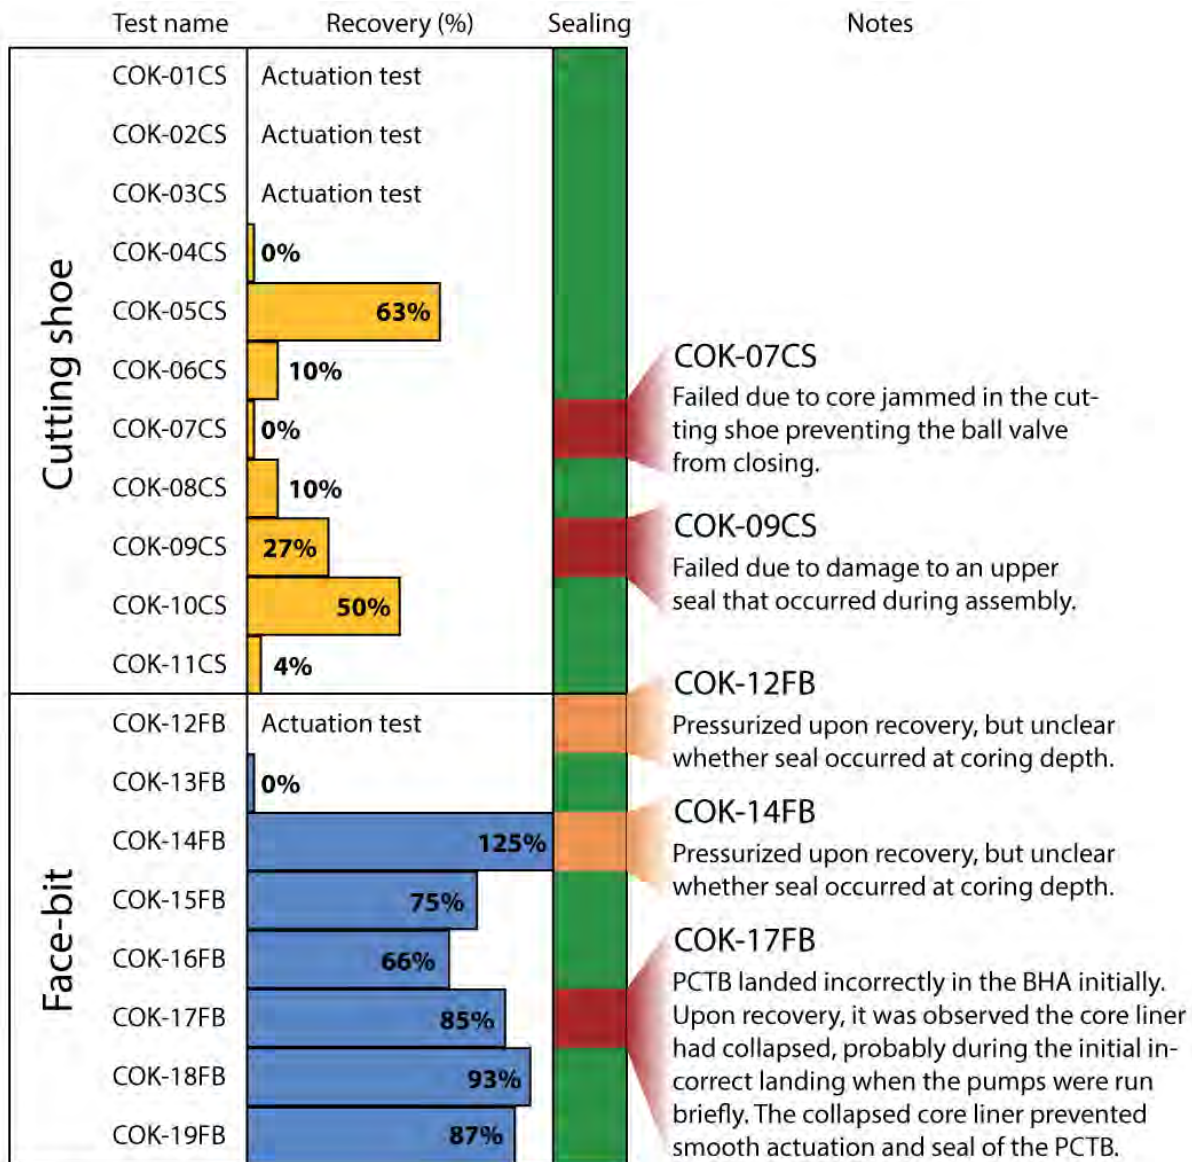
Figure 7-1. Recovery colored by configuration and seal success. The Face-bit configuration demonstrated higher recovery than the Cutting shoe configuration. Rate of successful sealing was 84%. In two tests, COK-12FB and COK-14FB, the pressure chamber was sealed and pressurized upon recover, but it is unclear whether seal occurred at coring depth. See Section 8.2.

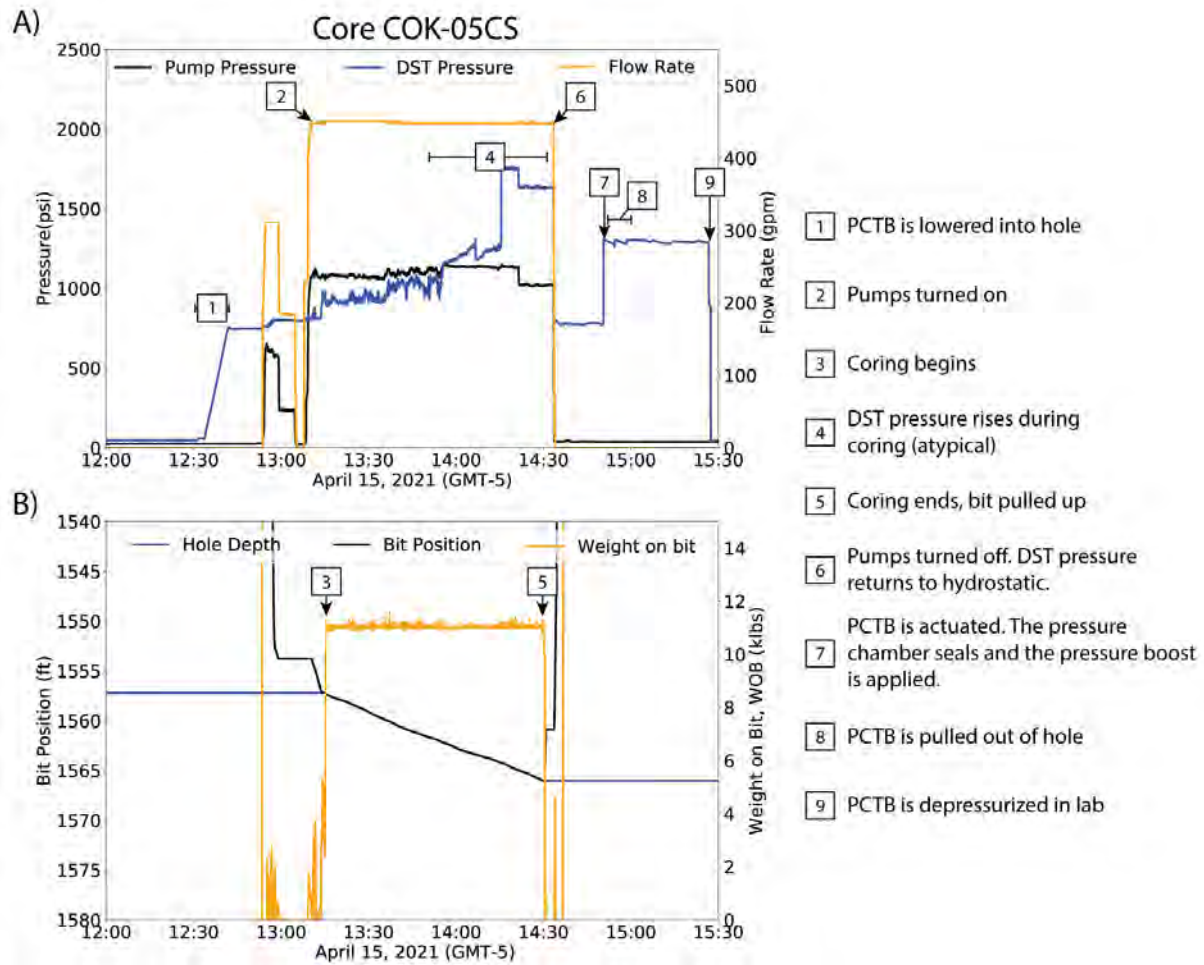
Figure 7-2. DST and rig instrumentation plots for core COK-05CS. The PCTB tool boosted and sealed correctly, and 5.58' of pressurized core was recovered (63% recovery). See also Table 7-2. DST data timestamps were shifted +3.5 minutes to match to rig instrumentation timestamps. A) Pump Pressure (psi), DST Pressure (psi), and Flow Rate (gpm). B) Hole depth (ft), Bit Position (ft), and Weight on Bit (klbs).

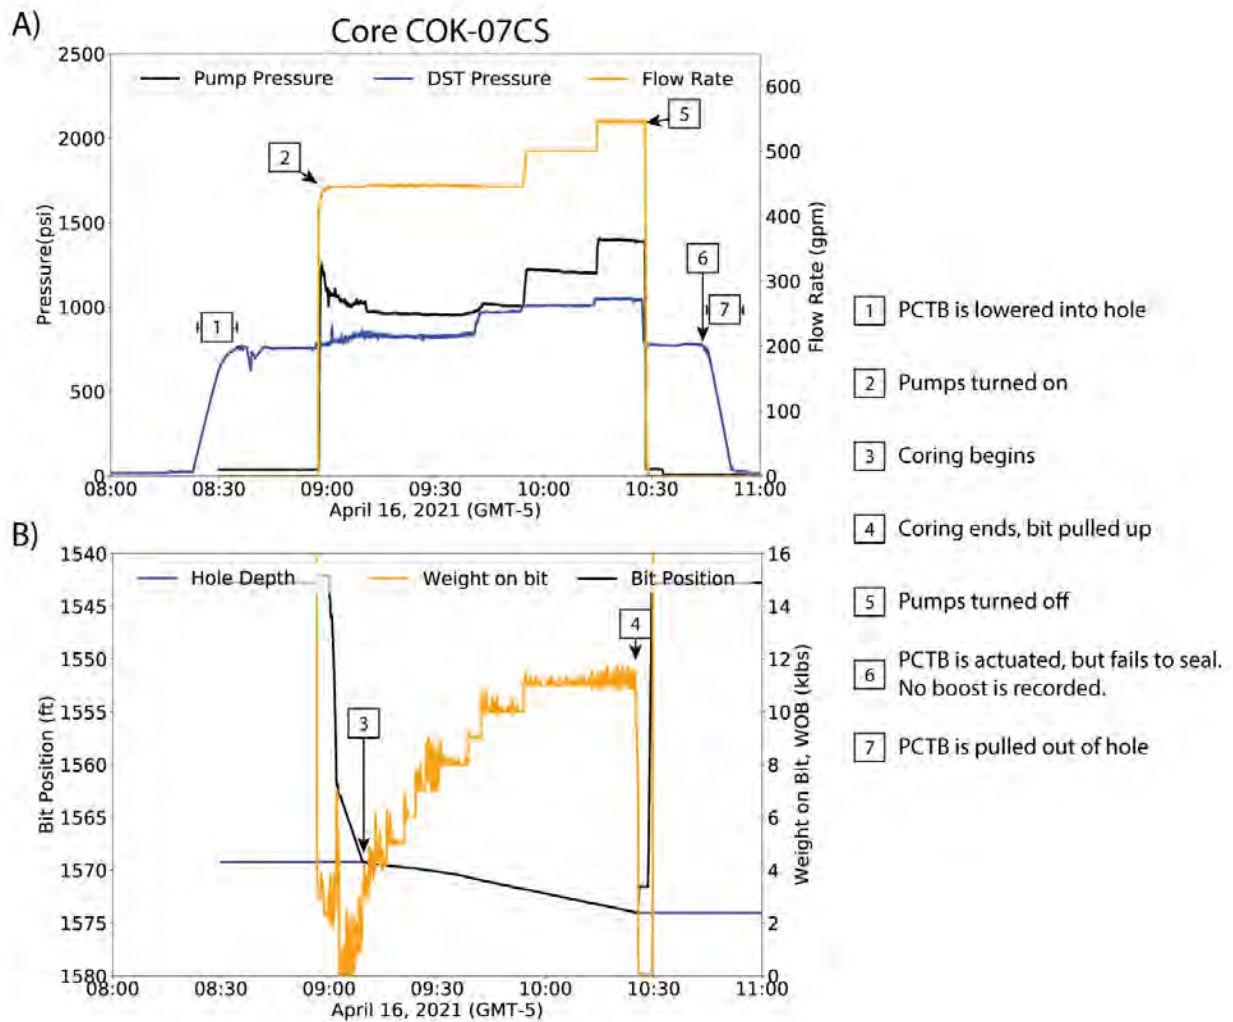
Figure 7-3. DST and rig instrumentation plots for core COK-07CS. The PCTB failed to seal due to a damaged upper seal. See also Table 7-7-3. DST data timestamps were shifted +3.5 minutes to match rig instrumentation timestamps. A) Pump Pressure (psi), DST Pressure (psi), and Flow Rate (gpm). B) Hole depth (ft), Bit Position (ft), and Weight on Bit (klbs).

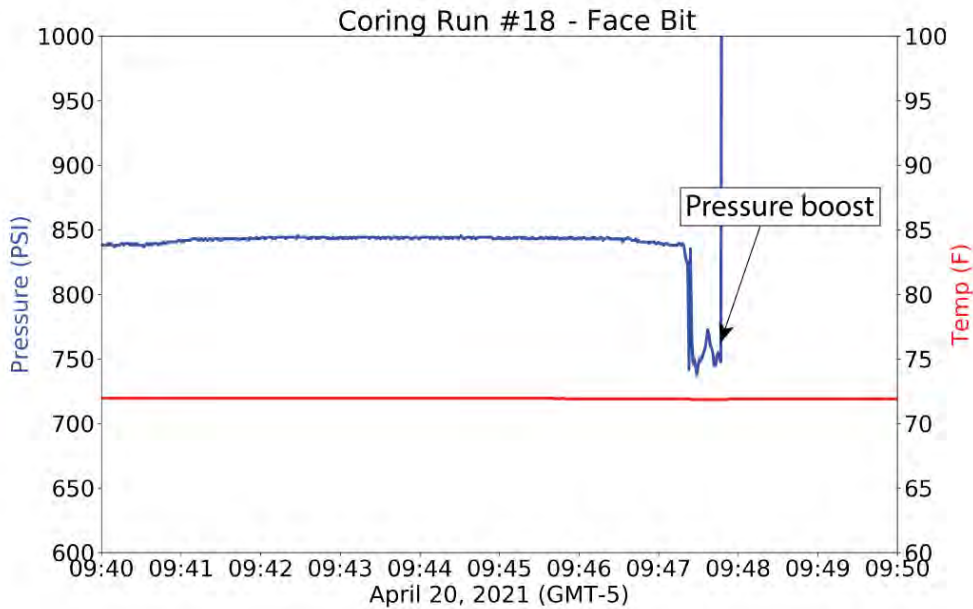
Figure 7-4. DST pressure and temperature data for COK-18FB, showing an on-time pressure boost. The plot is zoomed in to show a decrease in DST pressure similar in magnitude to those seen in COK-12FB and COK-14FB, but occurring over seconds instead of minutes prior to the boost. This drop in pressure prior to boost is not always observed, but has frequently occurred in this land test, the previous land test, and the GOM2-1 marine test.

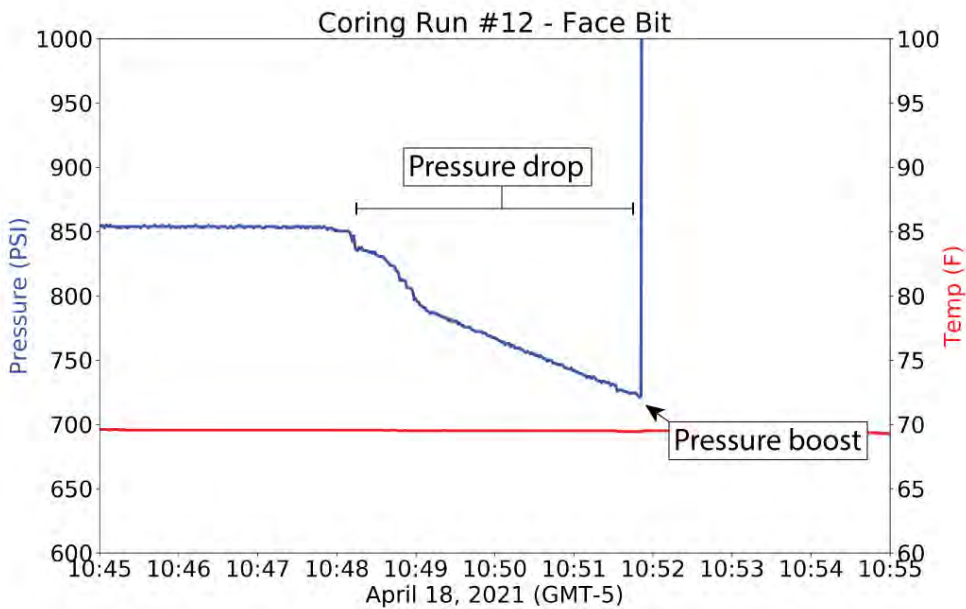
Figure 7-5. DST pressure and temperature data for COK-12FB, zoomed in to show a decrease in pressure lasting 3m40s just before the pressure boost is recorded.

In two tests, we observed a gradual pressure drop of approximately 125 psi that occurred approximately 3 minutes after coring ended but before the boost fired. This has been interpreted in two ways: as slow actuation at coring depth due atypically slow wireline actuation, or a partial seal at coring depth as a result of an incomplete upper seal followed by a delayed pressure boost. Remedial recommendations were made to address both possibilities.

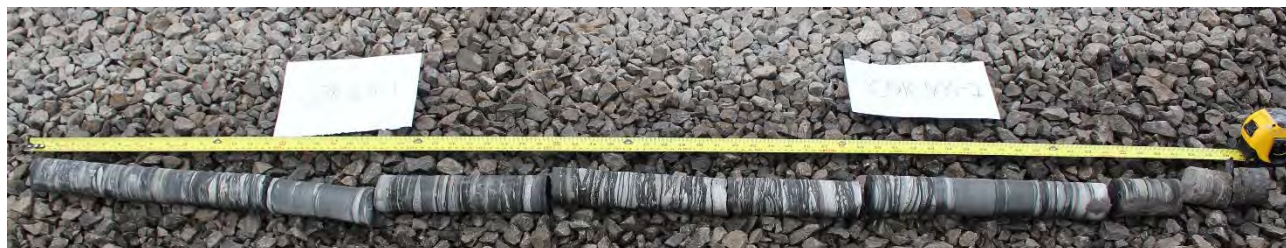
Figure 7-7. Core COK-05CS contained 5.58 ft (63.4% recovery) of interbedded shale. There are breaks in the core section, but the breaks are sharp and unrounded.

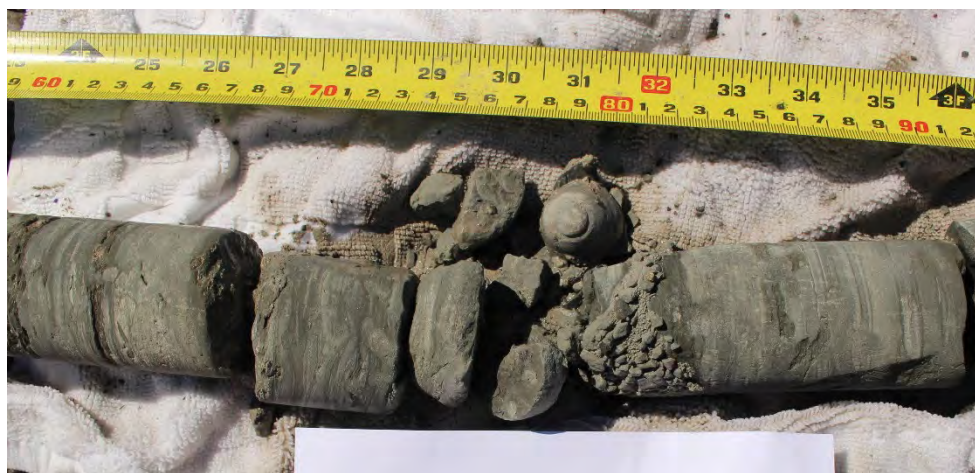
Figure 7-8. Clear evidence of biscuiting in core COK-15FB. The lithology of this core is sandier than most of the other cores.

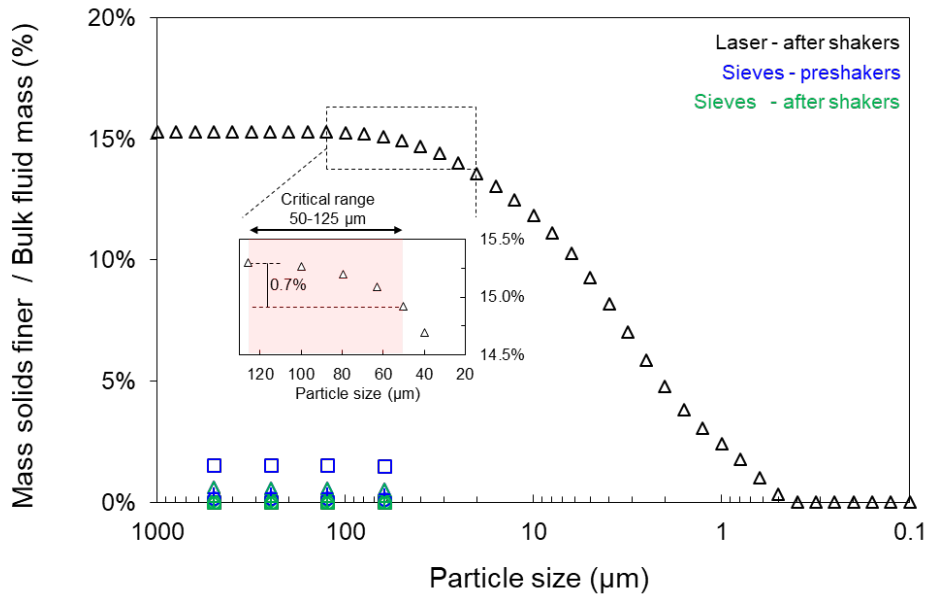
Figure 7-9. Cumulative particle size distribution of the suspended particles in the mud normalized with respect to mass of mud. Marker type represent test day (squares 4/16, diamonds 4/17, circles 4/18, triangles 4/19, cross 4/20). Inset is a zoomed in region for the particle range for failure.

The drilling mud used in the PCTB Land Test III was characterized to determine if it contained the critical range of grit size (53-125  $\mu\text{m}$ ) and minimum concentration ( $\geq 0.24\%$ ) that resulted in failure during the Land Test II and subsequent bench tests. Laser diffraction analysis of mud samples indicated that target range of particulates were present in concentrations approximately three times greater than that needed to cause failure (0.7%). The high concentration of grit in the critical range indicate that the PCTB Land Test III appropriately tested the modifications intended to remove sensitivity of the ball valve actuation to grit.

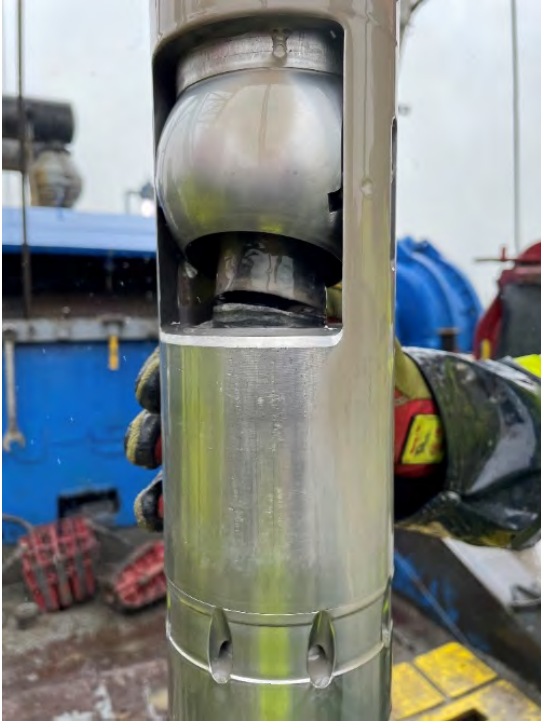
*Figure 8-1. In test COK-07CS, a small length of core was jammed in the cutting shoe and protruded up through the ball valve, preventing it from closing.*

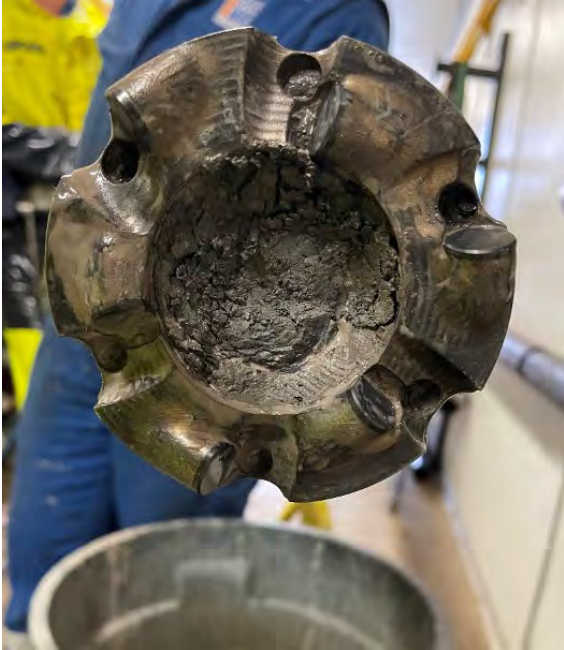
*Figure 8-2. The jammed cutting shoe of test COK-07CS, seen from the bottom.*

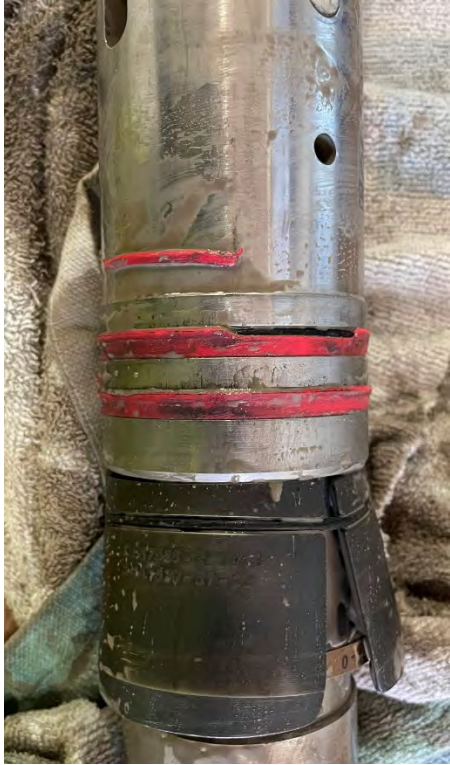
*Figure 8-3. COK-09CS failed to seal and actuate properly due to a damaged plug seal on the upper end of the inner core barrel. The damaged seal is shown here after post-deployment disassembly.*

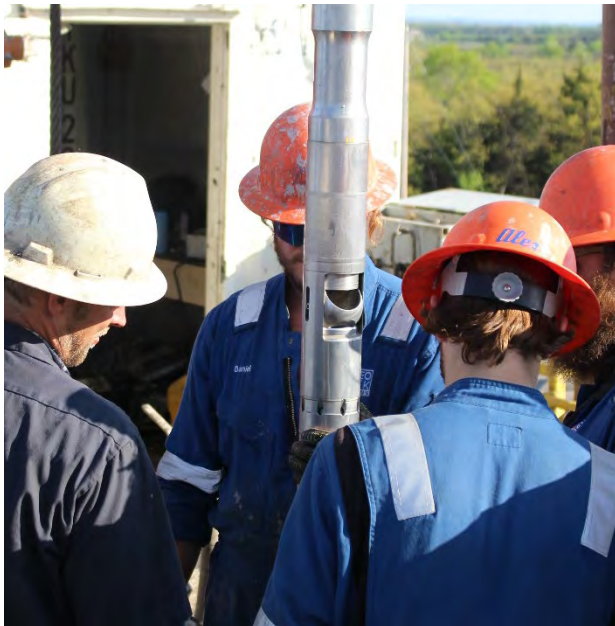
*Figure 8-4. Upon retrieval of COK-17FB, the ball valve was visibly open.*

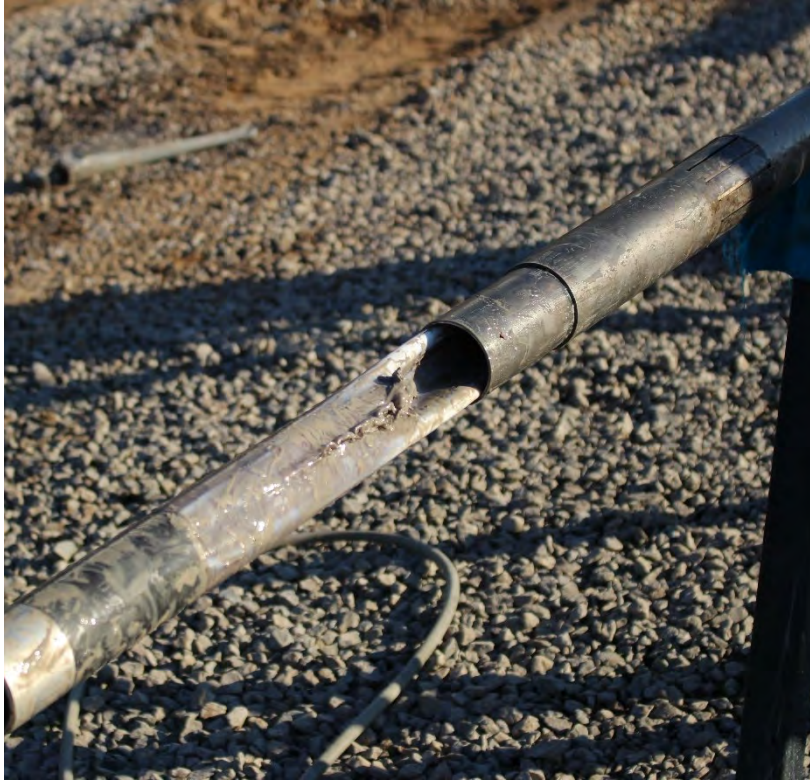
*Figure 8-5. Collapsed core liner of COK-17FB. Despite the collapsed core liner, 1.1 ft of core entered the inner core barrel and was captured.*

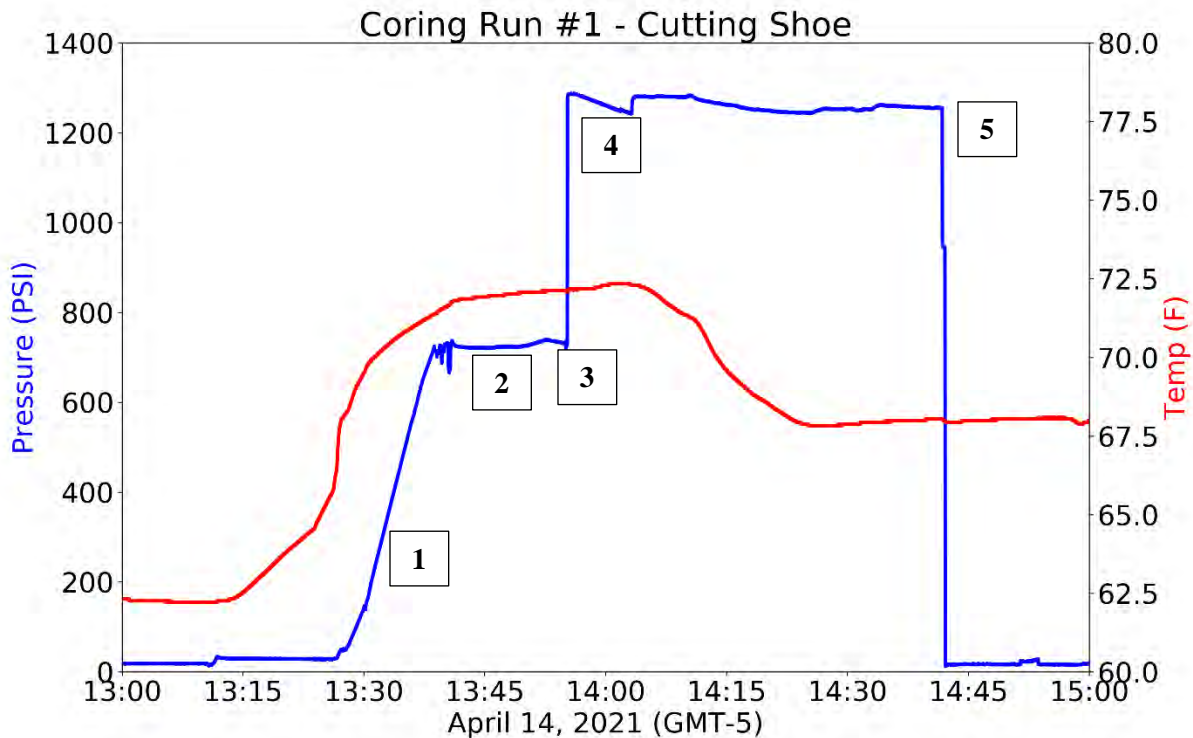
Figure 1: **Coring Test 1 (COK-01CS)**. DST pressure and temperature data. This was a water core with no circulation. Summary of events: **1:** Tool lowered down hole to 1400 ft.; **2:** PCTB latched into BHA at 1400 ft. **3:** Inner core barrel retrieved, ball valve seals, and pressure boost is preserved; **4:** Pressure held as tool is removed from hole. **5:** Depressurized in lab.

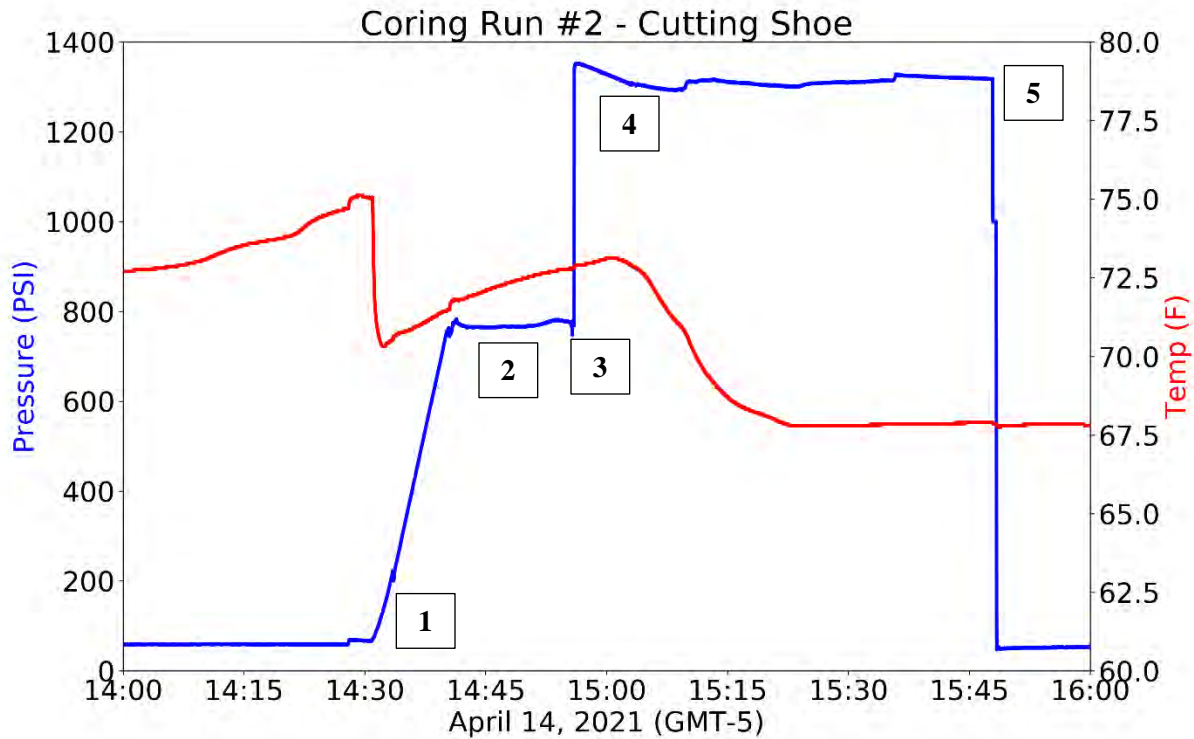
Figure 2: **Coring Test 2 (COK-02CS).** DST pressure and temperature data. Water core (no core taken), no circulation. **1:** Inner core barrel lowered down hole to latch into BHA at 1400 ft. **2:** PCTB at BHA while running tool is recovered and pulling tool is deployed. **3:** PCTB is actuated. **4:** Inner core barrel is removed from hole. **5:** Depressurized in lab.
