DOE Award No.: DE-FE0023919

Quarterly Research Performance Progress Report

(Period Ending 06/30/21)

Deepwater Methane Hydrate Characterization & Scientific Assessment

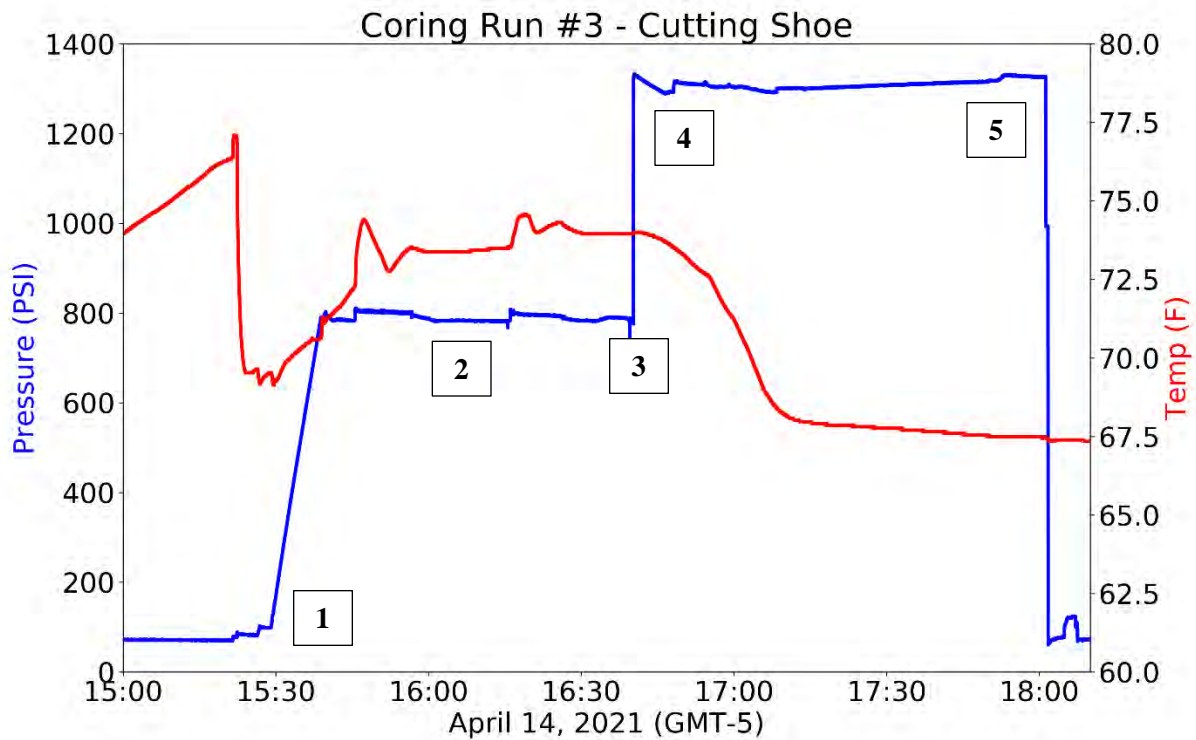
Figure 3: **Coring Test 3 (COK-03CS)**: DST pressure and temperature data, no core taken (water core) dynamic fluid with pump flow for ten minutes at 300 GPM. **1**: Inner core barrel lowered down hole to latch into BHA; **2**: PCTB at BHA while running tool is recovered and pulling tool is deployed. **3**: PCTB is actuated. **4**: Inner core barrel is removed from hole. **5**: Depressurized in lab.1.

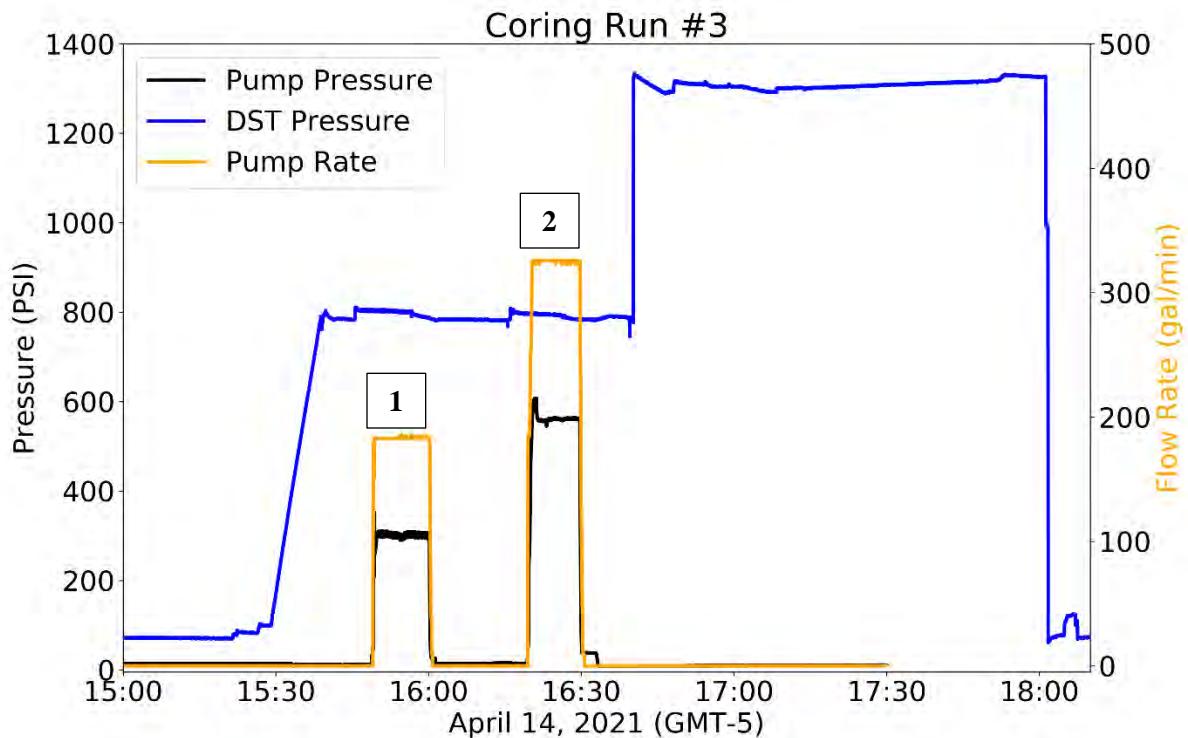
Figure 4: **Coring Test 3 (COK-03CS):** DST pressure, and rig instrumentation (pressure and flow rate). **1:** circulation while the inner core barrel was hung on the wireline (180 GPM). **2:** circulation while the inner core barrel was locked into the BHA (315 GPM). The pressure boost is clearly recorded, and pressure was maintained as the PCTB was brought to the surface.

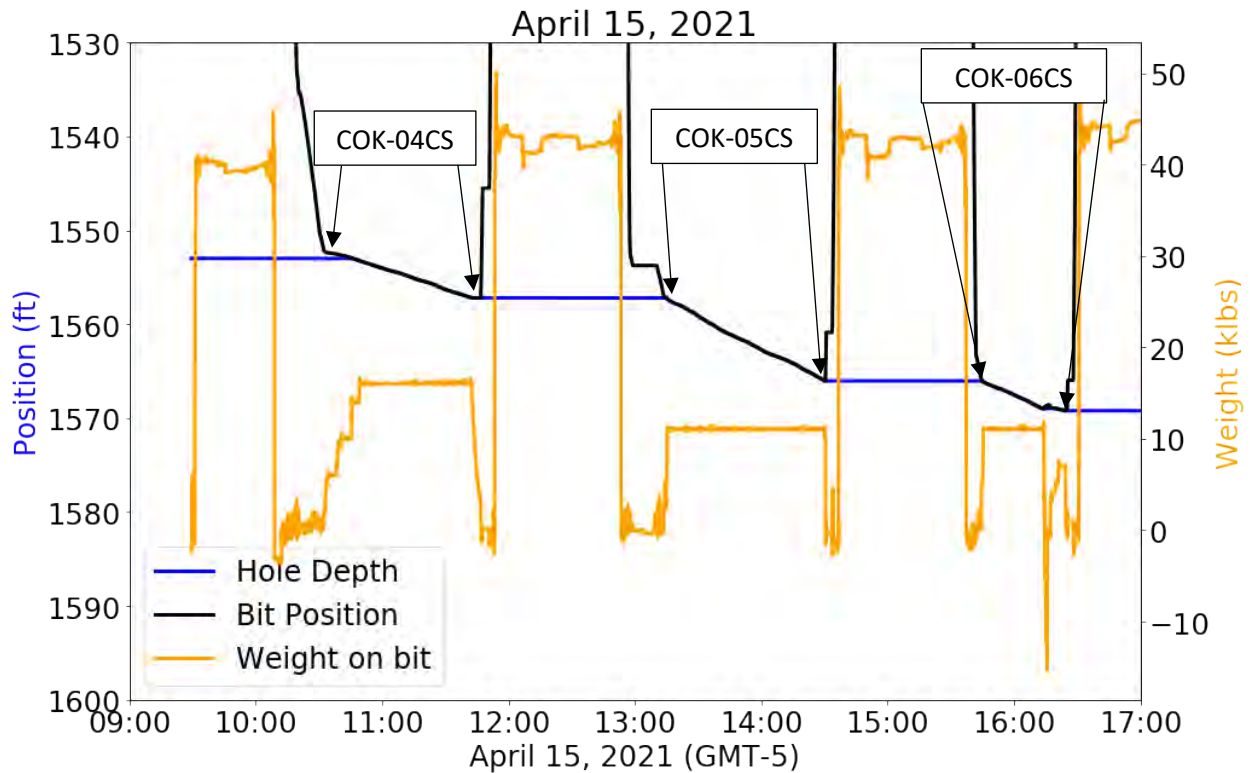
Figure 1: **Drilling Summary for April 15, 2021.** Bit position, hole depth, and weight on bit for three coring runs (COK-04CS, COK-05CS, and COK-06CS). The rate of penetration for COK-04CS was approximately 4 ft/hr, whereas the rate of penetration for COK-05CS increased to approx. 7 ft/hr. The interval from 1553'-1568.3' was drilled while these three cores were taken.

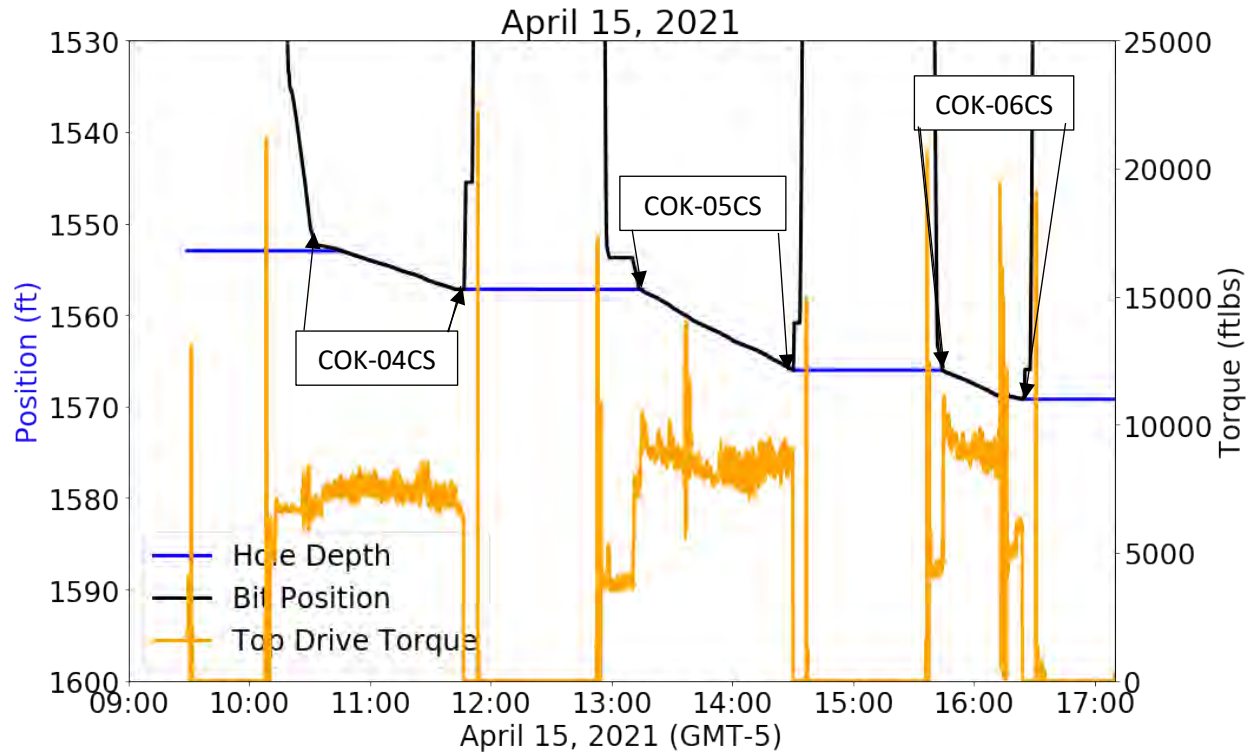
Figure 2: **Drilling Summary for April 15, 2021.** Bit position, hole depth, and top drive torque for coring runs COK-04CS, COK-05CS, and COK-06CS. Coring run COK-06CS was cut short because torque exceeded 20,000 ft-lbs. In response, the driller raised the bit. Once the bit is lifted off bottom, it is exceedingly difficult to collect more core. For this reason, the test was ended.

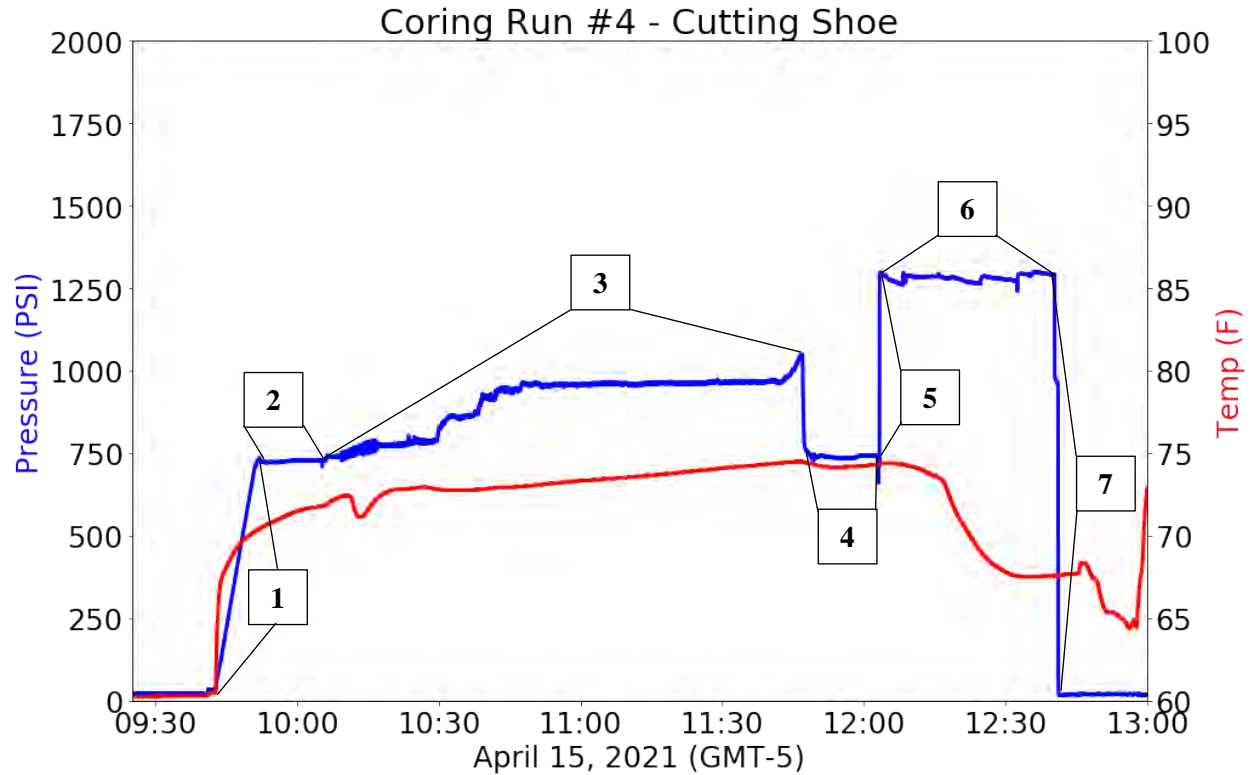
Figure 3: **Coring Test 4 (COK-04CS)**. DST pressure and temperature data. No core recovered. Small pieces of debris or cement were collected in core liner. PCTB sealed successfully. Summary of events: **1:** Core barrel lowered down hole and latched into BHA at 1552.8 ft. **2:** Core barrel at BHA and running tool released. **3:** Coring begins with flow at 240 GPM. Pressure builds up as pump pressure increases. **4:** Coring ends and pulling tool is deployed. Pressure returns to in situ. **5:** PCTB is actuated. **6:** Wireline pulled out core barrel. **7:** Depressurized in lab.

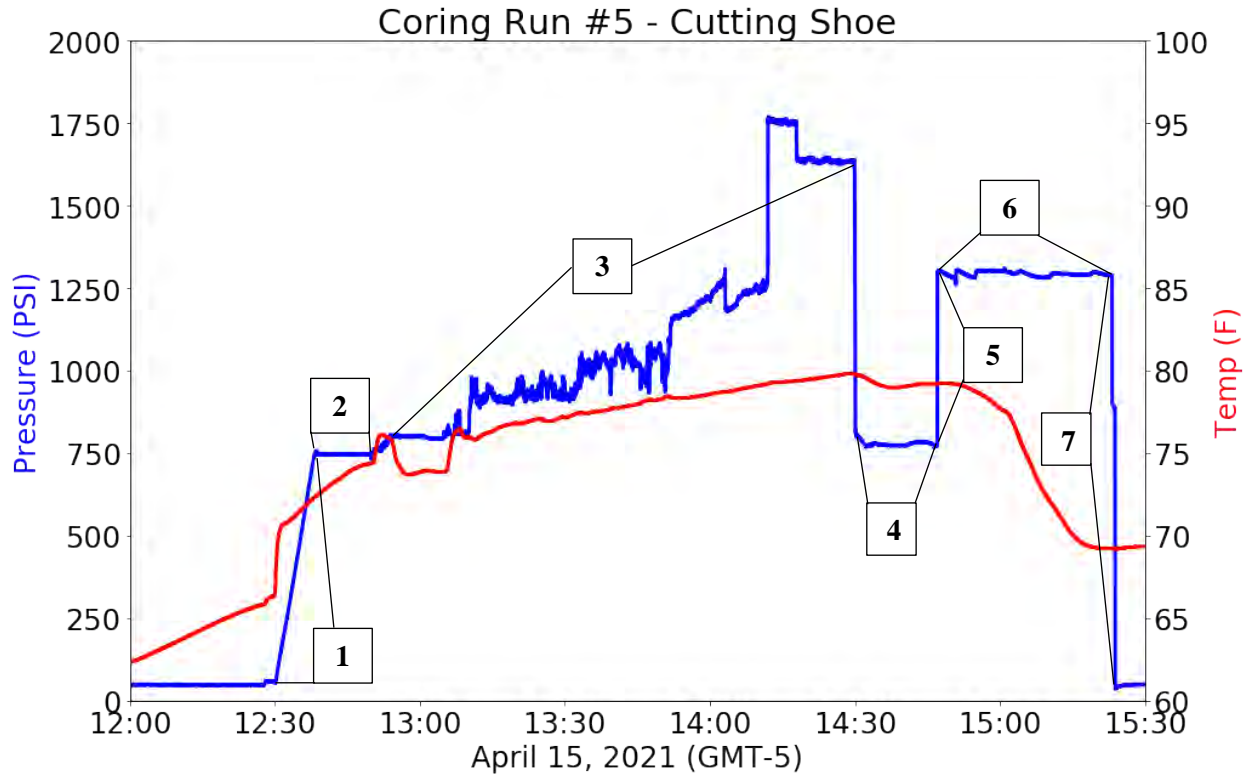
Figure 3: **Coring Test 5 (COK-05CS)**. DST pressure and temperature data. 67” of core recovered. PCTB sealed successfully and pressure maintained as tool retrieved and brought to lab. Summary of events: **1:** Core barrel lowered down hole and latched into BHA at 1557.5 ft. **2:** Core barrel at BHA and running tool released. **3:** Coring begins with flow at 240 GPM. Pressure builds up as pump pressure increases. **4:** Coring ends and pulling tool is deployed. Pressure returns to in situ. **5:** PCTB is actuated. **6:** Wireline pulled out core barrel. **7:** Depressurized in lab.

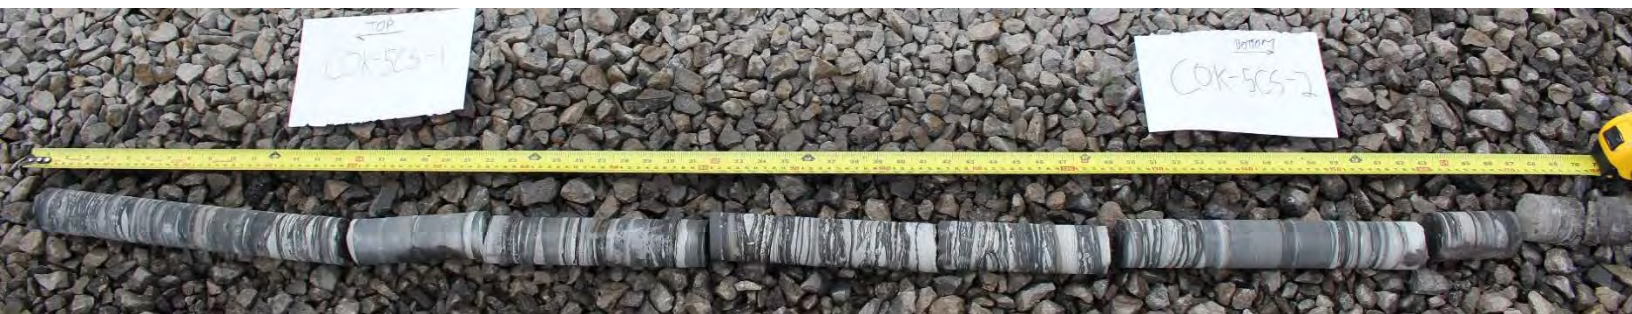
Figure 4: **Coring Test 5 (COK-05CS)**. 5.58 feet (67 inches) of core recovered. Good quality core with few fractures and smooth edges. Fractures appear to be from removal from core liner. Some biscuiting/fractures at bottom of core near ball valve.

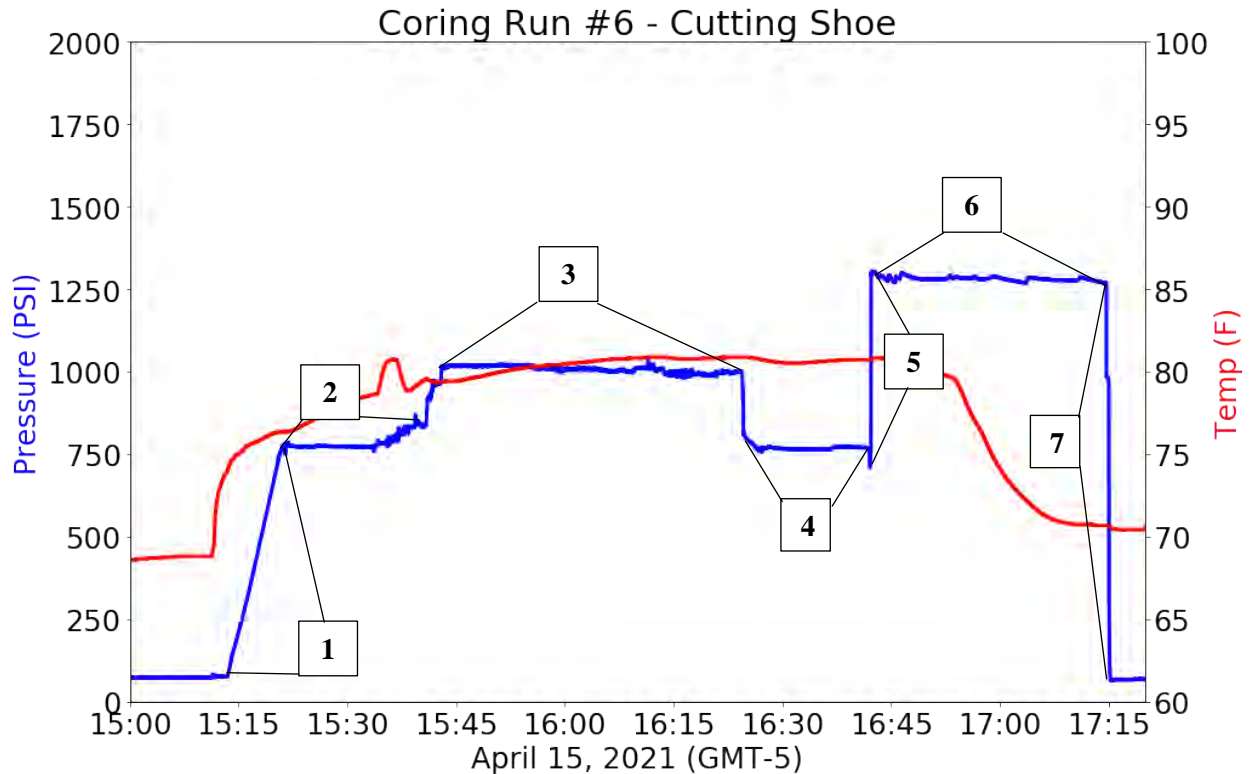
Figure 5: **Coring Test 6 (COK-06CS).** DST pressure and temperature data. 4” of core recovered. PCTB sealed successfully and pressure maintained as tool retrieved and brought to lab. Summary of events: **1:** Core barrel lowered down hole and latched into BHA at 1566 ft. **2:** Core barrel at BHA and running tool released. **3:** Coring begins with flow at 240 GPM. Pressure builds up as pump pressure increases. **4:** Coring ends and pulling tool is deployed. Pressure returns to in situ. **5:** PCTB is actuated. **6:** Wireline pulled out core barrel. **7:** Depressurized in lab.

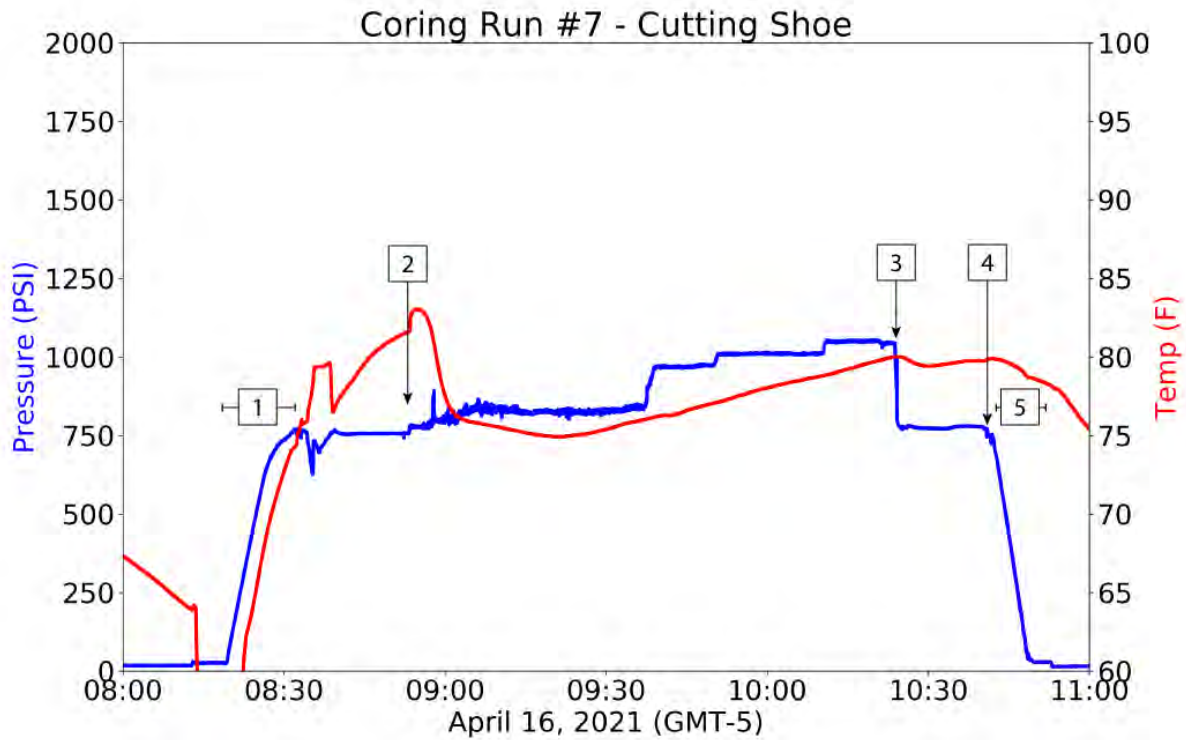
Figure 3: **Coring Test 7 (COK-07CS)**. DST pressure and temperature data. Summary of events: **1:** Core barrel lowered down hole and latched into BHA at 1569.4ft. **2:** Pumps turn on at 450 GPM. **3:** Pumps turn off. **4:** PCTB is actuated. Core extending through the ball prevented ball closure; no boost or seal is recorded. **5:** PCTB is brought back to rig floor.

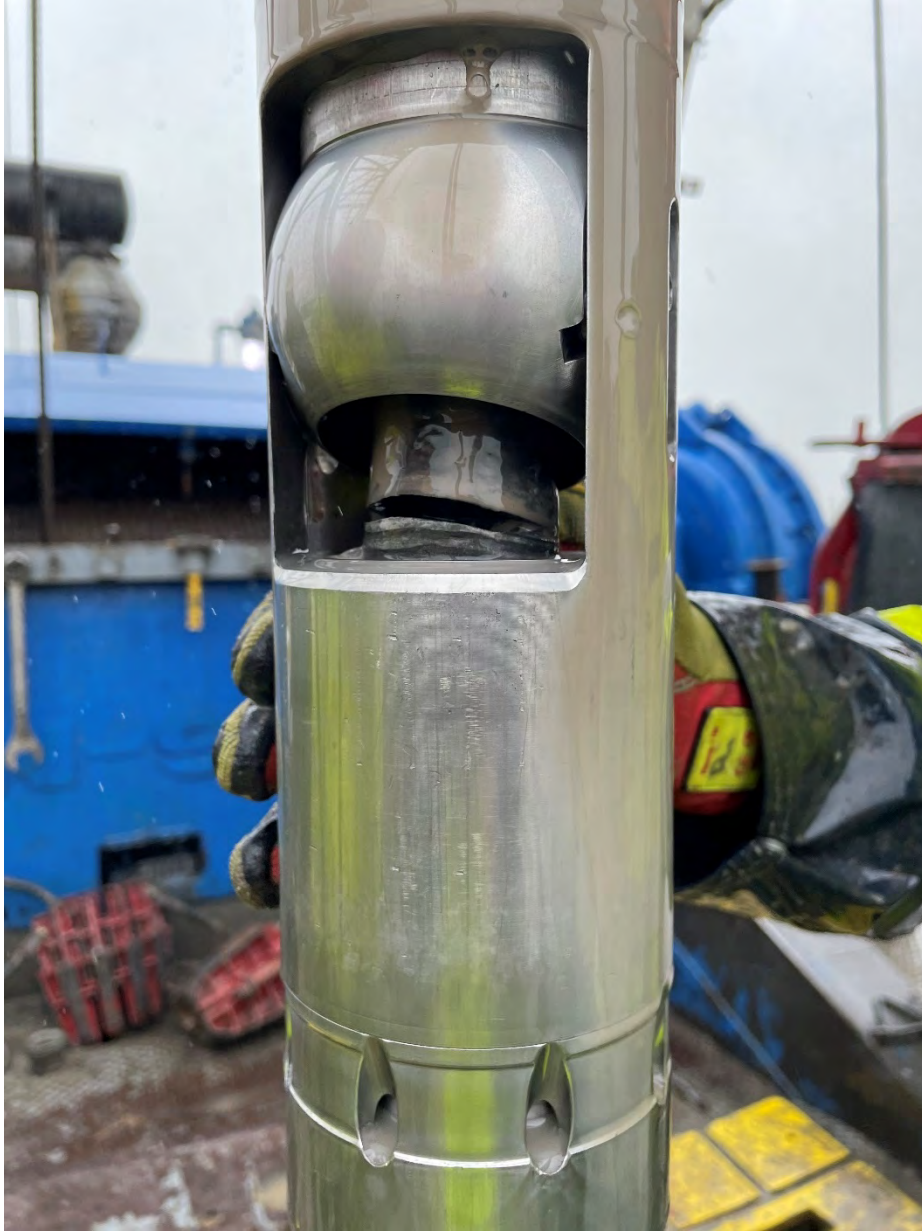
Figure 4: **Coring Test 7 (COK-07CS)**. Core that was not pulled up when the PCTB actuated blocked the ball from closing.

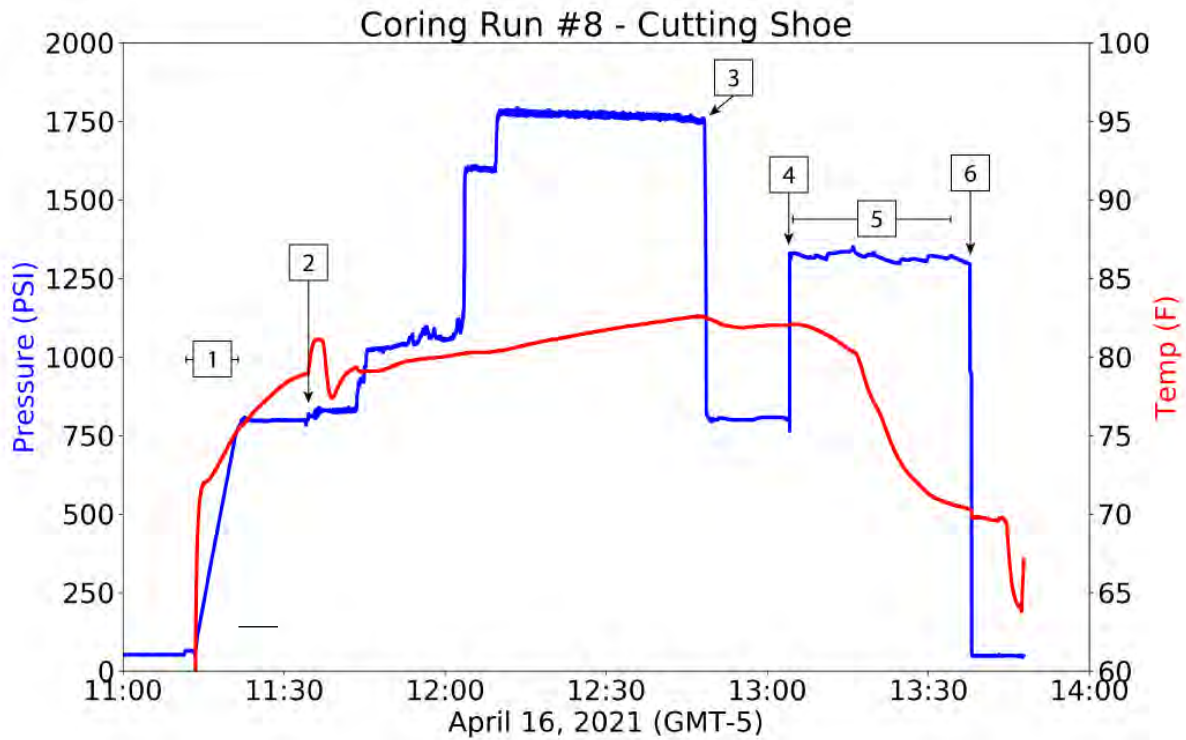
Figure 3: **Coring Test 8 (COK-08CS)**. DST pressure and temperature data. Summary of events: **1:** Core barrel lowered down hole and latched into BHA at 1574 ft. **2:** Pumps turned on with flow at 450 GPM. **3:** Pumps turned off. Pressure returns to in situ. **5:** PCTB is actuated, and a pressure boost and seal is recorded. **5:** PCTB returns to rig floor. **6:** Depressurized in lab.

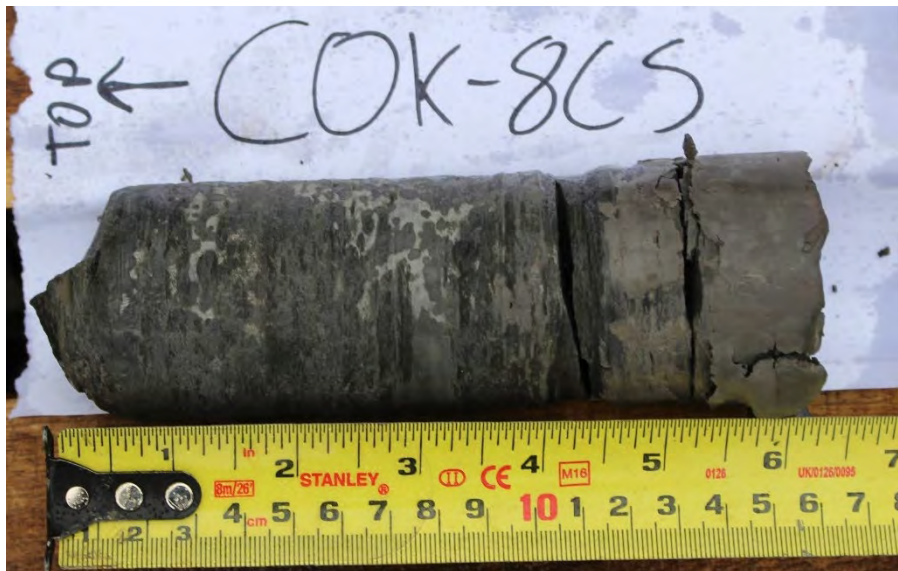
Figure 4: **Coring Test 8 (COK-08CS)**. 6" of jammed core.

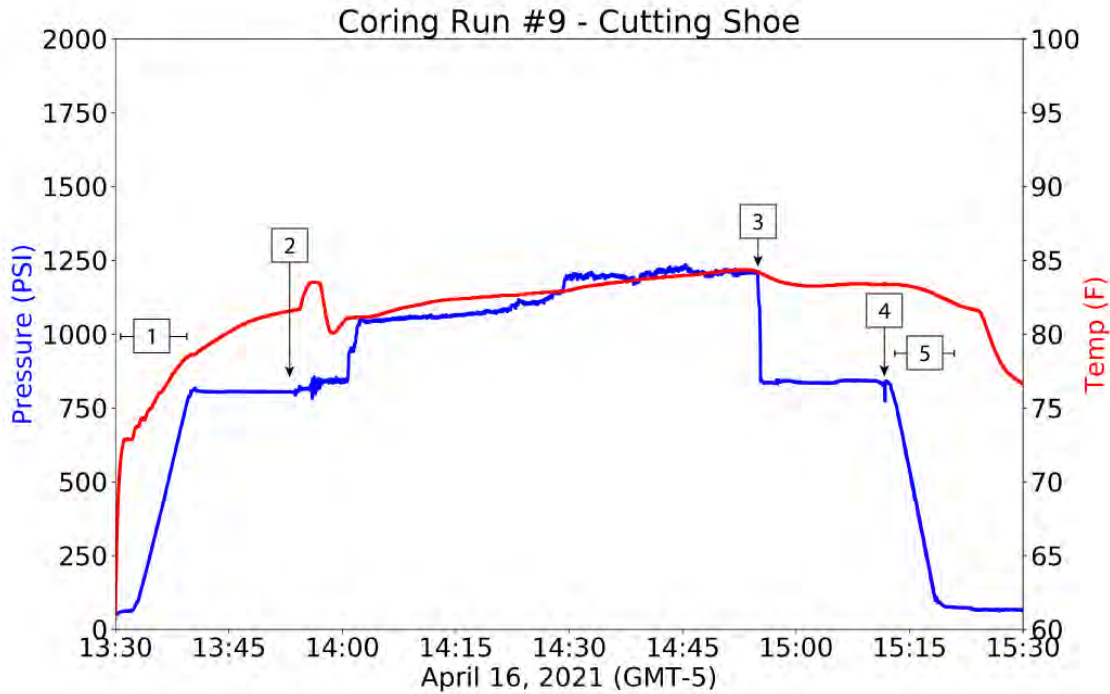
Figure 5: **Coring Test 9 (COK-09CS).** DST pressure and temperature data. Summary of events: **1:** Core barrel lowered down hole and latched into BHA at 1579.2 ft. **2:** Pumps turned on with flow at 450 GPM. **4:** Pumps turned off. Pressure returns to in situ. **5:** PCTB is actuated, but did not seal due to damaged upper seal. **6:** PCTB returns to rig floor.

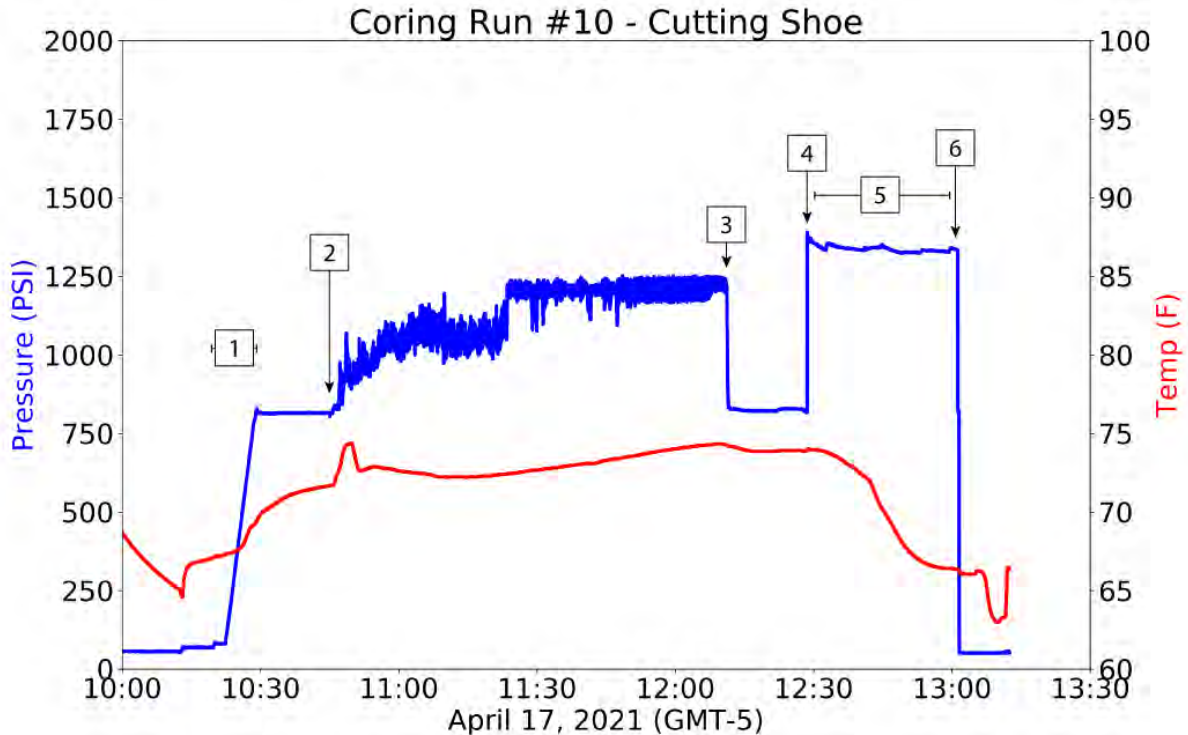
Figure 4: **Coring Test 10 (COK-10CS).** DST pressure and temperature data. Summary of events: **1:** Core barrel lowered down hole and latched into BHA at 1583.7ft. **2:** Pumps turn on at 315 GPM. **3:** Pumps turn off. **4:** PCTB is actuated. **5:** PCTB is brought back to rig floor. **6:** PCTB is depressurized in the lab.

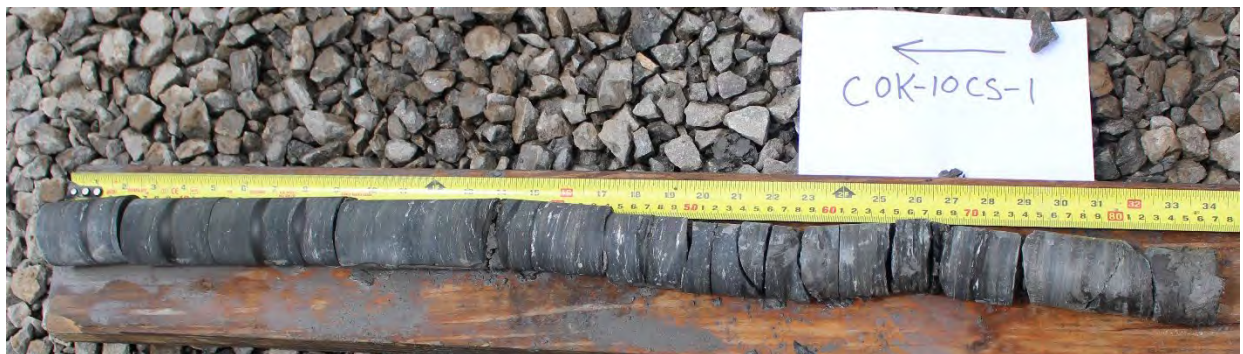
Figure 5: **Coring Test 10 (COK-10CS).** The 34" of recovered core was very fragile upon inspection. Shale is the predominant lithology.

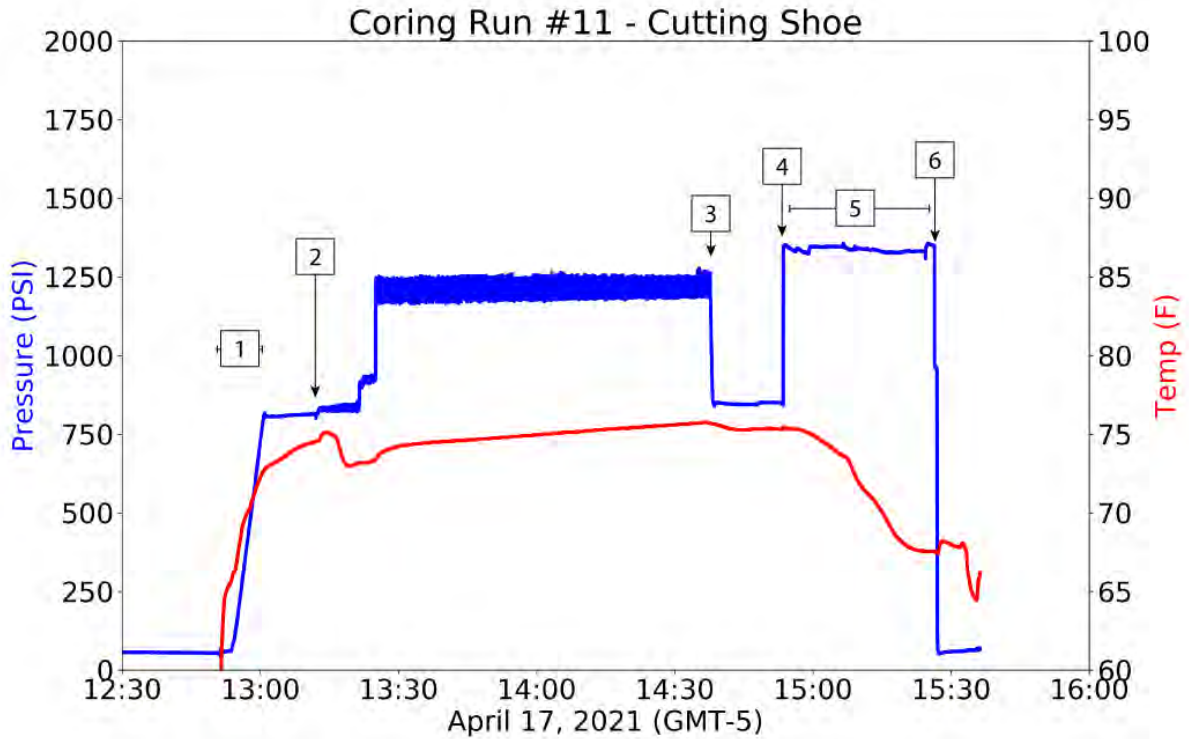
Figure 6: **Coring Test 11 (COK-11CS).** DST pressure and temperature data. Summary of events: **1:** Core barrel lowered down hole and latched into BHA at 1589.4ft. **2:** Pumps turn on at 315 GPM. **3:** Pumps turn off. **4:** PCTB is actuated. **5:** PCTB is brought back to rig floor. **6:** PCTB is depressurized in the lab.

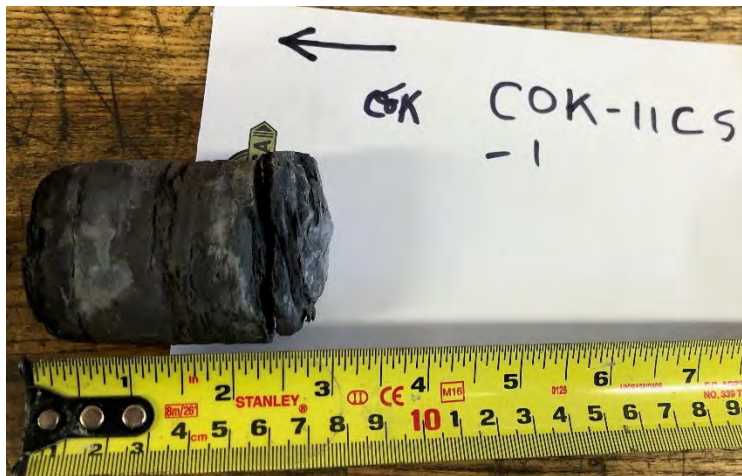
Figure 7: **Coring Test 11 (COK-11CS).** 3” of recovered core. The core was very fragile upon inspection.

**Coring Test 11 (COK-11CS):** The coring operation advanced 6.1 ft. The tool sealed and boosted successfully. The recovered was 0.25 ft, resulting in a recovery rate of 4.1%. Core quality is similar to COK-10CS, with primarily shale laminations.

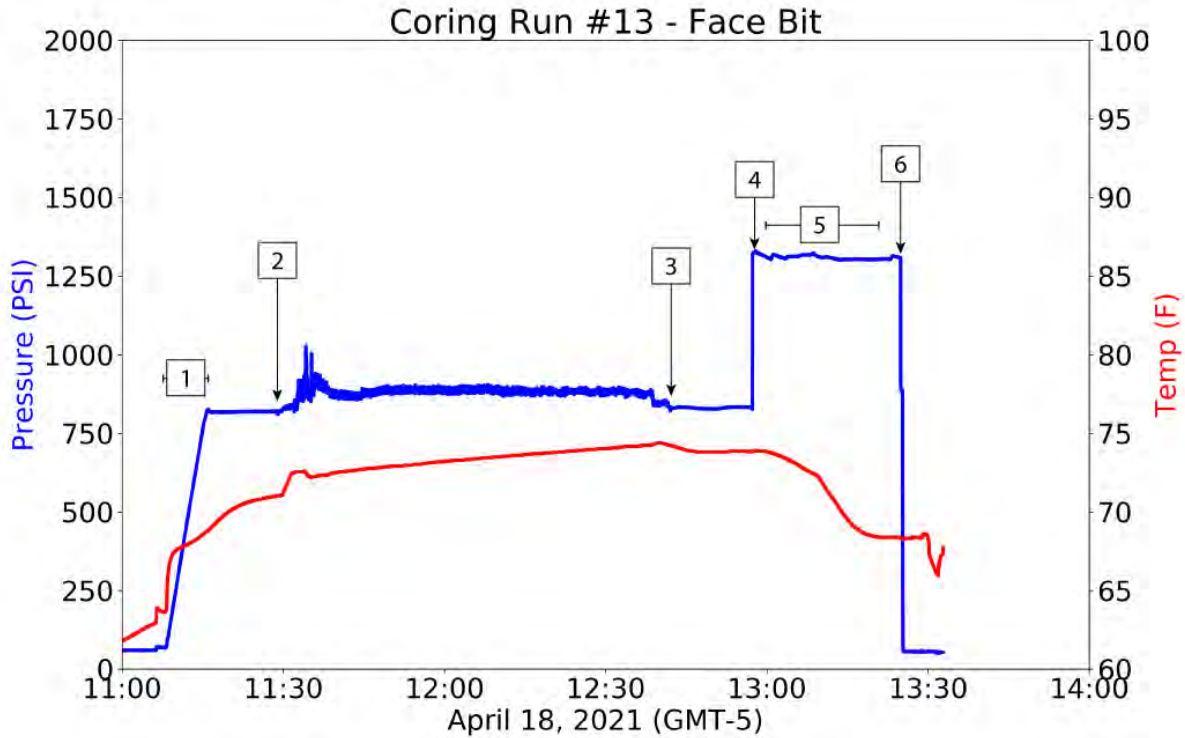
Figure 6: **Coring Test 13 (COK-13FB).** DST pressure and temperature data. Summary of events: **1:** Core barrel lowered down hole and latched into BHA at 1595.5 ft. **2:** Pumps turn on at 310 GPM. **3:** Pumps turn off. **4:** PCTB is actuated. **5:** PCTB is brought back to rig floor. **6:** PCTB is depressurized in the lab.

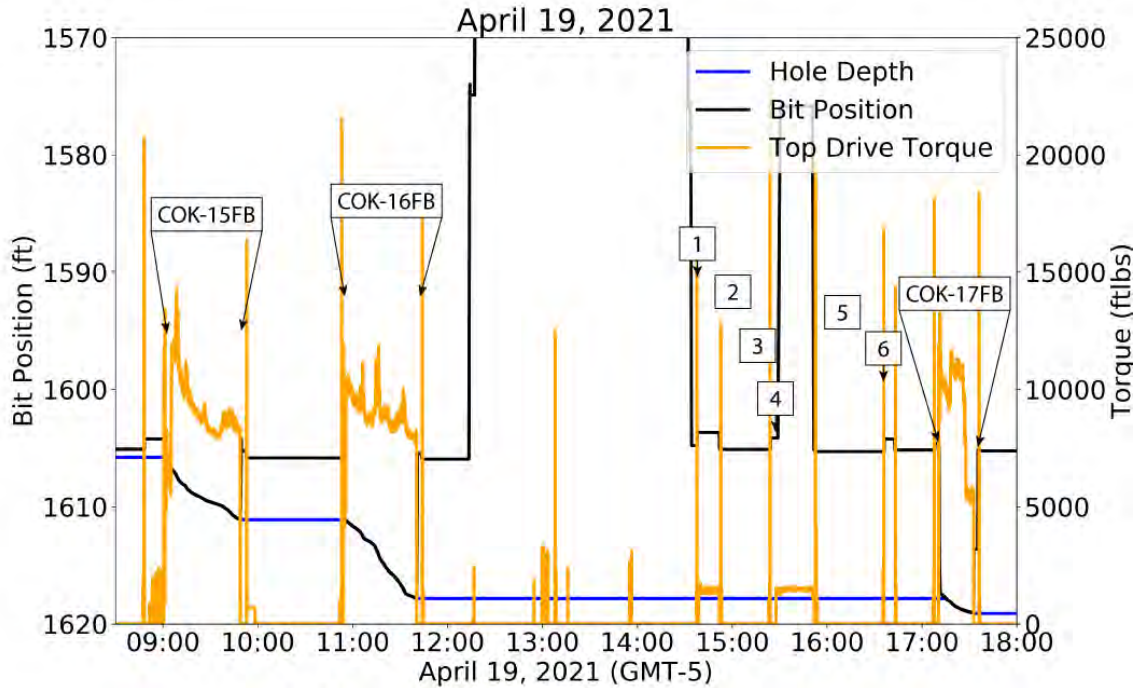
Figure 2: **Drilling Summary for April 18, 2021.** Bit position, hole depth, and top drive torque for coring runs COK-15FB, COK-16FB, and COK-17FB. Special events marked: 1. Circulation begins to clean BHA. 2. PCTB is sent downhole for test COK-17FB the first time. 3. PCTB lands too high and does not latch into BHA correctly. 4. Pumps are run, high standpipe pressure observed. 5. Emergency pulling tool retrieved PCTB. 6. Circulation begins to clean BHA.

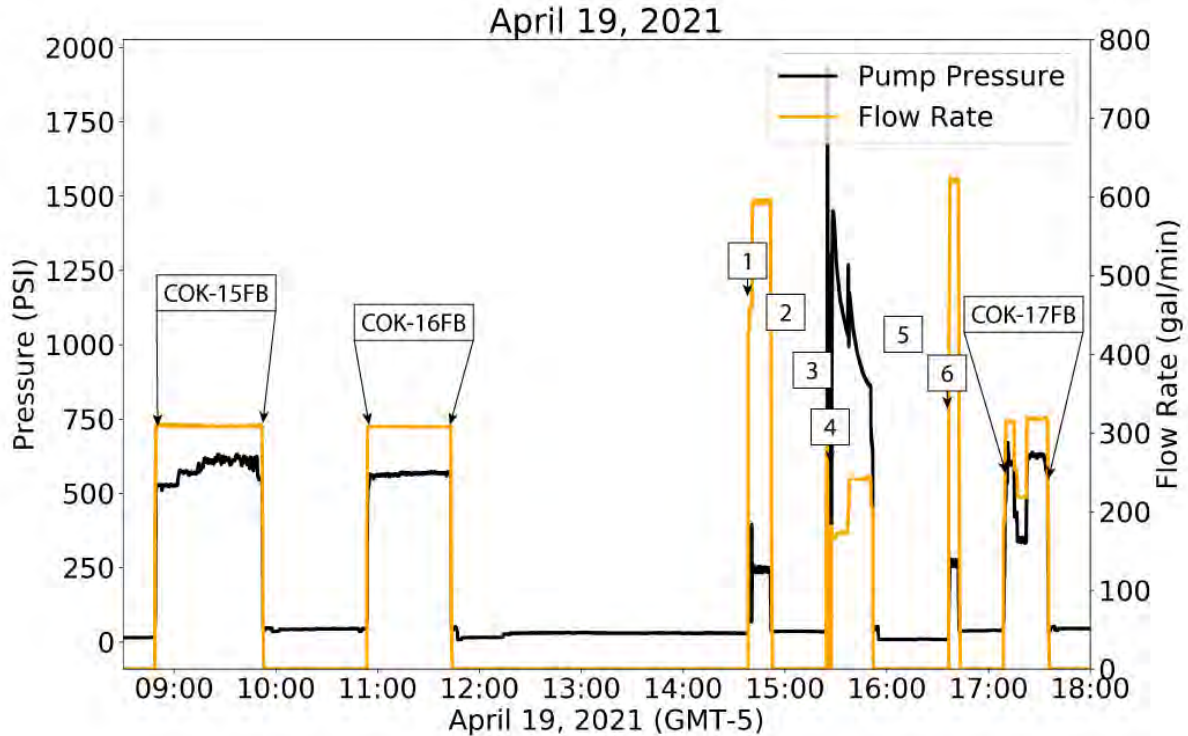
Figure 3: **Drilling Summary for April 18, 2021.** Pump Pressure and Flow Rate for coring runs COK-15FB, COK-16FB, and COK-17FB. Special events marked: 1. Circulation begins to clean BHA. 2. PCTB is sent downhole for test COK-17FB the first time. 3. PCTB lands too high and does not latch into BHA correctly. 4. Pumps are run, high standpipe pressure observed. 5. Emergency pulling tool retrieved PCTB. 6. Circulation begins to clean BHA.

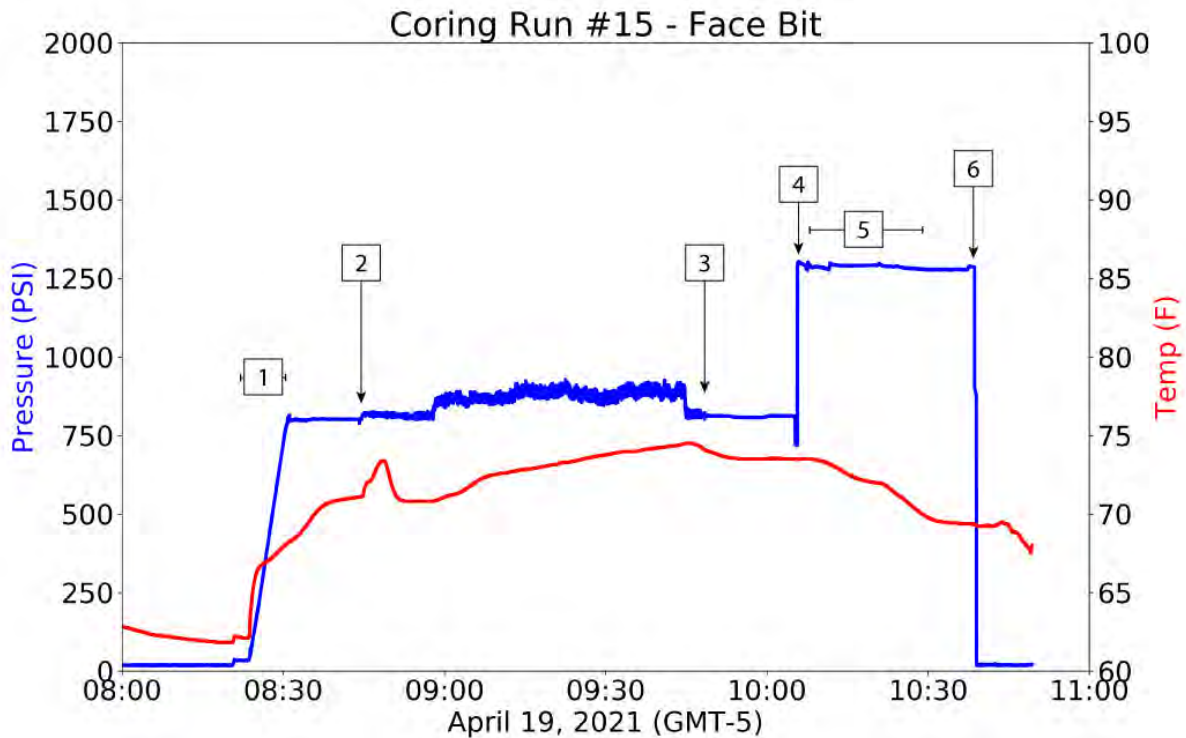
Figure 4: **Coring Test 15 (COK-15FB)**. DST pressure and temperature data. Summary of events: **1**: Core barrel lowered down hole and latched into BHA at 1605.8. **2**: Pumps turn on at 300 GPM. **2**: Pumps turn off. **4**: PCTB is actuated an a boost is recorded. **5**: PCTB is brought back to rig floor. **6**: PCTB is depressurized in the lab.

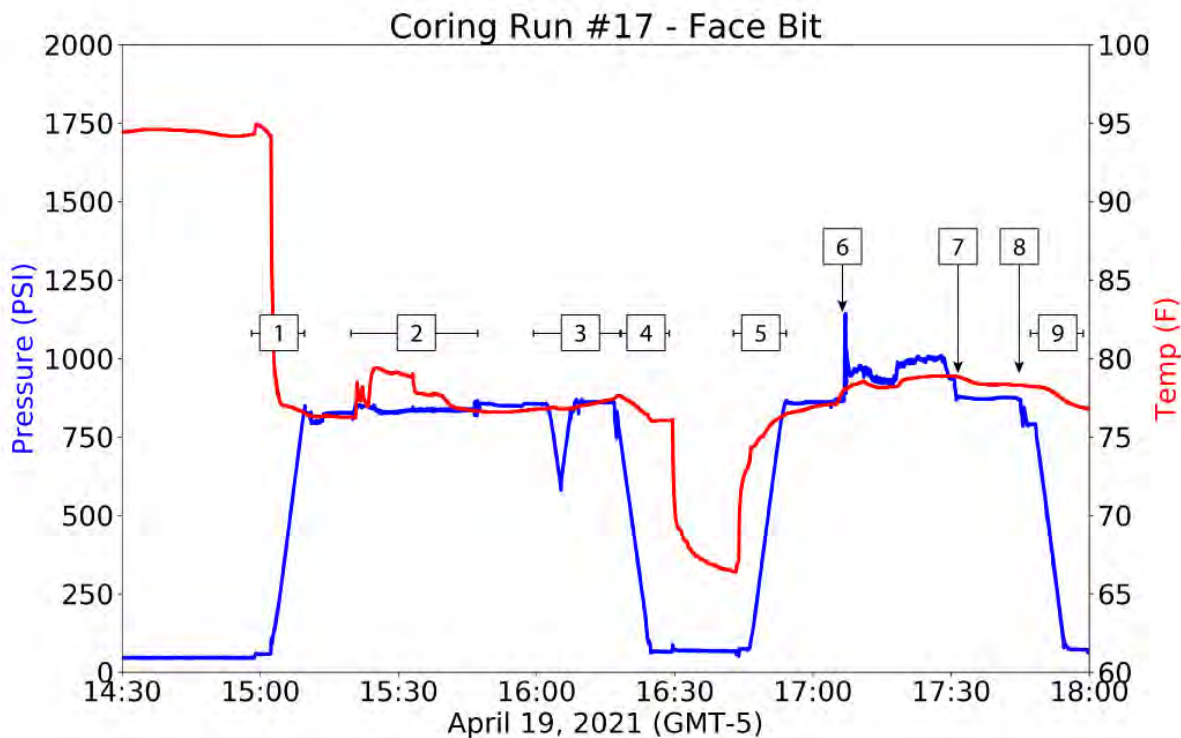
Figure 7: **Coring Test 17 (COK-17FB)**. DST pressure and temperature data. Summary of events: **1:** Core barrel lowered down hole and lands an estimated ~30 ft above the BHA. **2:** Circulation at 200-250 GPM. **3:** Attempts to retrieve the tool with emergency pulling tool. **4:** PCTB is pulled out of hole with emergency pulling tool. **5:** The same PCTB is run in hole. **6:** Pumps turned on at 310

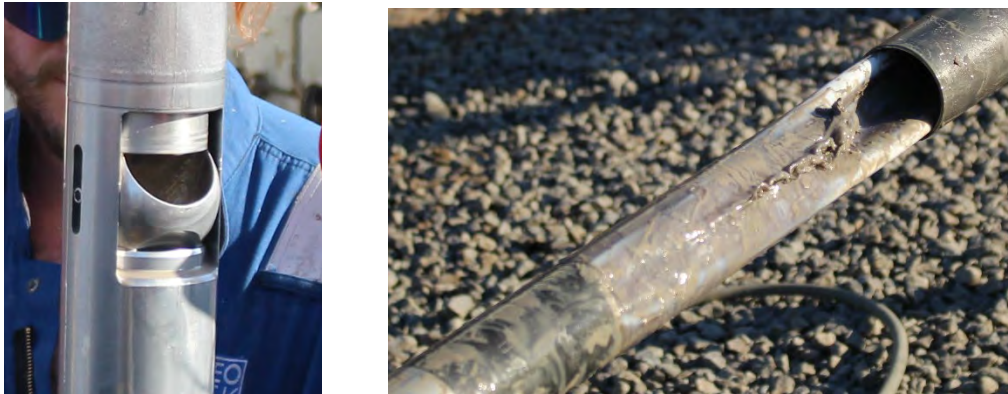
Figure 9: **Coring Test 17 (COK-17FB)**. Partial ball valve closure observed at the drilling floor (left) and collapsed core liner.

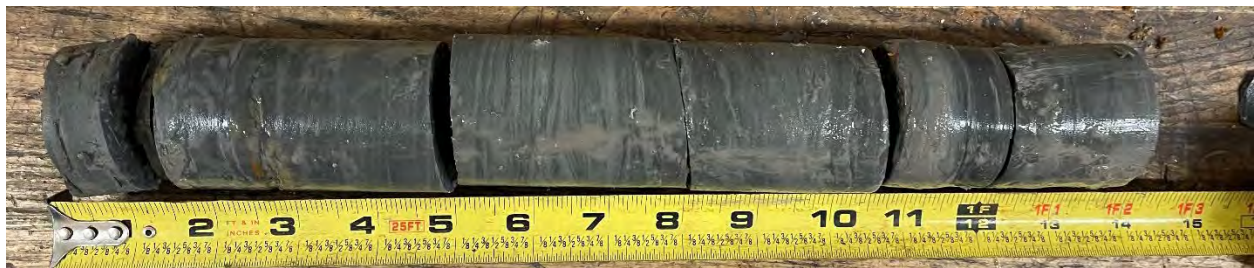
Figure 10: **Coring Test 17 (COK-17FB)**. 1.16 ft of recovered core from the core liner, despite partial collapse.

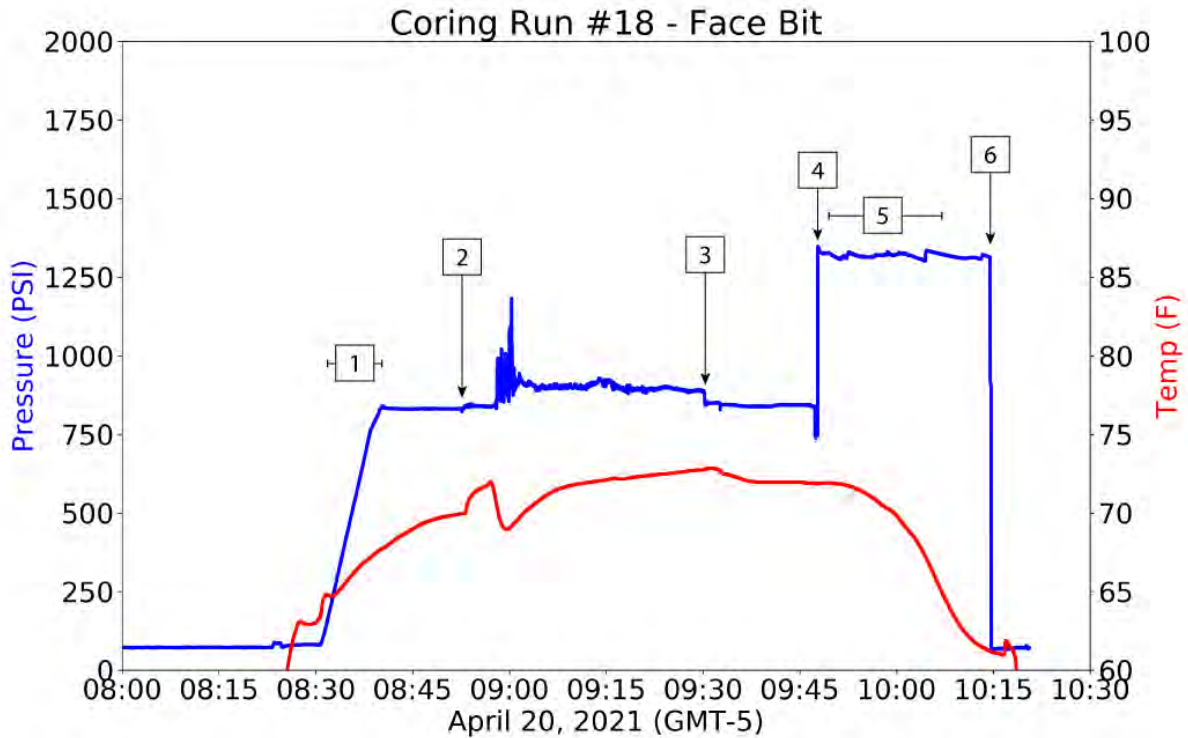
Figure 4: **Coring Test 18 (COK-18FB).** DST pressure and temperature data. Summary of events: **1:** Core barrel lowered down hole and latched into BHA at 1619.1 ft **2:** Pumps turn on at 311 GPM. **3:** Pumps turn off. **4:** PCTB is actuated and a boost is recorded. **5:** PCTB is brought back to rig floor. **6:** PCTB is depressurized in the lab.

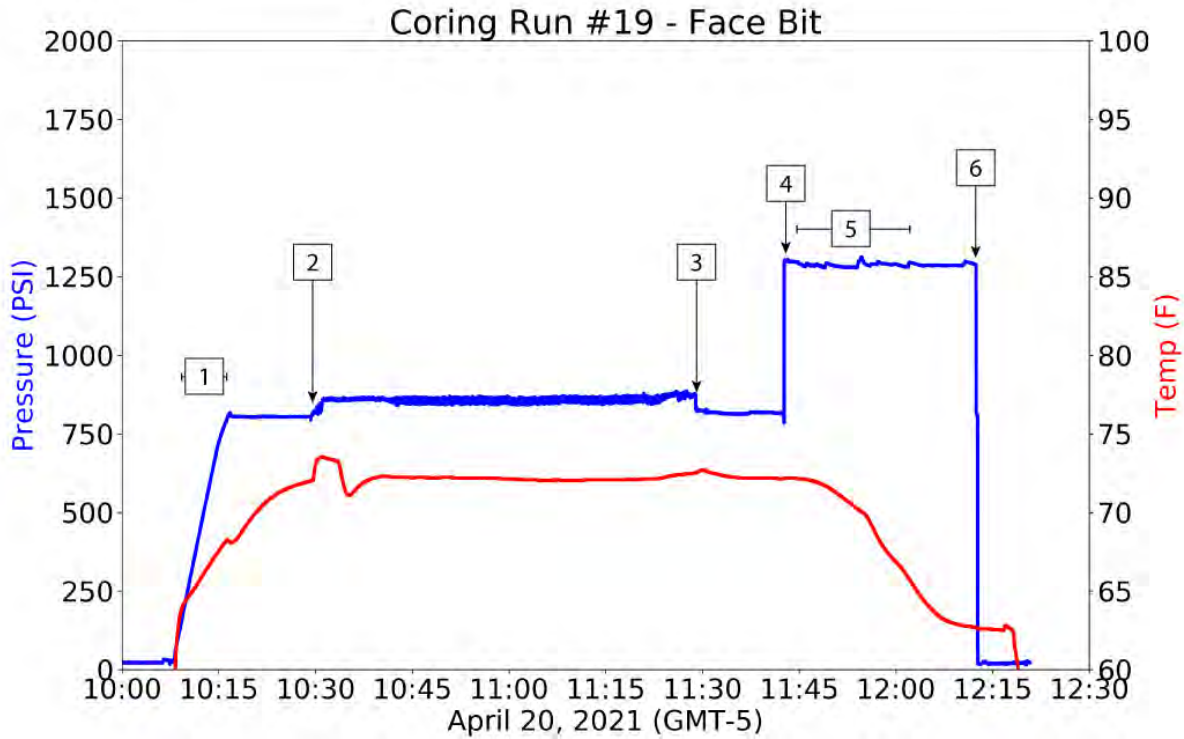
Figure 4: **Coring Test 19 (COK-19FB).** DST pressure and temperature data. Summary of events: **1:** Core barrel lowered down hole and latched into BHA at 1622.6. **2:** Pumps turn on at 285-313 GPM. **3:** Pumps turn off. **4:** PCTB is actuated and a boost is recorded. **5:** PCTB is brought back to rig floor. **6:** PCTB is depressurized in the lab.
