DOE Award No.: DE-FE0023919

Quarterly Research Performance Progress Report

(Period Ending 06/30/21)

Deepwater Methane Hydrate Characterization & Scientific Assessment

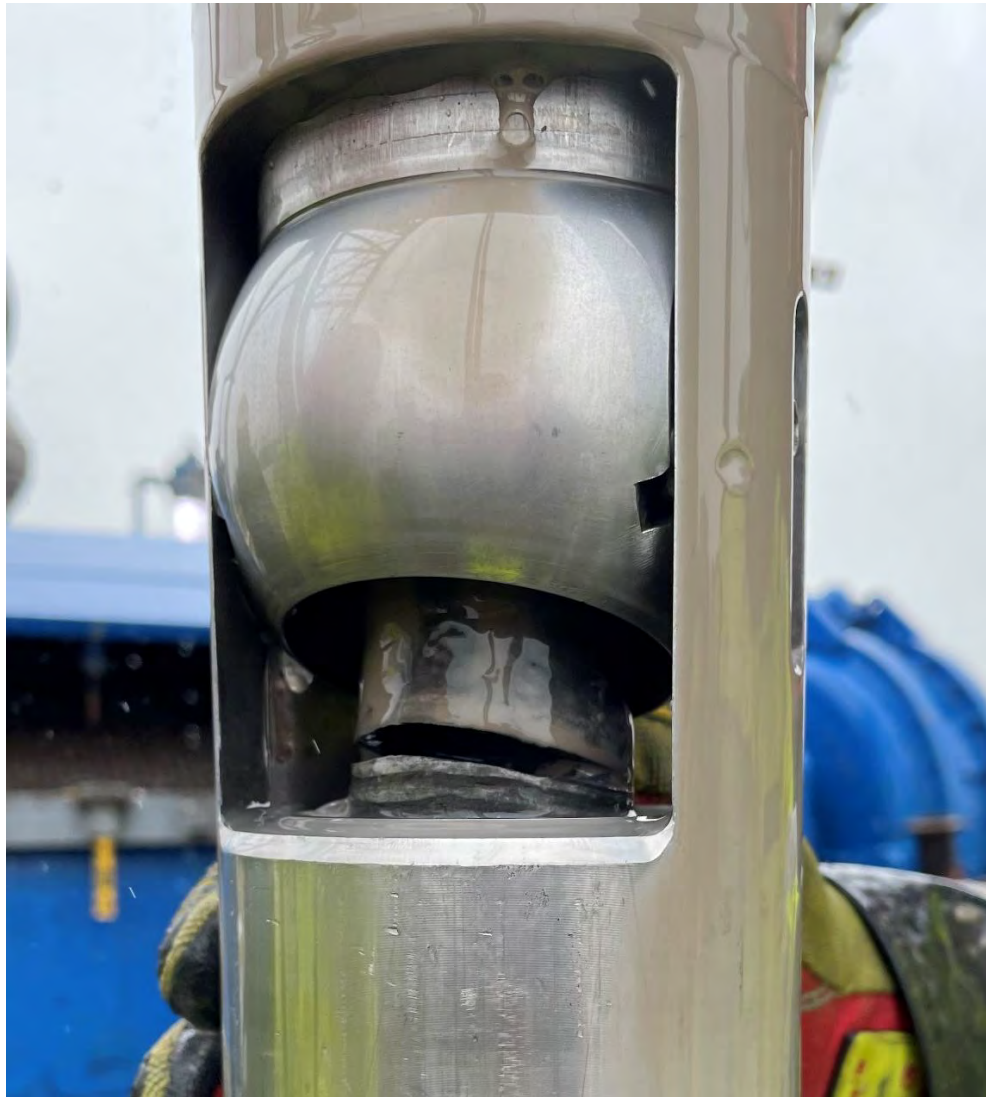
*Figure 1. Jammed core on test run 7CS causing ball valve to not close*

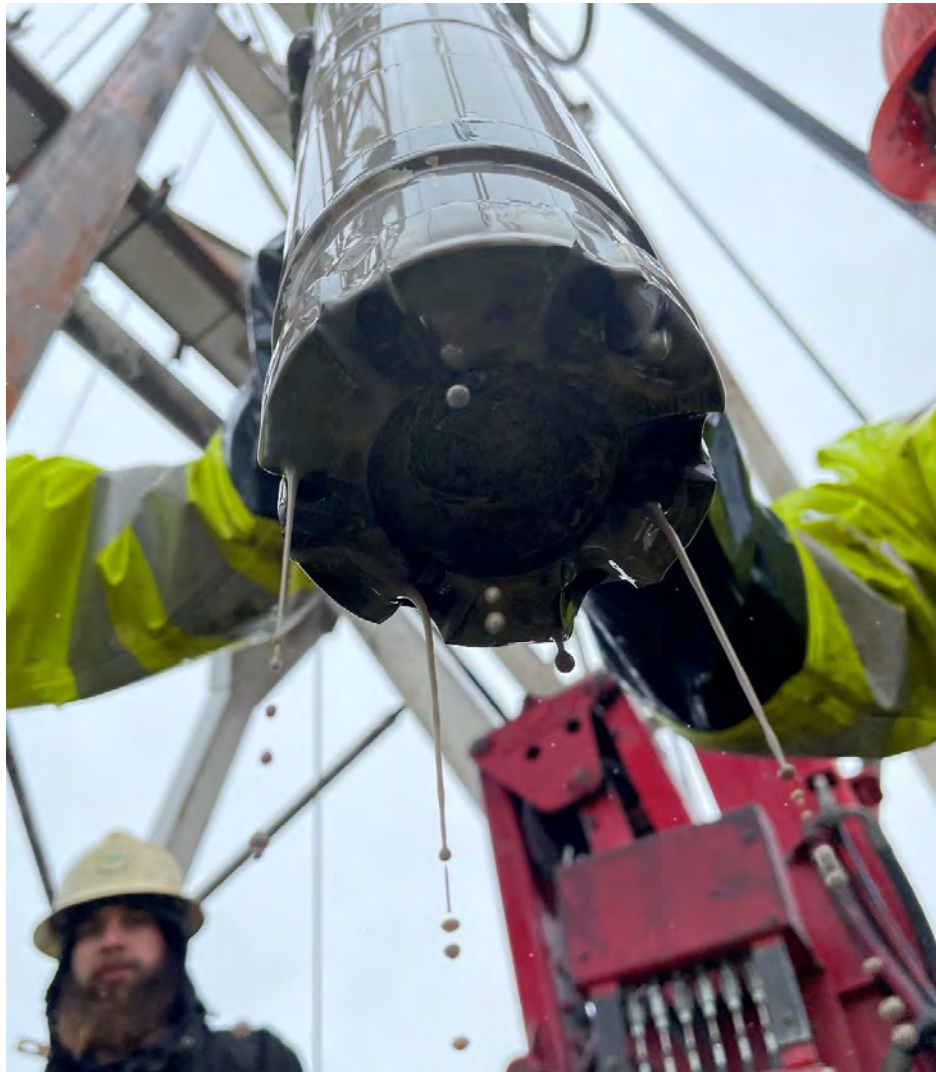
*Figure 2. Cutting shoe view of coring run 7CS*

The core liner failed to break the core at the base of the formation and pull it into the core barrel past the ball valve, resulting in the jamming shown above. The initial configuration of basket catcher and slip catcher was changed to a slip catcher only due to damage done to the core by the spinning basket catcher. This could be considered in future operational (marine sediment) deployments, as it suggests that the fingers of the basket catcher can do damage to even hard core.

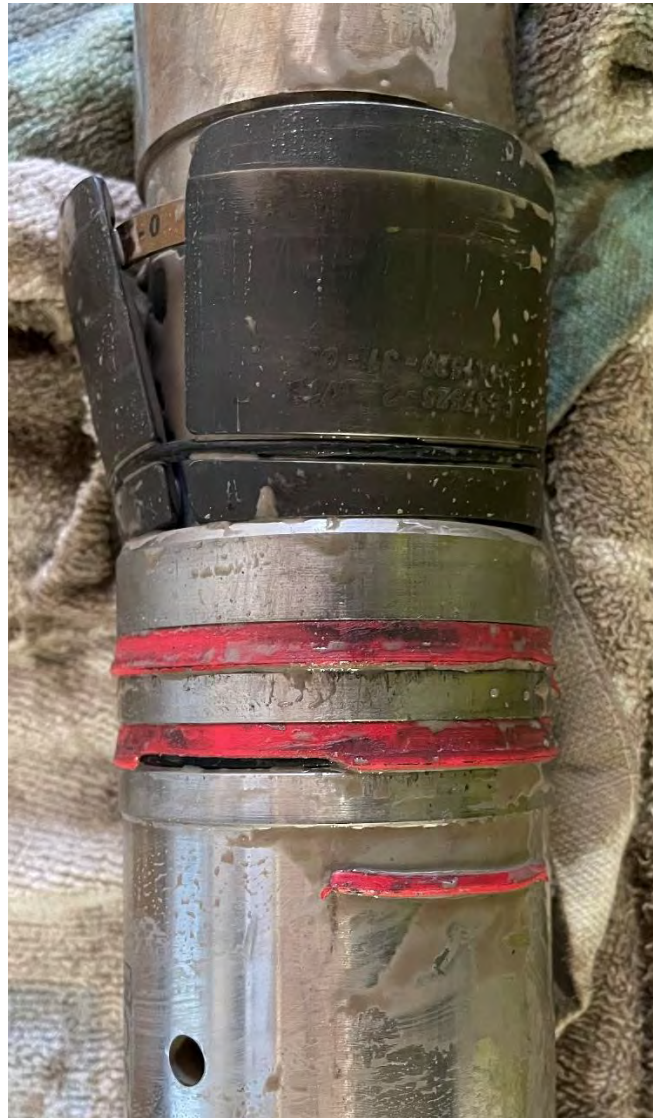
*Figure 3. Damaged IT plug polypak seal causing jamming of the tool during actuation*

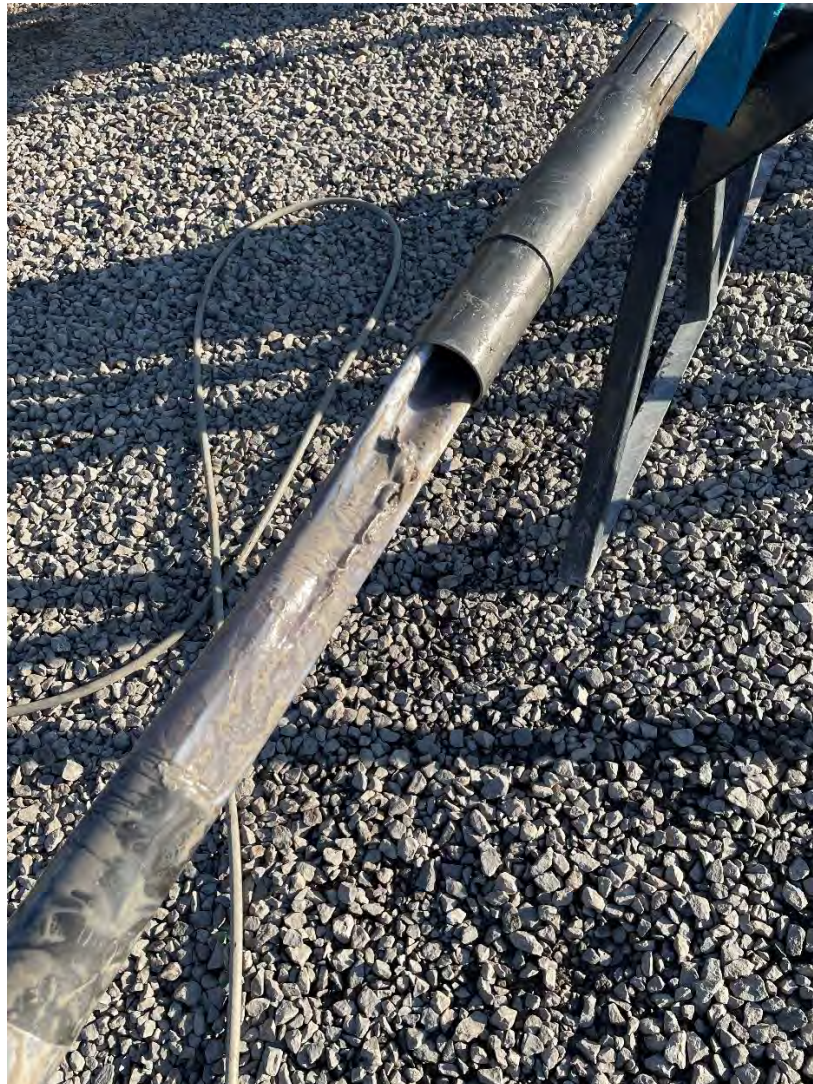
*Figure 4. Collapsed core liner on test 17FB*
