# GOM2 PRESSURE CORING TOOL WITH BALL VALVE (PCTB) LAND TEST II REPORT

08/06/20

The University of Texas at Austin 101 East 27<sup>th</sup> Street, Suite 4.300 Austin, TX 78712-1500 e-mail: pflemings@jsg.utexas.edu

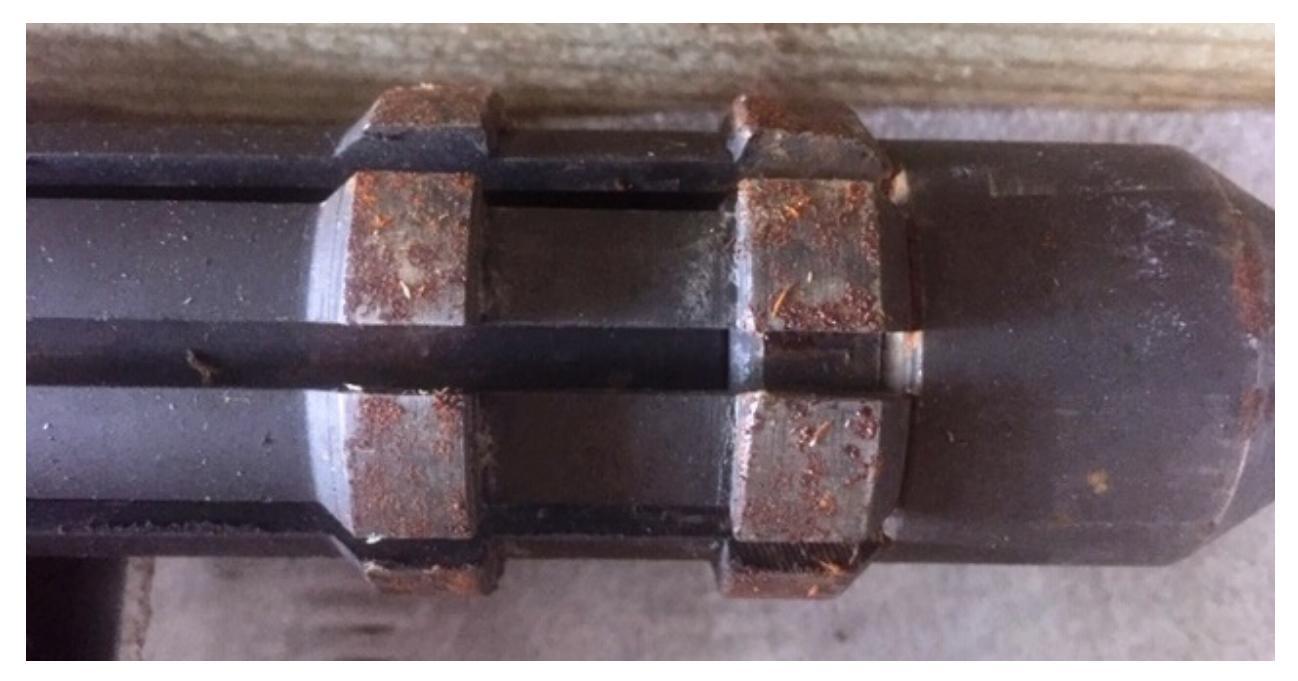
When the RPT reached the rig floor, visual inspection did not reveal any damage to the tool or the cause of the premature release.

Figure 4-1. PDS Running/Pulling Tool Collet.

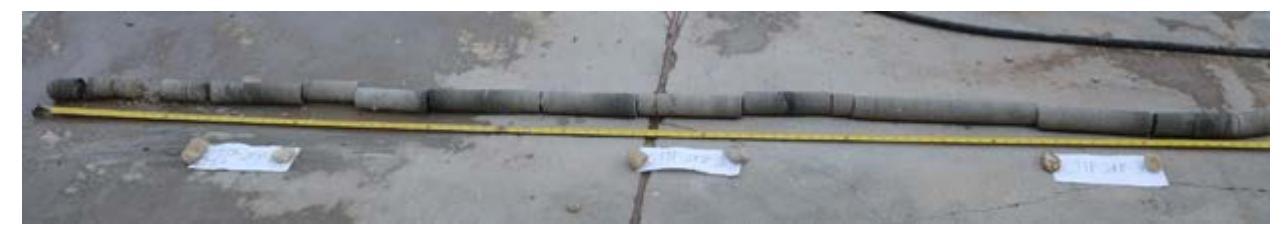
Figure 5-1. Core CTTF-02FB contained 8.9 ft of limestone and shale after recovery.

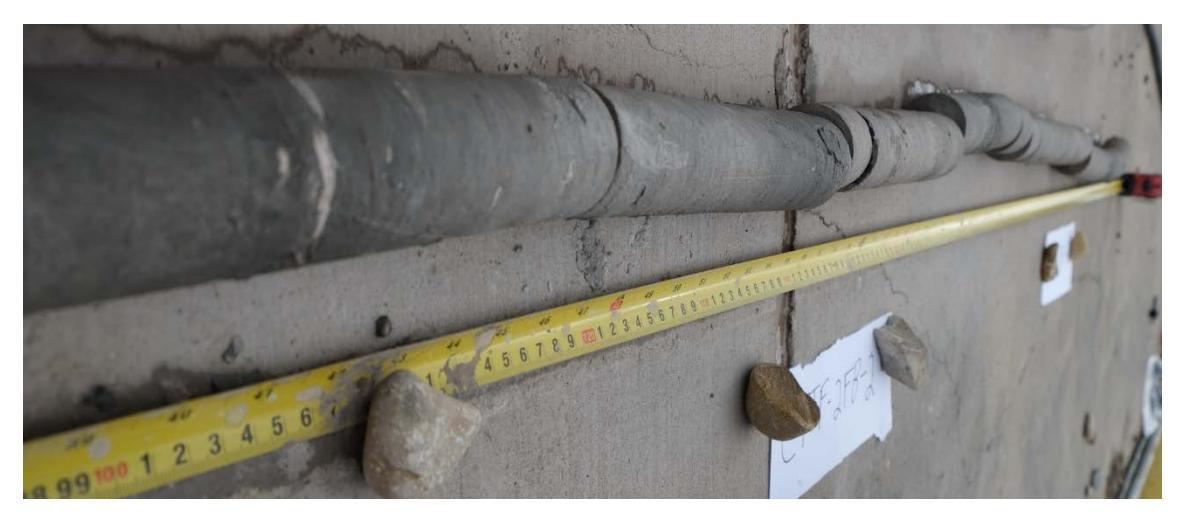
Core quality was very good in both PCTB configurations. The diameter of the core was consistent in all cores of both configurations, even across transitions between limestone and shale. Grooves on the exterior of the core were minimal. Core 'biscuiting' was common with core biscuits ranging from cm to tens of cm in length. Cores recovered with the PCTB-CS may contain more biscuits, but more detailed analysis will be required to determine differences between configurations.

Figure 5-2. A closer view of Core CTTF-02FB. The core is consistent in diameter between limestone (light-colored intervals) and shale (dark-colored intervals). Most biscuits are tens of cm in length and very minor spiral grooves are visible.

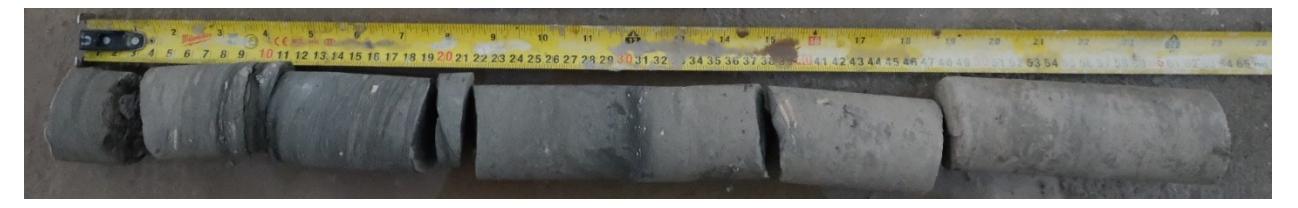
Figure 5-3. Core CTTF-04CS is a high-quality core from the cutting-shoe tool. The pressure was not maintained in the sample, but that core had high recovery (80%) and had good quality.

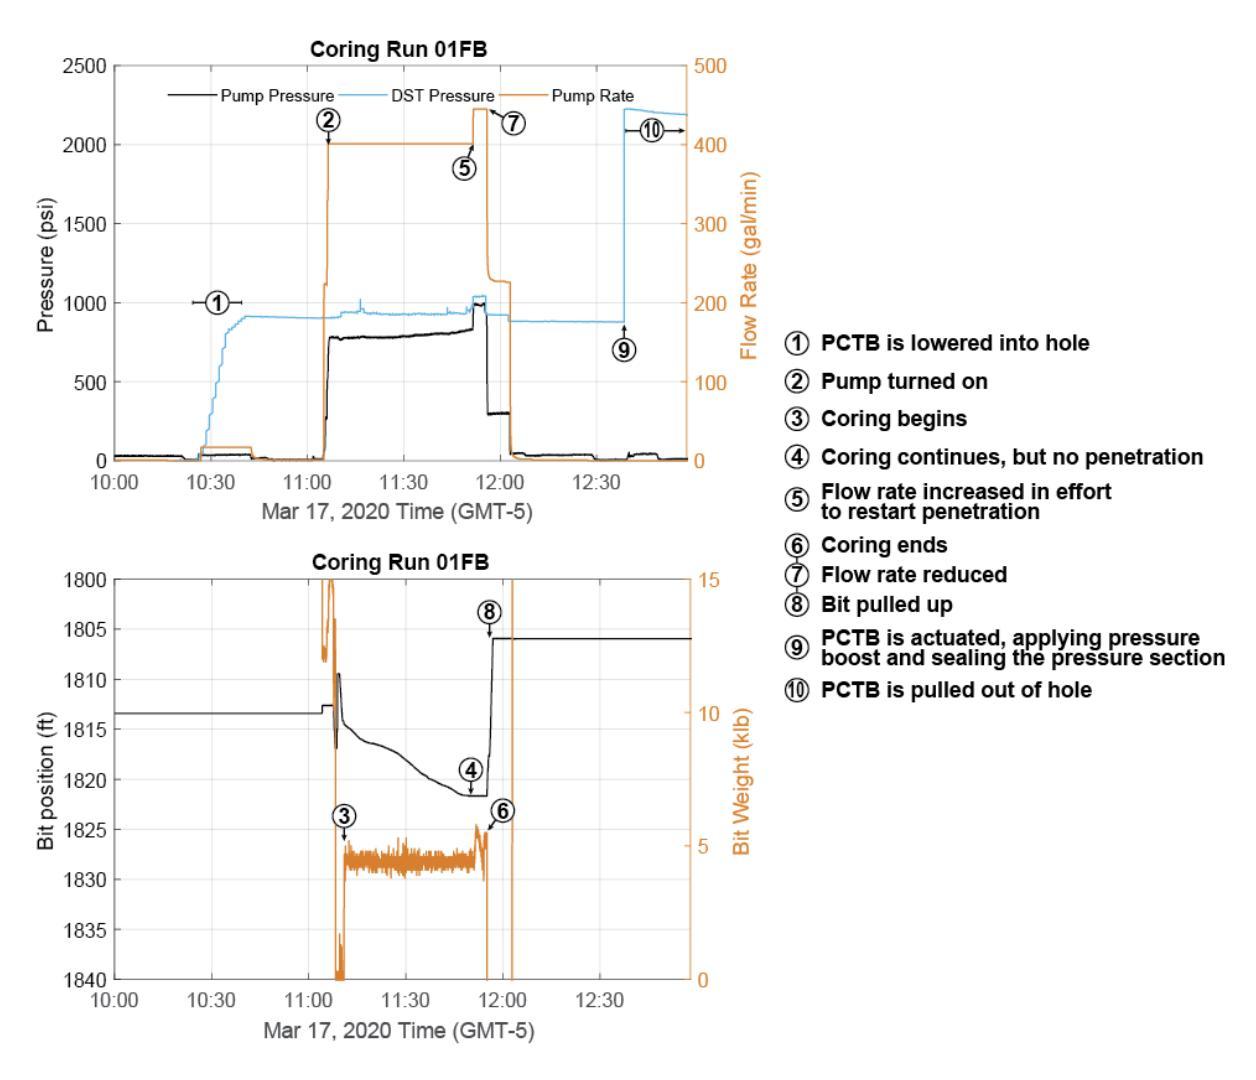
Figure 5-4 and Table 5-1 show our interpretation of significant events that occurred during coring run CTTF-01FB which occurred on 3/17/2020. (1) At 10:26 the PCTB was lowered into the hole, shown by the increase in hydrostatic pressure being recorded by the DST. (2) At 11:06 the pumps were turned on. (3) At 11:11 there was weight on bit and coring begins. Bit depth began to increase, and slight pressure perturbations can be seen in the DST pressure. (4) At 11:48 penetration halted. We interpret this to be the bit becoming balled-up. (5) At 11:51 flow rate was increased to try (unsuccessfully) to resume

penetration. (6, 7, 8) At 11:55 flow rate was reduced and the bit was raised, ending the coring. (9) At 12:38 the pulling tool actuated the PCTB, closing the ball valve and triggering the pressure boost. The pressure boost was recorded as an increase in DST pressure of ~1300psi. (10) The PCTB was pulled out of the hole from 12:38 to 13:17. DST pressure indicates that tool pressure was held near constant, indicating a good seal. The slight decrease in pressure as the tool was pulled out of the hole has been observed in every previous successful test, and is attributed to compressibility and changing pressure outside of the tool, and does not indicate a poor seal.

Figure 5-4. DST and rig instrumentation plots for core CTTF-01FB. The PCTB tool boosted and sealed correctly, and pressurized core was recovered. See also Table 5-1. DST data timestamps were shifted +5.5 minutes to match to rig instrumentation timestamps.

We had one successful coring test: PCTB-1FB (Table 4-1). In this case, a clear pressure increase was recorded when the tool sealed (Figure 5-4).

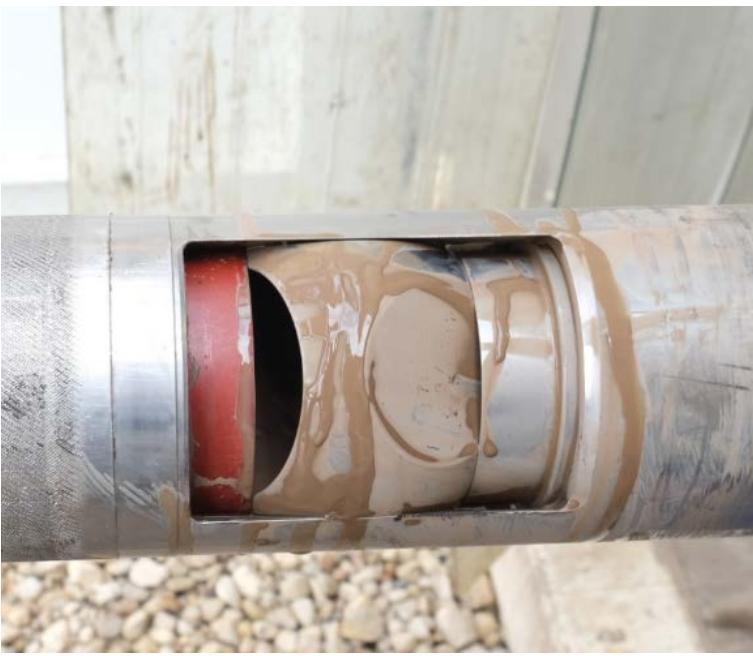
The final deployment of the PCTB was to test the PCTB-CS within casing, without actually coring rock (a 'water core'). The ball valve did not seal (e.g. Figure 5-6).

In 6 out of 7 cases, the ball only partially closed and no increase in pressure was recorded (e.g. Figure 5-5). In some cases, when the tool was recovered to the surface, the ball valve was partially closed (Figure 5-6). However, in other cases the ball valve appeared closed at the surface (Figure 5-7). We interpret that in cases where the ball valve appeared sealed at the surface, the ball sealed only after the boost was fired, perhaps while being recovered.

Figure 5-6. Illustration of a partially closed ball valve after recovery from the hole. The red object is the seal carrier. When the PCTB is actuated, a spring to the left of the seal carrier drives the seal carrier downward, which in turn drives ball downward (to the right). When the ball is forced downwards, it rotates around a pin into the closed orientation, sealing the bottom of the autoclave.

To resolve this issue, it will be necessary to be able to systematically recreate the failure mode where sediments jam the seal carrier. Geotek will explore this immediately at Salt Lake by adding sediment to mud to simulate the conditions at Cameron. At the same time, Geotek and Pettigrew Engineering will explore possible design changes to improve sealing in the presence of mud with cuttings.

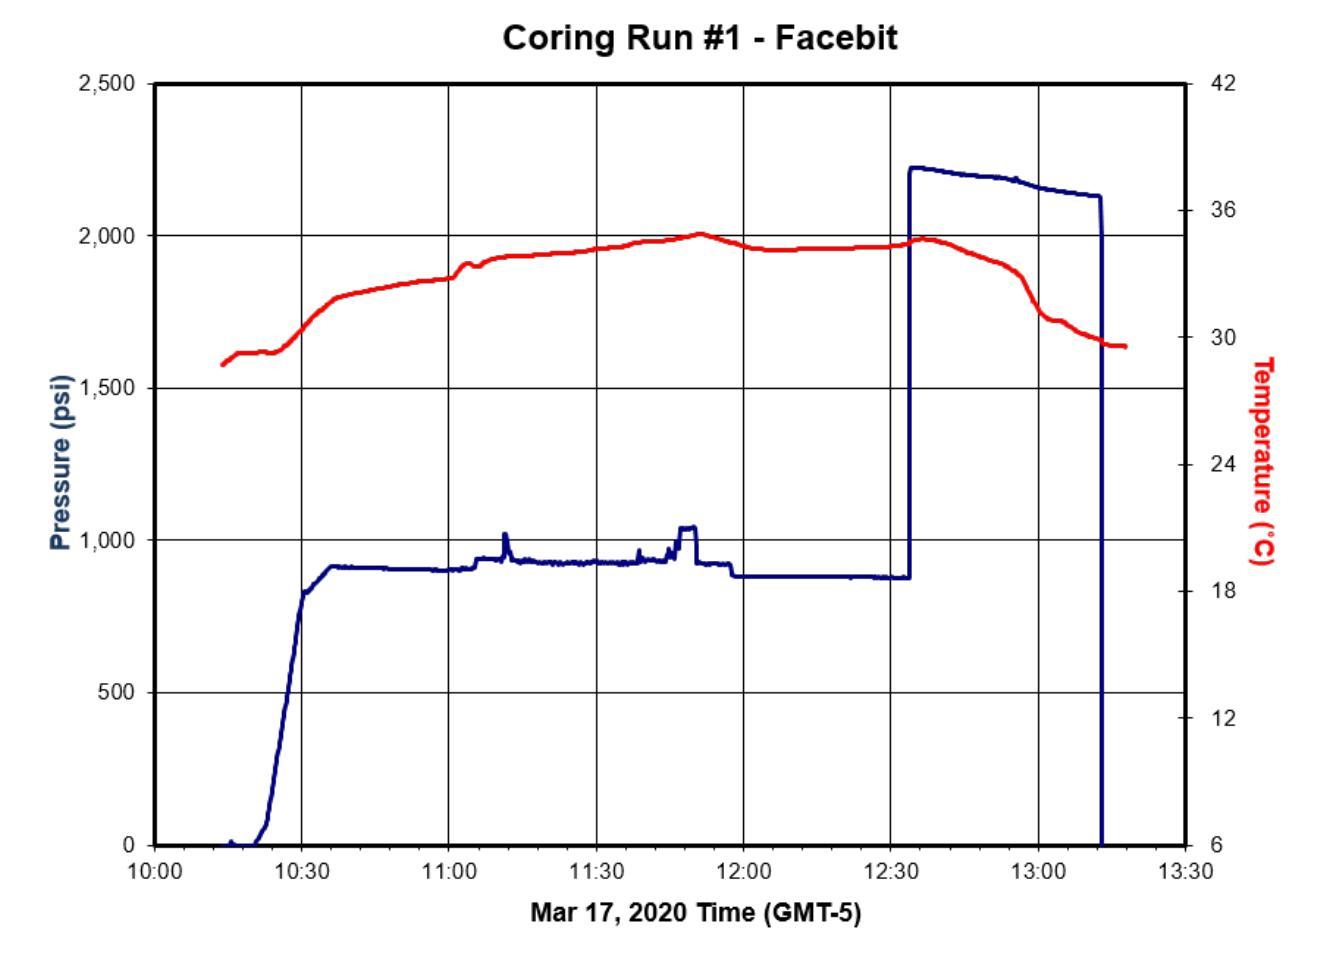
Figure A1. DST pressure and temperature record for CTTF-01FB. Boost pressure clearly recorded.

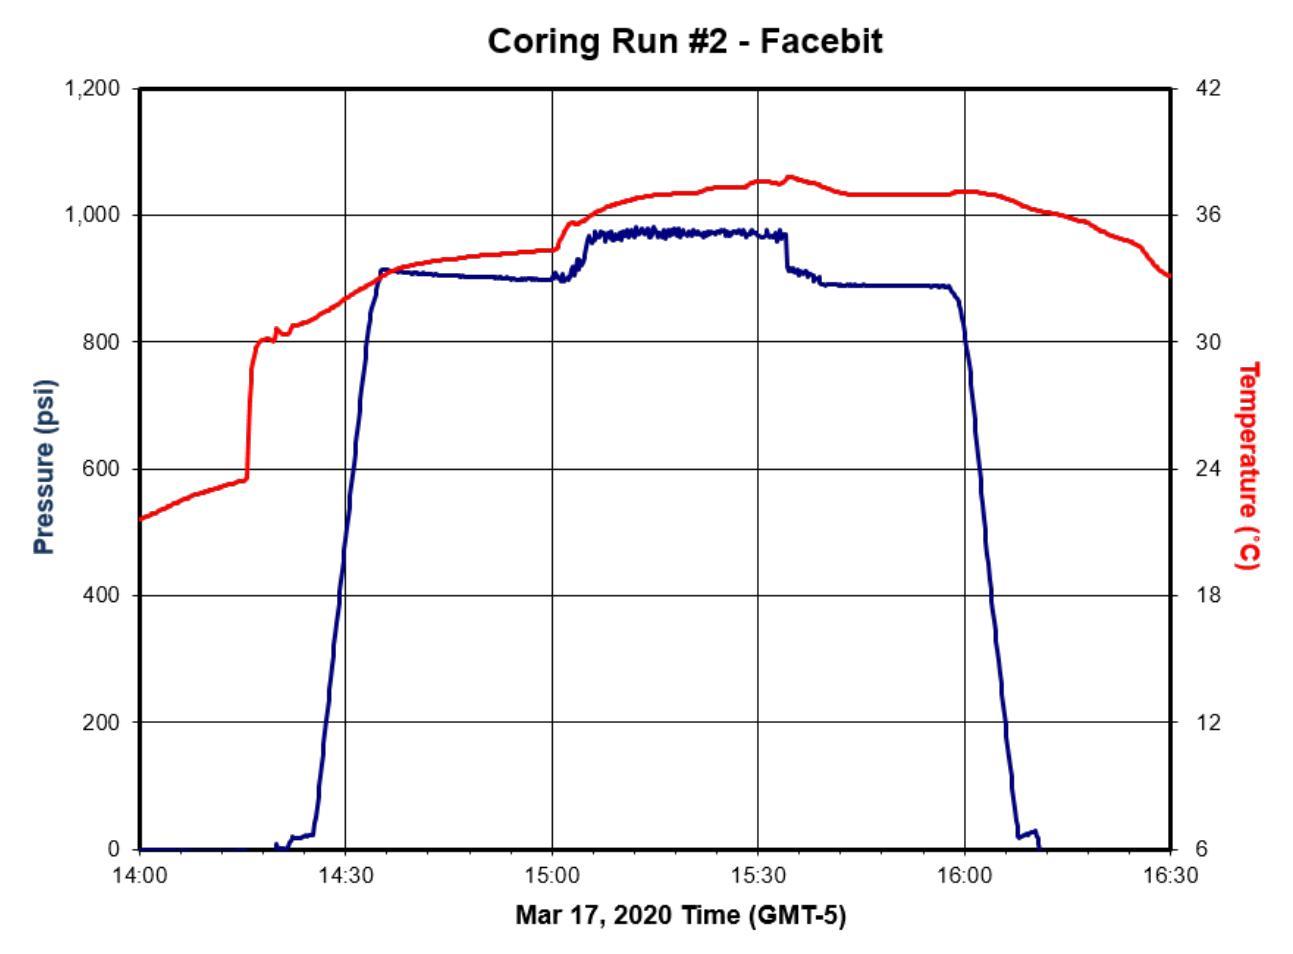
Figure A2. DST pressure and temperature record for CTTF-02FB. No boost pressure recorded.

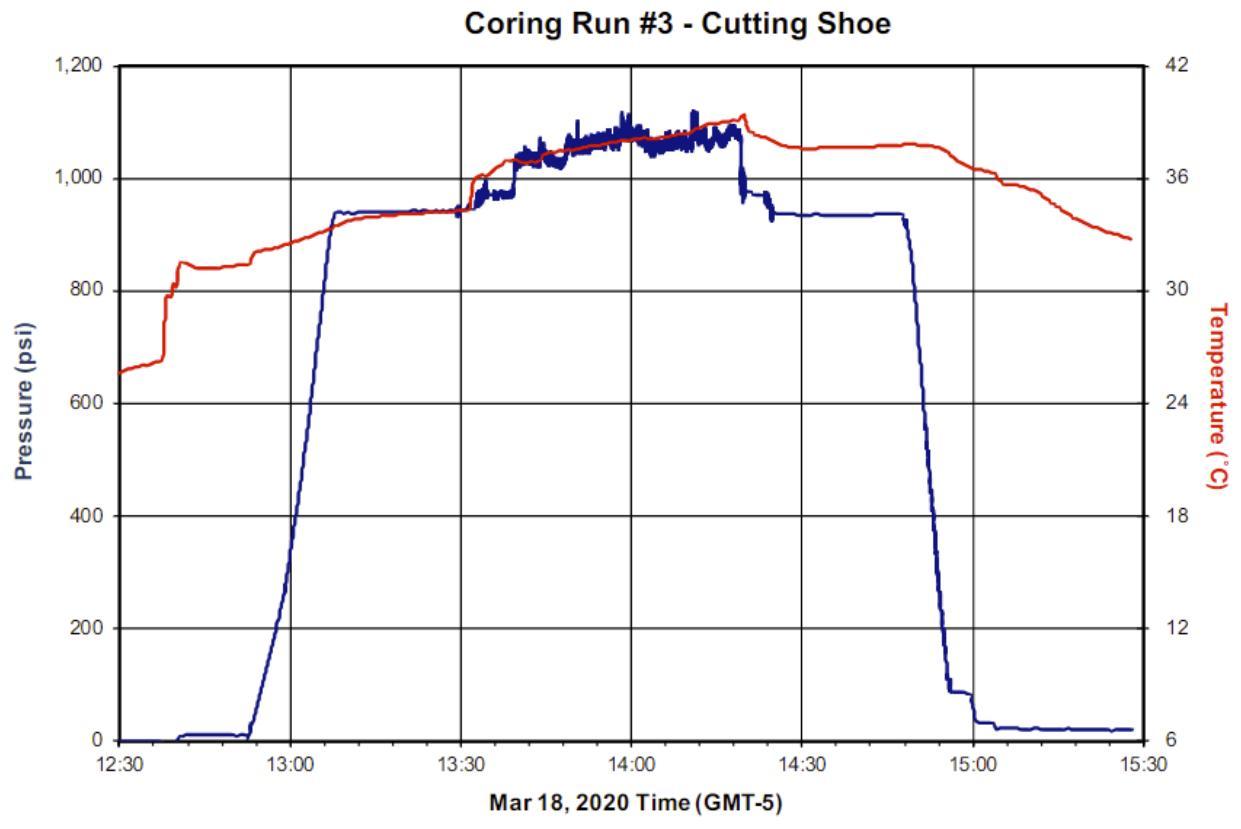
Figure A3. DST pressure and temperature record for CTTF-03CS. No boost pressure recorded.

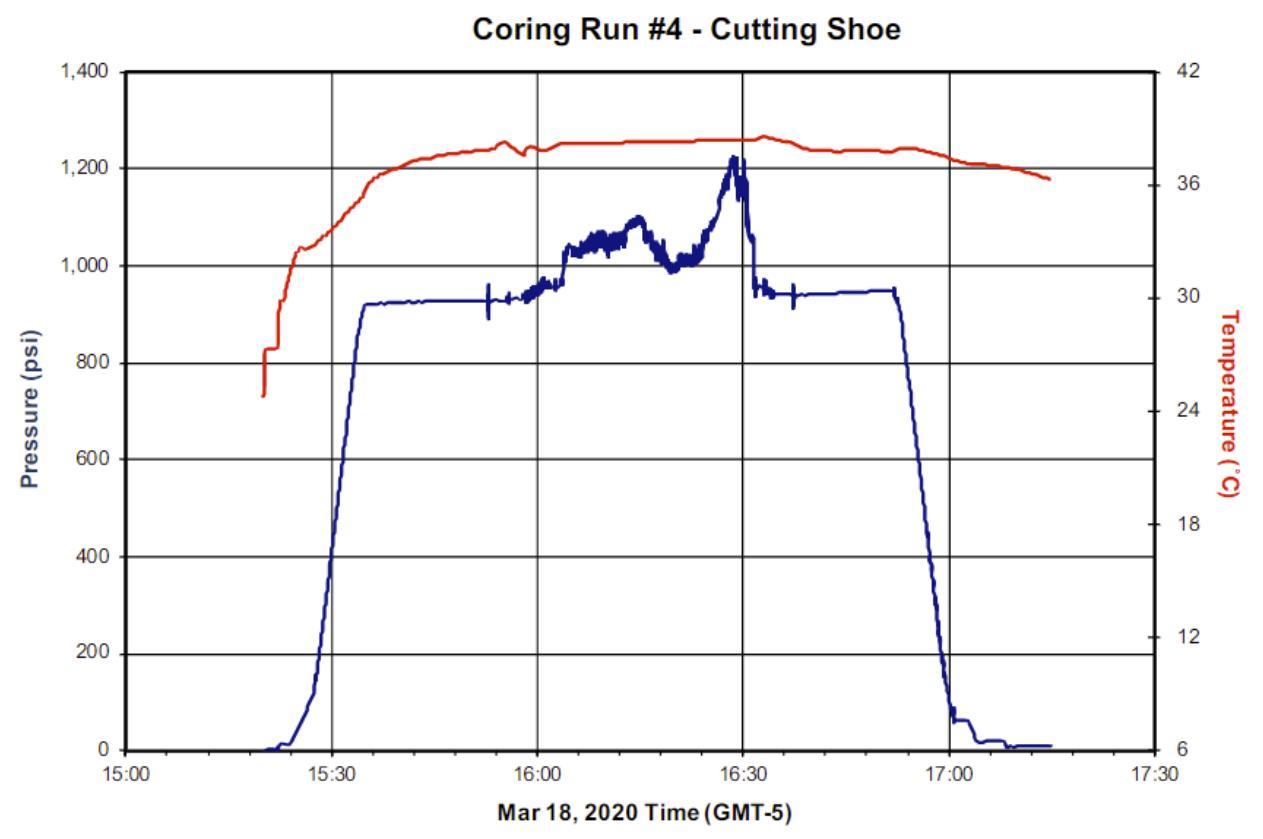
Figure A4. DST pressure and temperature record for CTTF-04CS. No boost pressure recorded.

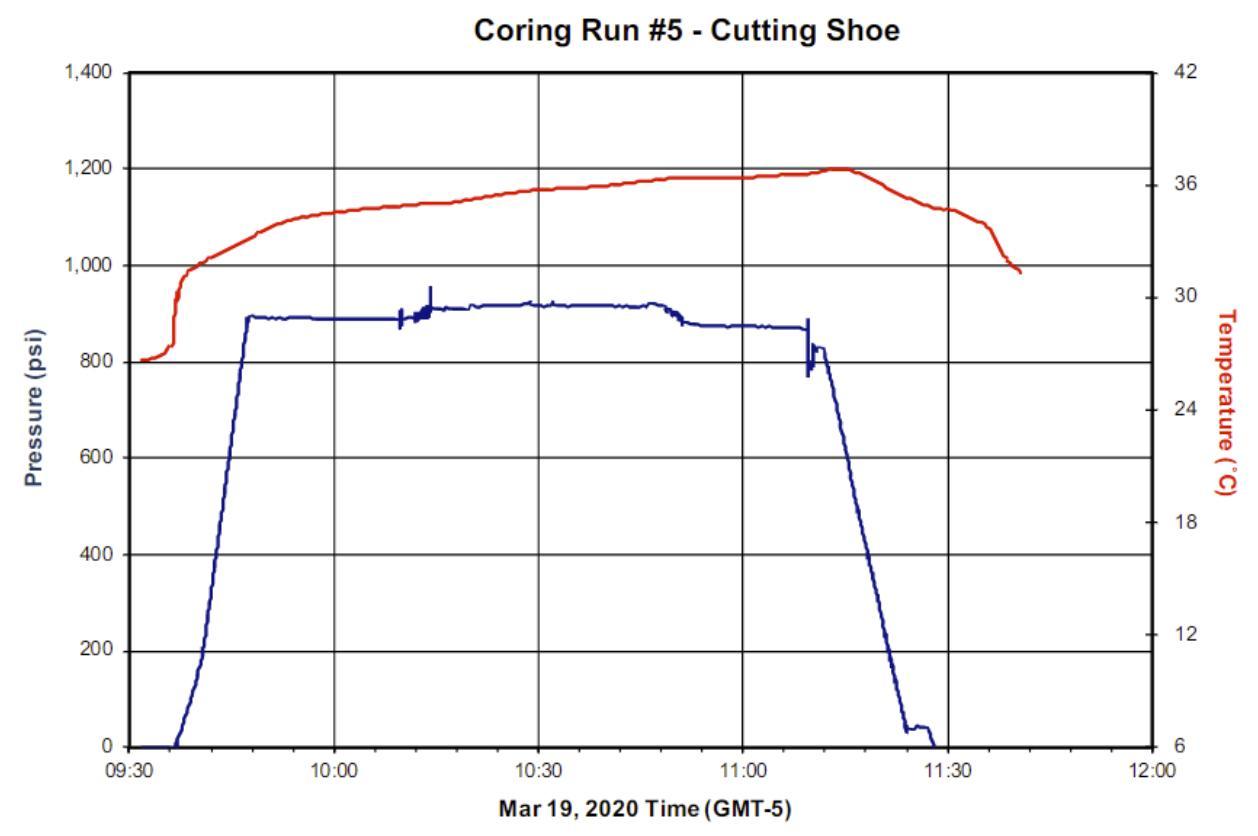
Figure A5. DST pressure and temperature record for CTTF-05CS. No boost pressure recorded.

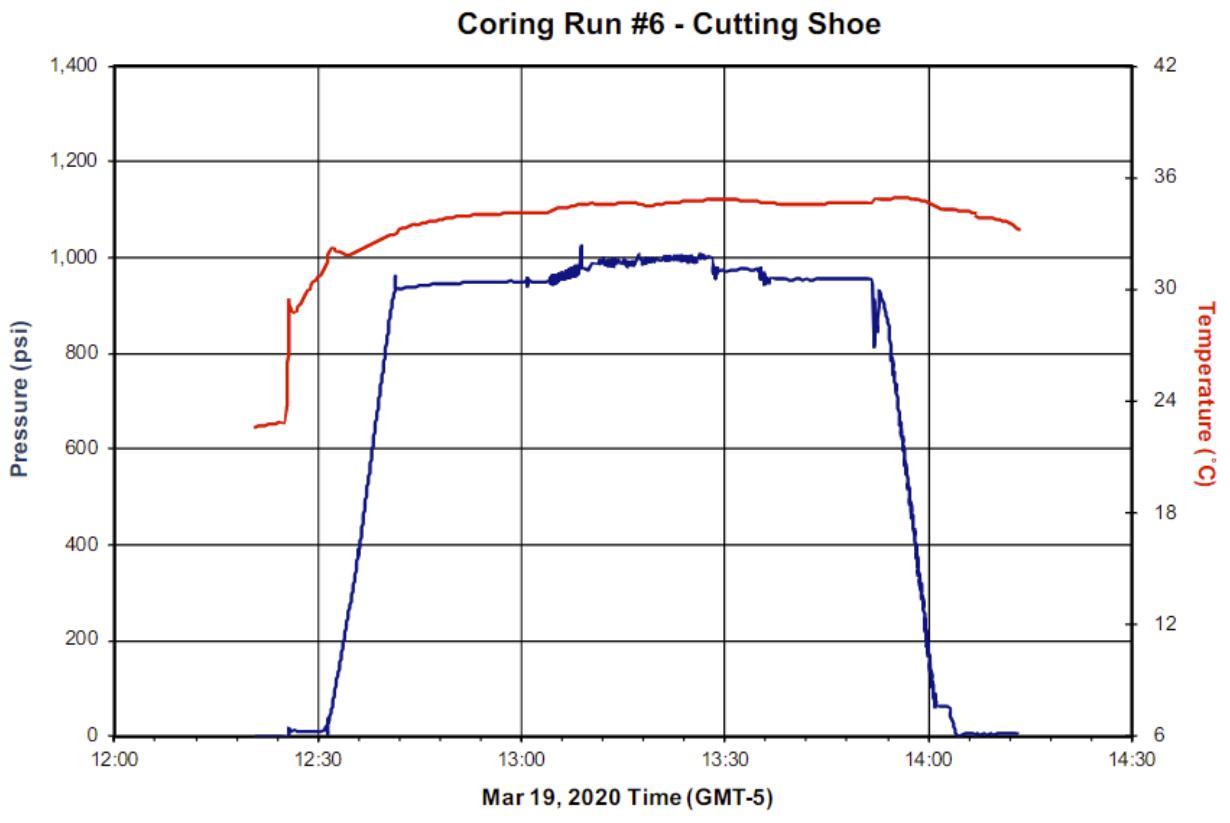
Figure A6. DST pressure and temperature record for CTTF-06CS. No boost pressure recorded.

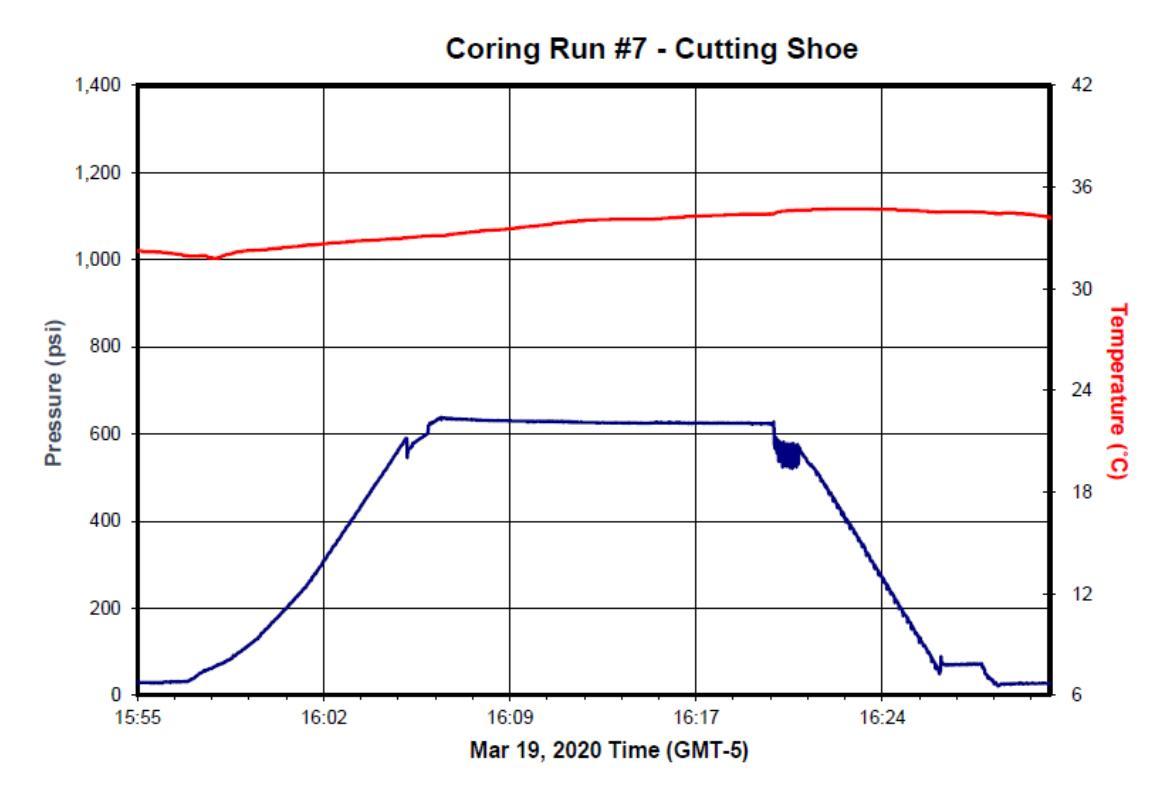
Figure A7. DST pressure and temperature record for CTTF-07CS. No boost pressure recorded.

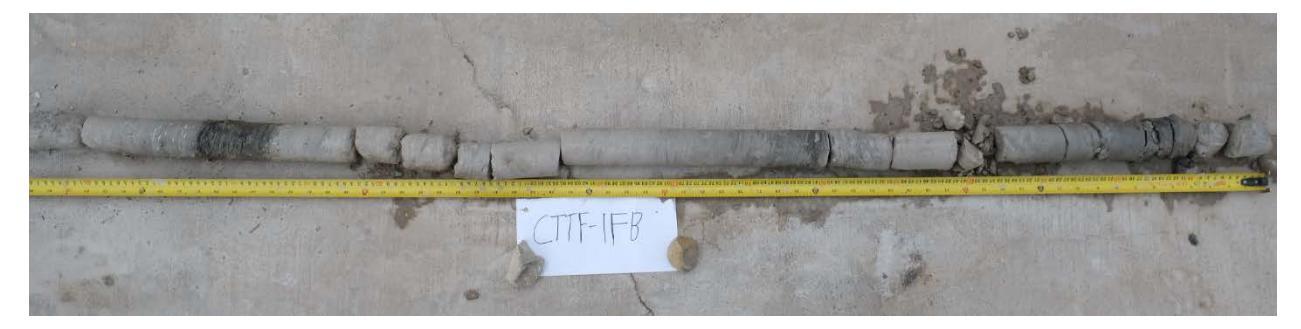
**<u>Coring Test 1 (core CTTF-1FB)</u>**: 6.6 ft of formation were penetrated over 48 minutes. At 11:45, the rate of penetration slowed, it was interpreted that the bit was balling, and we ceased coring 11:52. The ball valve closed, and pressure recorded in the autoclave was 2100 psi.

70"(178 cm) of core was recovered in CTTF-1FB. Core recovery was 91%. The core was largely cylindrical with no marked variations in diameter. The core was predominantly composed of light gray indurated carbonate rich rock. Occasional layers of dark gray to charcoal fissile shale was found One ~15 cm section of almost pure shale was encountered. The core was cut into two sections: CTTF-1FB-1 and CTTF-1FB-2. The sections were photographed, labelled, put back in the core liner and preserved.

Figure 1: Core CTTF-1FB: 1.78 m of core were recovered composed of light grey resistant carbonate and more fissile charcoal colored shale.

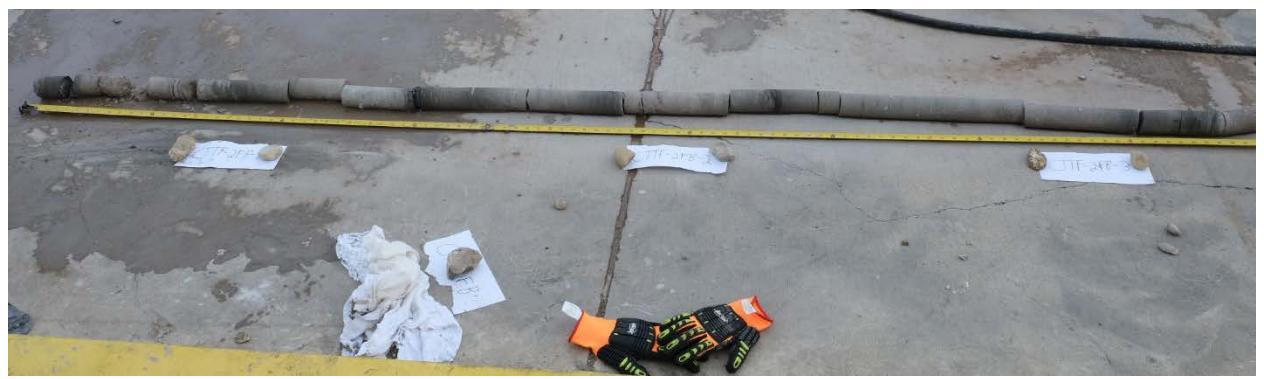
2.7 m of core (8.9 ft) of core were recovered resulting in a core recovery of 92%. The core was largely cylindrical with no marked variations in diameter. The core was predominantly composed of light gray indurated carbonate rich rock. Occasional layers of dark gray to charcoal fissile shale was found The core was cut into 3 sections: 1) CTTF-2FB-1: 0-0.90, 2) CTTF-2FB-2: 0.90-1.90 m, and 3)CTTF-2FB-3: 1.90-2.70 m.

*Figure 2: Core CTTF-2FB: 2.7 m of core were recovered composed of light grey resistant carbonate and more fissile charcoal colored shale.*

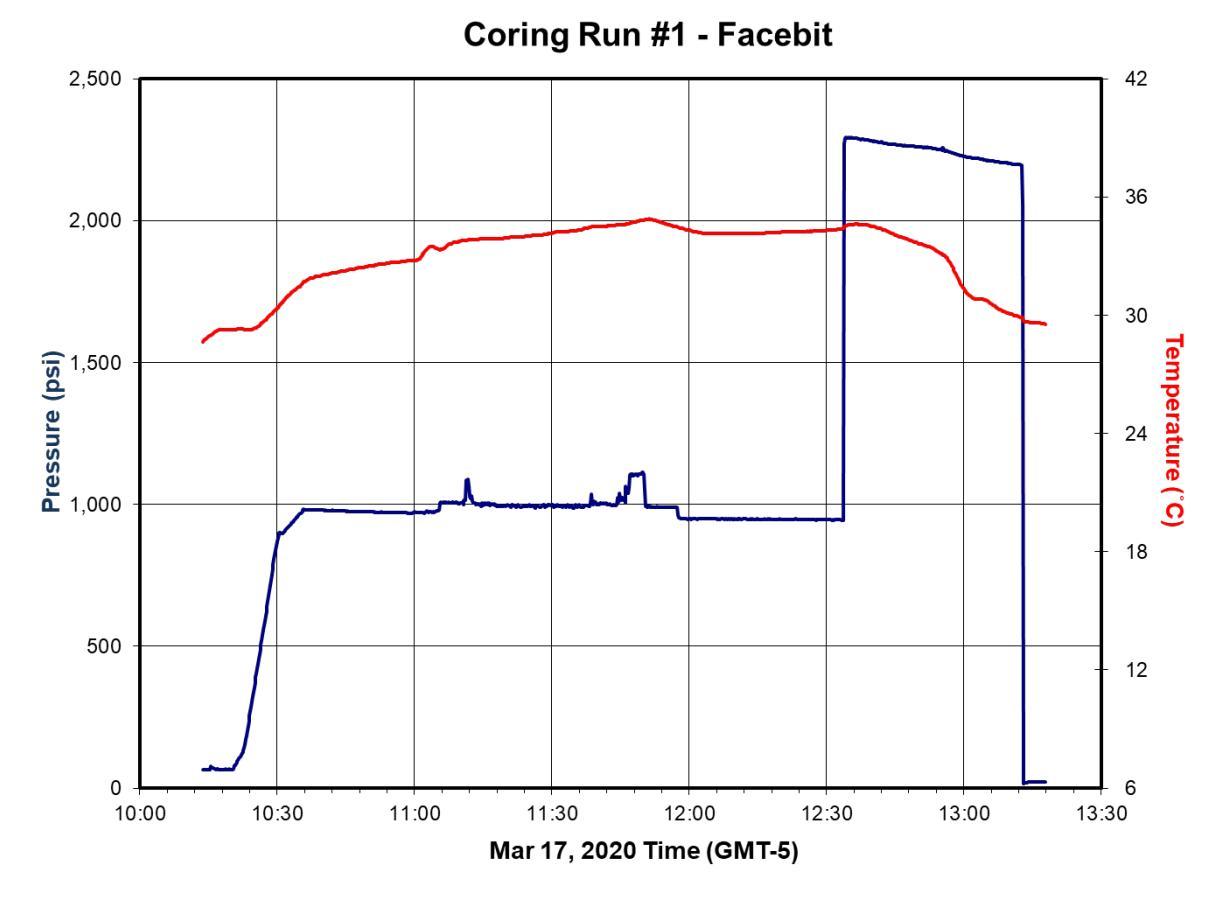
Figure 3: DST pressure and temperature record for **CTTF-1FB**. Boost pressure clearly recorded.

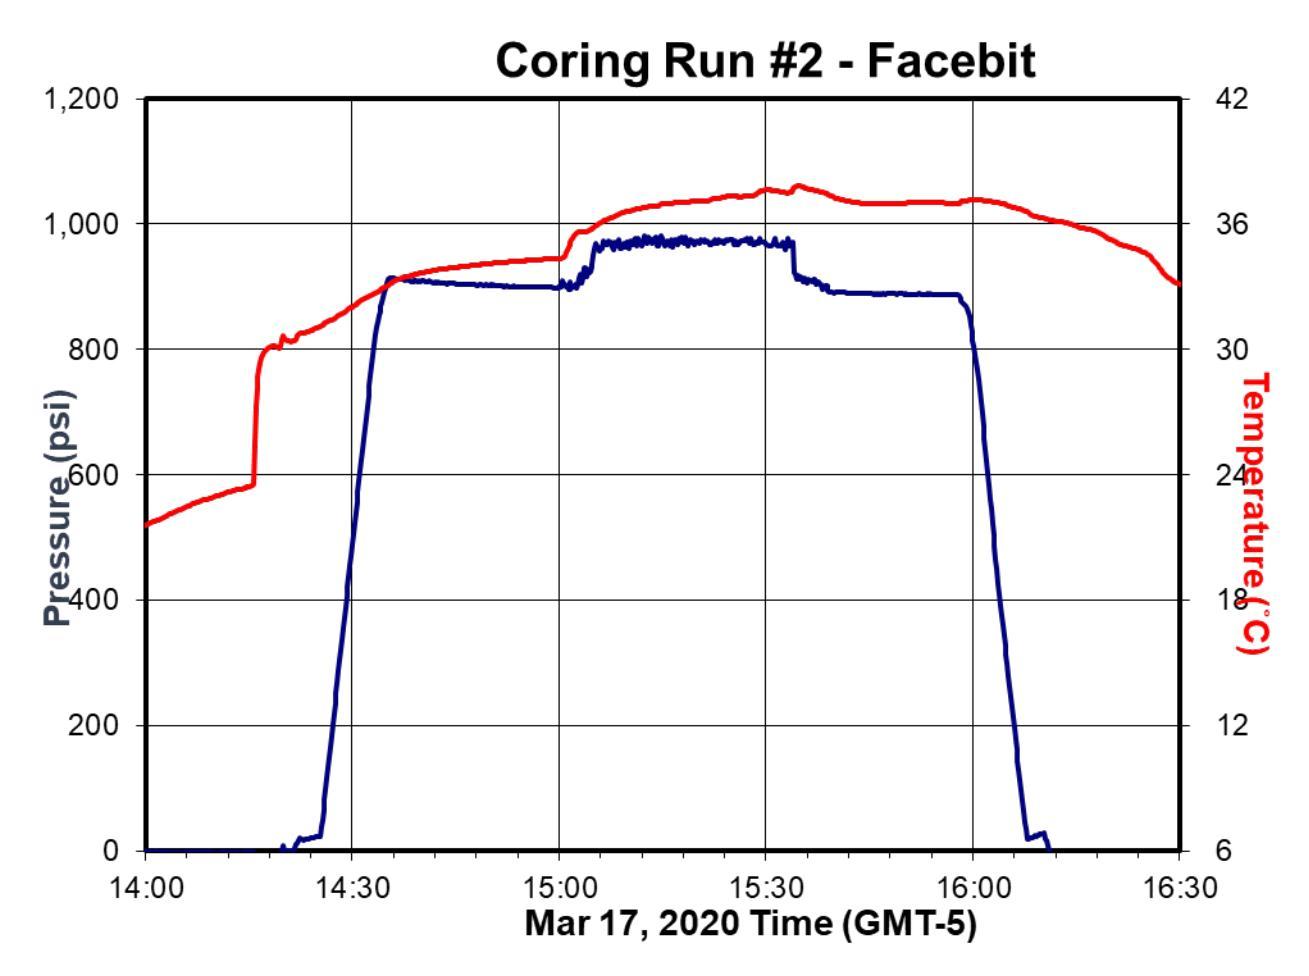
Figure 4: DST pressure and temperature record for CTTF-2FB. No boost pressure recorded.

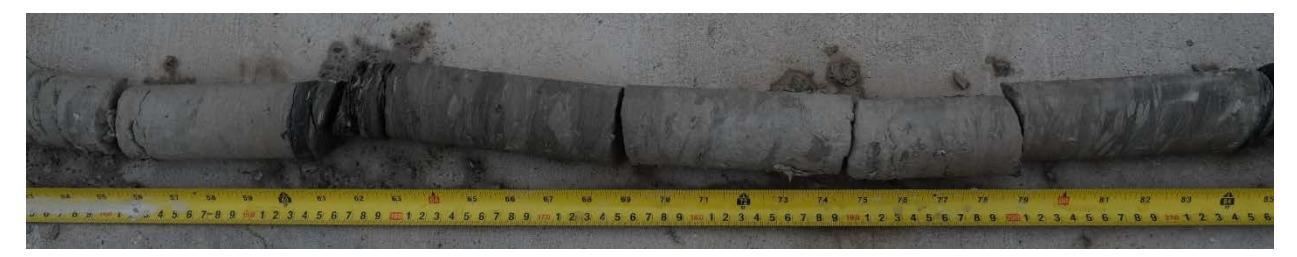
**Coring Test 3** (core CTTF-03CS): Coring advanced the bit from 1831.5 to 1841.0 ft. 9.5 ft of formation were penetrated over 50 minutes. The ball valve did not close, and pressure was not maintained in the autoclave.

114" (290 cm) of core was recovered in CTTF-03CS. Core recovery was 79%. The core was largely cylindrical with no marked variations in diameter. The core was predominantly composed of light gray indurated carbonate rich rock. Occasional layers of dark gray to charcoal fissile shale was found One ~15 cm section of almost pure shale was encountered. The core was cut into three sections: CTTF-03CS-1, CTTF-03CS-2, and CTTF-03CS-3. The sections were photographed, labelled, put back in the core liner and preserved. The core quality was perhaps more broken up than the previous face-bit cores.

*Figure 1: Core CTTF-03CS-2: 2.30 m of core were recovered composed of light grey resistant carbonate and more fissile charcoal colored shale.*

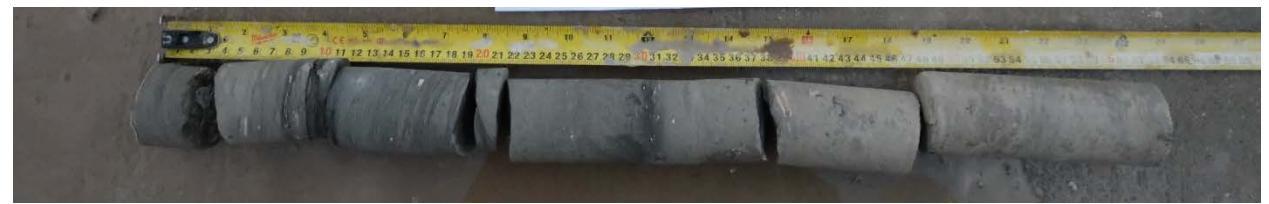
**Coring Test 4** (core CTTF-04CS): Coring advanced the bit from 1841.0-1843.5' MD from 16:00 to 16:34 with 600 gal/min circulation. This core was cut shorter to test the concept that the core length was affecting the ability of ball valve to seal.

0.62 m of core (2.0 ft) of core were recovered resulting in a core recovery of 80%. The core was very good quality and was largely cylindrical with no marked variations in diameter. The core was

predominantly composed of light gray indurated carbonate-rich rock. At the top of the core, few layers of dark gray to charcoal shale were found which transitioned to pure limestone. The core was left in one section: 1) CTTF-04CS-1 (0-0.62 m).

*Figure 2: Core CTTF-04CS: 0.62 m of core were recovered composed of light grey resistant carbonate and charcoal colored shale.*

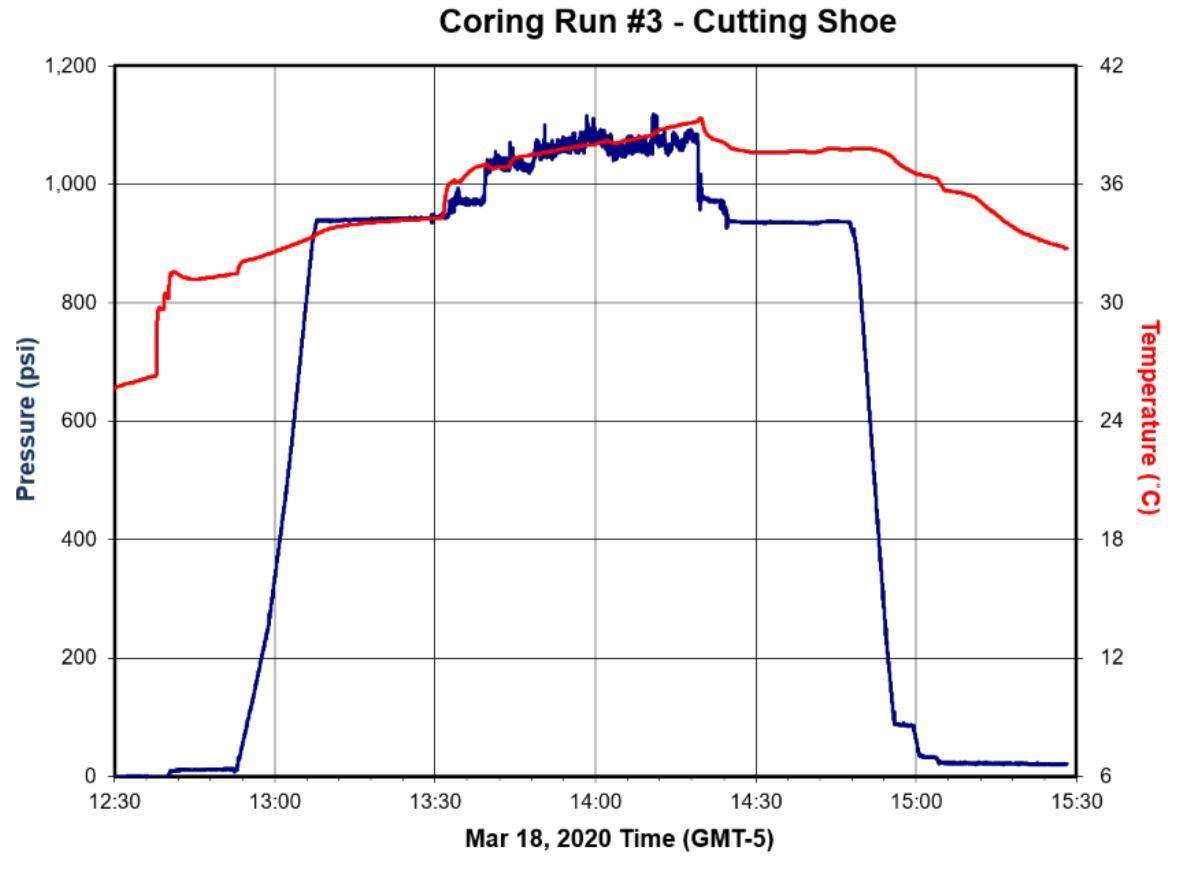
Figure 3: DST pressure and temperature record for CTTF-03CS.

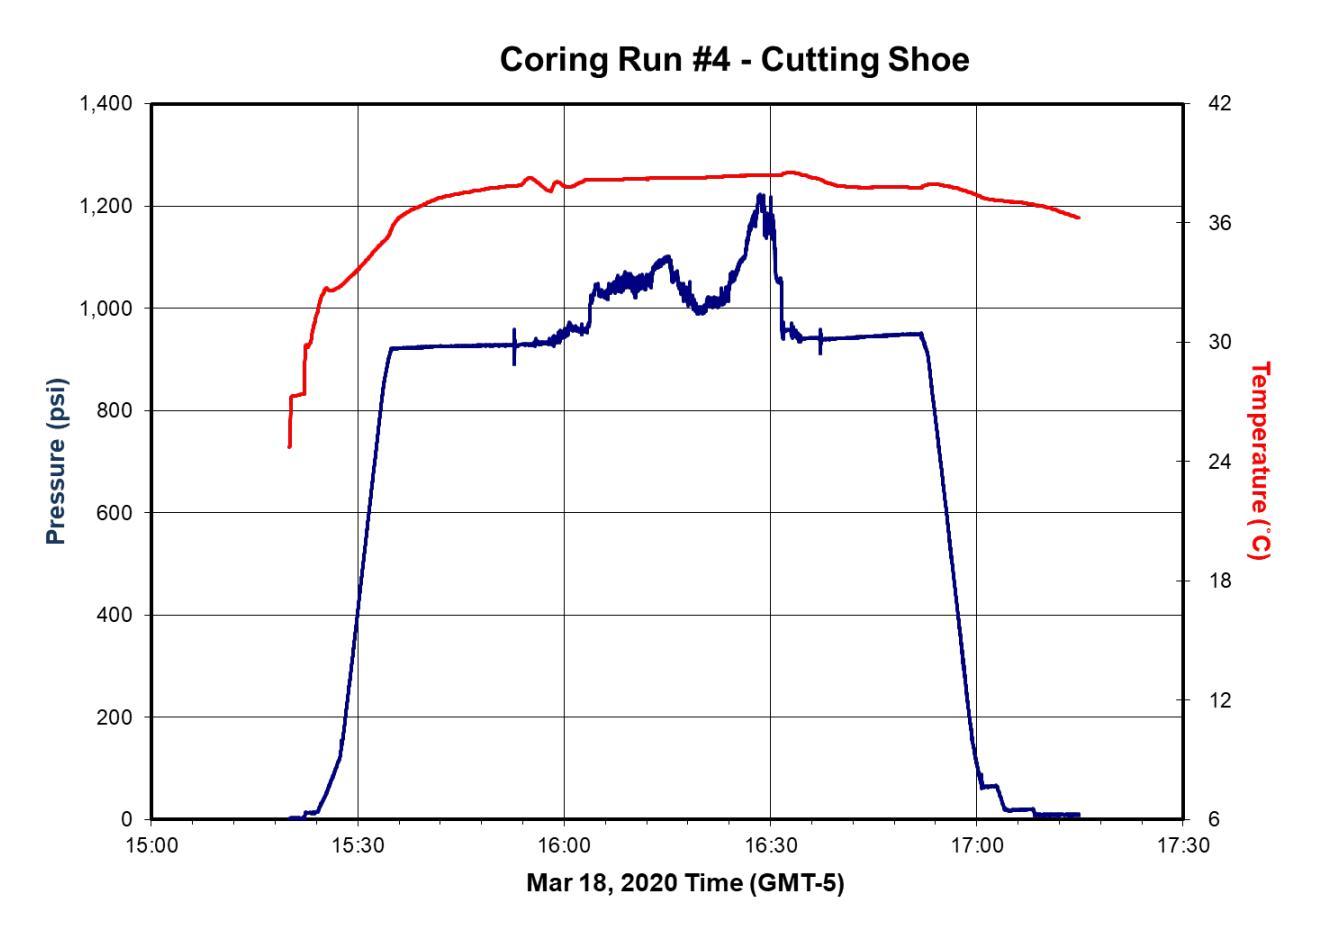
Figure 4: DST pressure and temperature record for **CTTF-04CS**.

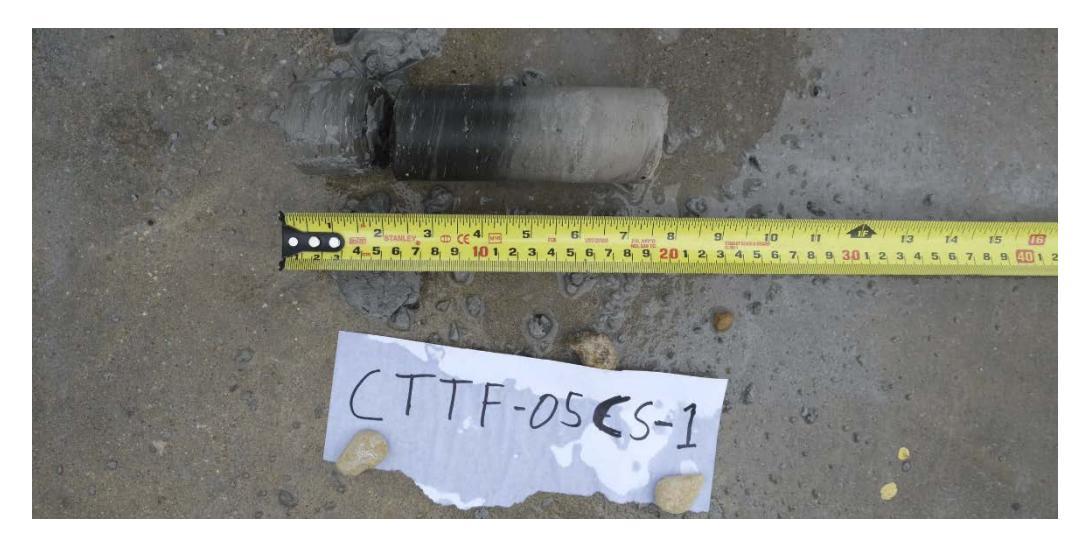
<u>Coring Test 5</u> (core CTTF-05CS): Coring advanced the bit from 1843.5 to 1843.8 ft. 0.3 ft of formation were penetrated over 45 minutes. The ball valve did not close, and pressure was not maintained in the autoclave.

7" (18 cm) of core was recovered in CTTF-05CS. The core was largely cylindrical with no marked variations in diameter. The core was predominantly composed of light gray indurated carbonate rich rock. One 4 cm layer of dark gray to charcoal fissile shale was found. The core was photographed, labelled, put back in the core liner and preserved. The core quality is very good.

*Figure 3: Core CTTF-05CS-1: 0.18 m of core were recovered composed of light grey resistant carbonate and more fissile charcoal colored shale.*

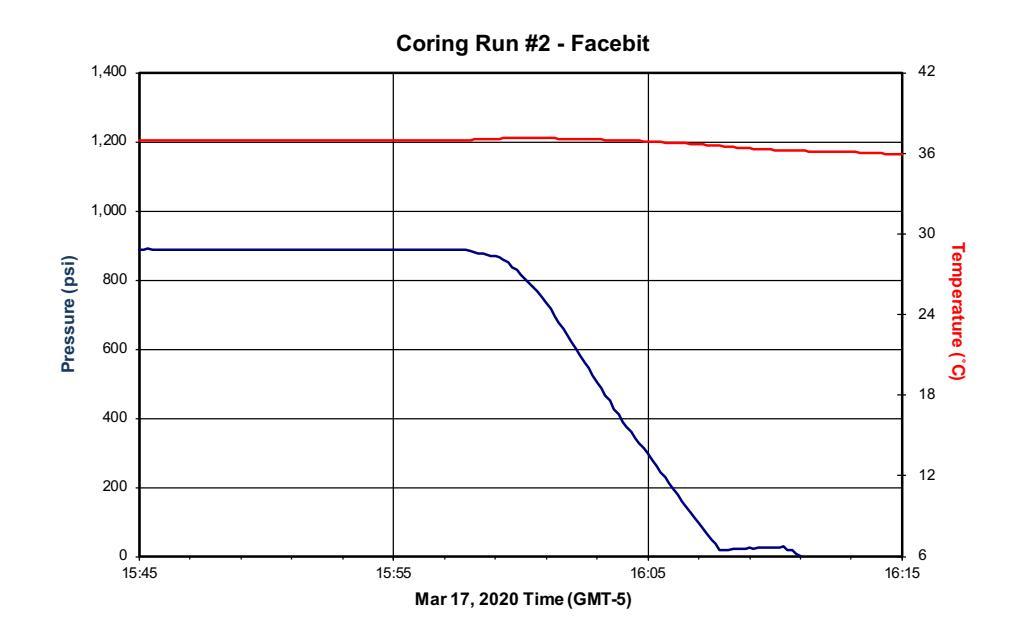
At the surface the autoclave did not appear to be pressurized, which was confirmed by a pressure transducer reading equal to atmosphere. A complete post-run analysis was performed on the tool to determine the mode of failure. The autoclave and pressure section were pressure tested to 3000 psi in their in-situ state. No leaks were observed at any point in this process. Next the tool was disassembled and checked for damage and incorrectly assembled parts. All was found to be in order. The ball valve was isolated and its articulation checked. The ball was found to be extremely stiff to open, suggesting increased friction between the seal carrier and the ball valve housing.

Failure mode: Inconclusive

Figure 3. DST record from 2FB blown up around the period of core retrieval. Note that there is no indication of boost.

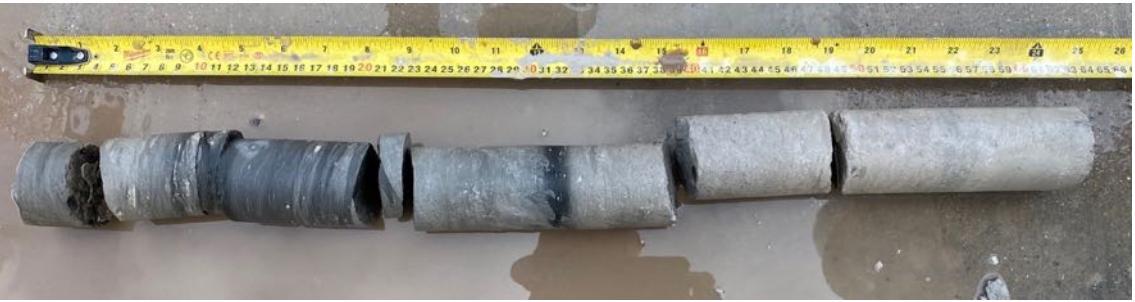
At the surface the ball was again observed to be only partially closed. In post-run analysis the seal carrier was found to be stiff and difficult to move, with significant amounts of fine grit present in the annulus between seal carrier and ball valve housing.

Failure mode: Incomplete ball closure

Figure 7. Core recovered during coring run 4CS.

Corrective action: Use lower drilling fluid flow rate to lessen forcing of fine particles into ball valve assembly

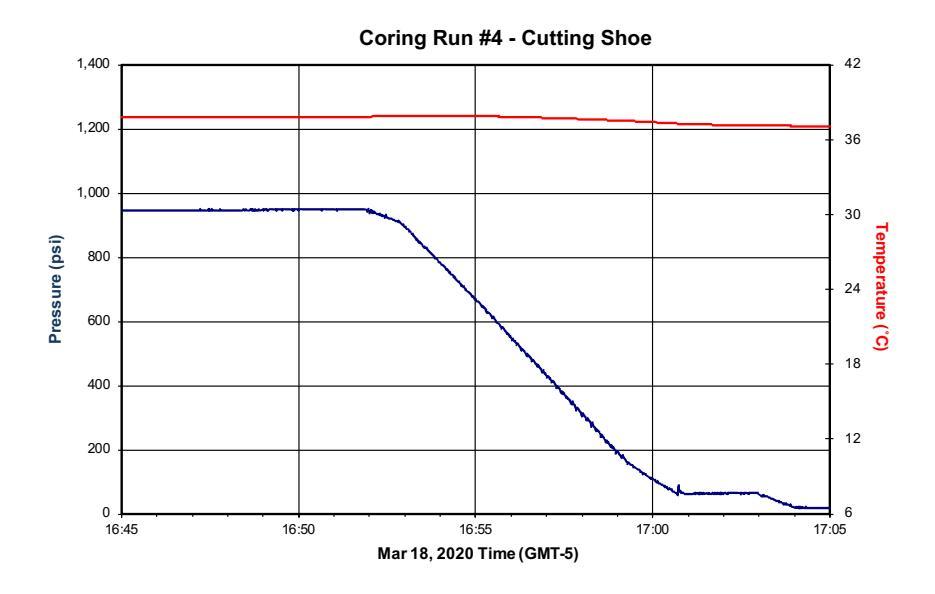
Figure 9. DST record from 4CS blown up around the period of core retrieval. Note that there is no indication of boost.
