# GOM2 PRESSURE CORING TOOL WITH BALL VALVE (PCTB) LAND TEST II REPORT

08/06/20

The University of Texas at Austin 101 East 27<sup>th</sup> Street, Suite 4.300 Austin, TX 78712-1500 e-mail: pflemings@jsg.utexas.edu

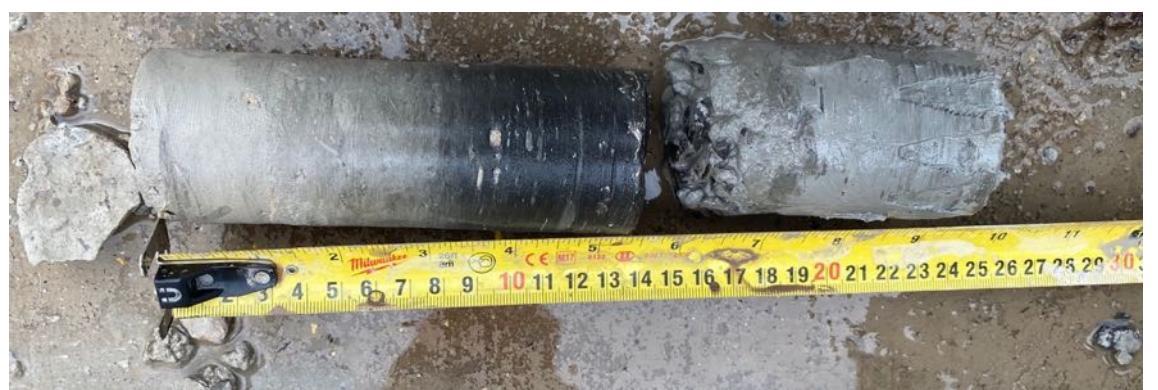
Recovered core was 0.8 ft. in length. A compact plug of consolidated cuttings was found in the core catcher.

Figure 10. Core recovered during coring run 5CS.

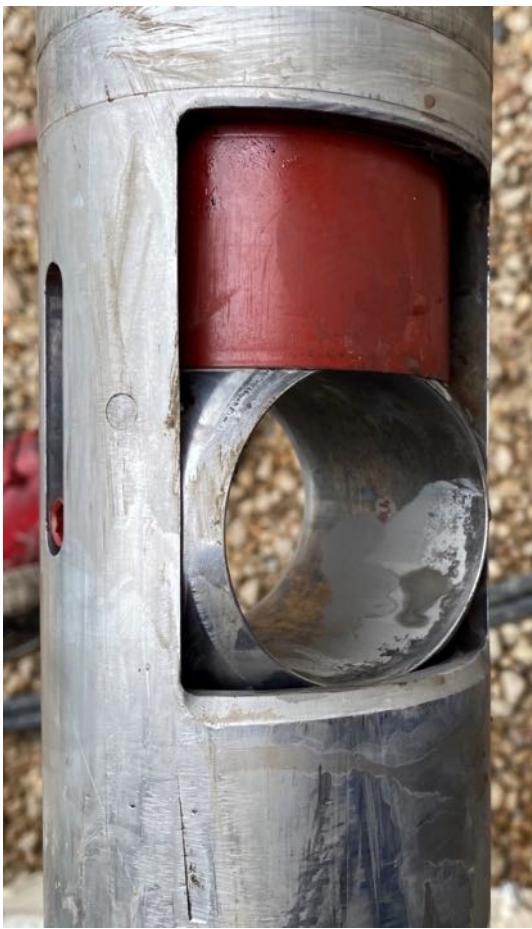
The tool arrived at the surface without pressure. The ball valve appeared closed but closer observation showed that it was slightly cocked, leaving an obvious leak path. Post-run analysis found the same stiffness in the ball valve observed in prior tests. Fine grit was again observed on the surface of the seal carrier.

Failure mode: Incomplete ball closure

Figure 11. Seal carrier (red part), ball valve and ball follower after coring run 5CS. The ball is in the closed position and was most likely jostled into this position during handling at or from the rig floor.

Corrective action: Increase drilling fluid flow rate

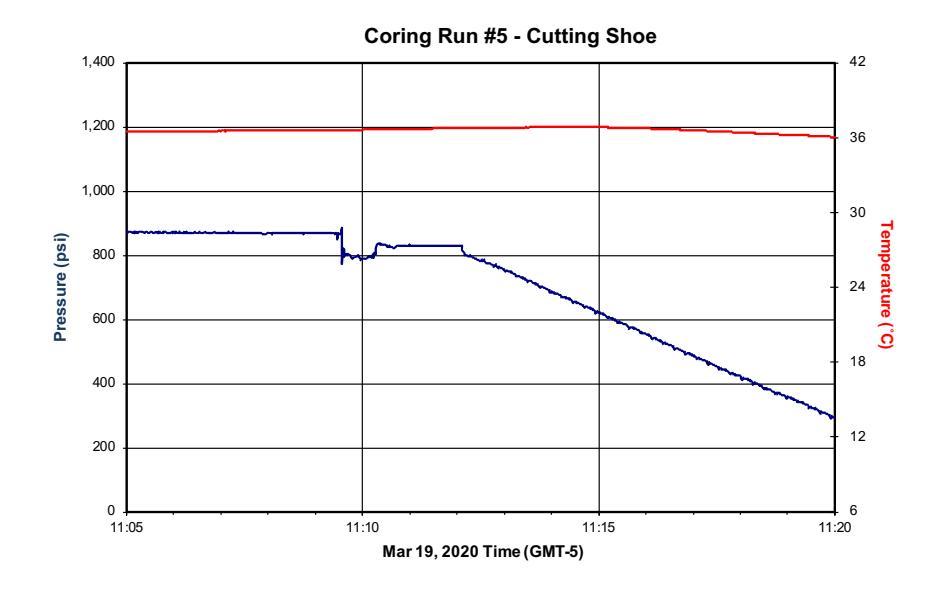
Figure 12. DST record from 5CS blown up around the period of core retrieval. Note the unusual pressure record around the start of core retrieval.

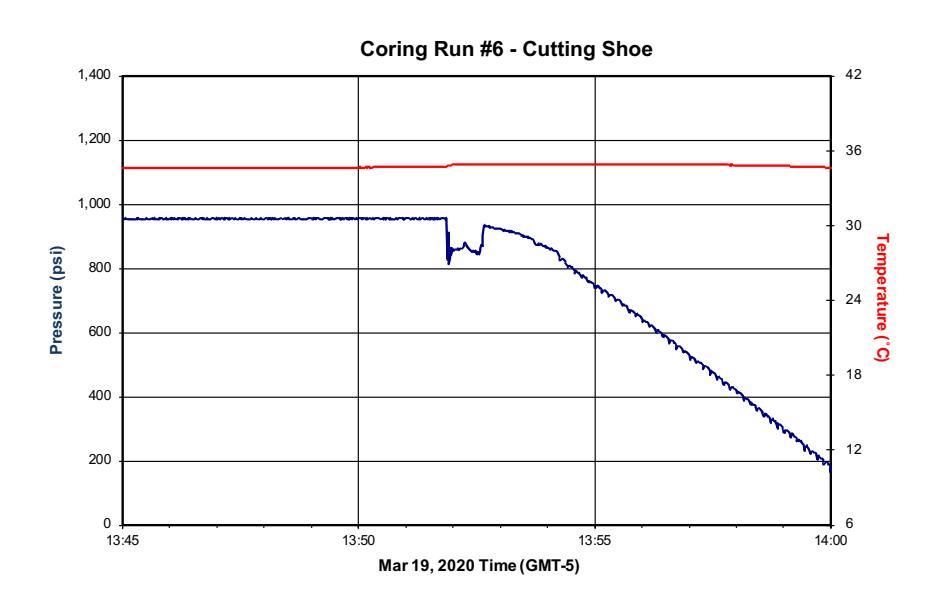
At the surface, the ball was again observed to be partially open. In post-run analysis the ball valve mechanism was again found to be stiff with grit present.

Failure mode: Incomplete ball closure

Figure 14. DST record from 6CS blown up around the period of core retrieval. Note the unusual pressure record around the start of core retrieval.

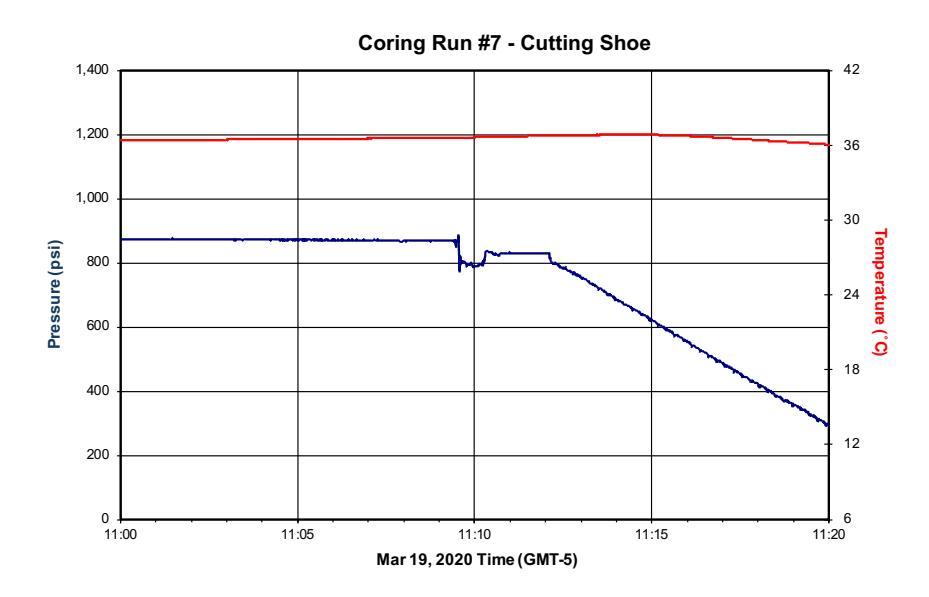
At the surface the tool was observed to be unpressurized, although the ball did appear to be fully closed. The tool was taken to the service van and pressure tested in in-situ condition. The autoclave and pressure section were tested to 1800 psi (boost pressure) without leaks. Pressurizing the tool took many times longer than normal, indicating that the tool was empty when the ball closed. This suggests that the ball was open while the tool was pulled up hole, draining the contents before the ball closed at some point before reaching the surface.

Failure mode: Presumed incomplete ball closure

Figure 15. DST record from 7CS blown up around the period of core retrieval. Note the unusual pressure record around the start of core retrieval.

Corrective action: None; end of field test

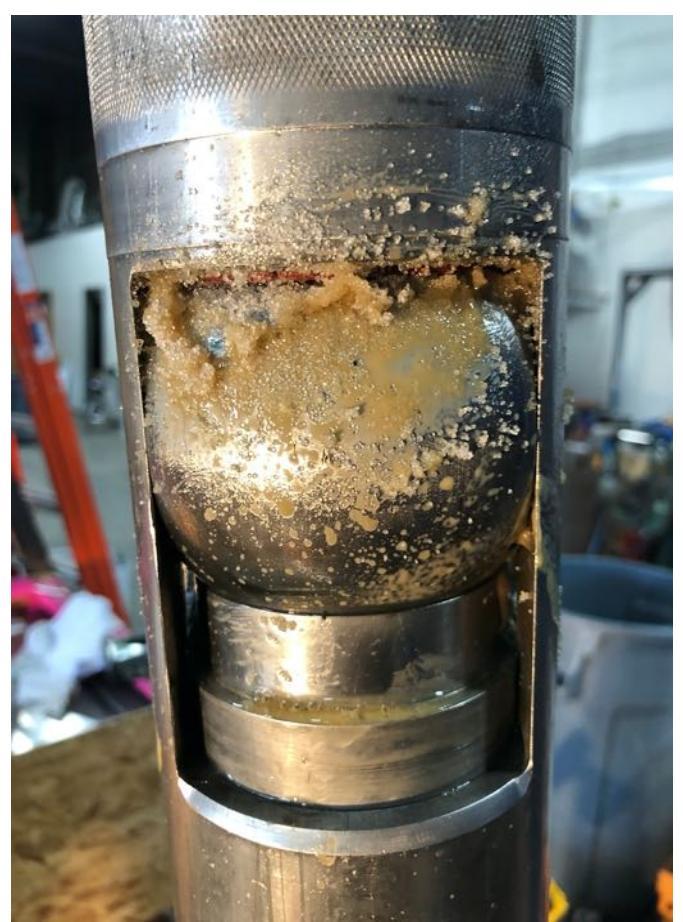
Figure 19. Ball valve covered with #100 mesh sand

The ball valve actuated fully and the #100 sand created no discernable issues during the test.
